Assessment of Restorative Maintenance Practices on the Infiltration Capacity of Permeable Pavement

U.S. Geological Survey—Upper Midwest Water Science Center, 8505 Research Way, Middleton, WI 53562, USA; wrselbig@usgs.gov (W.R.S.); nbuer@usgs.gov (N.H.B.)

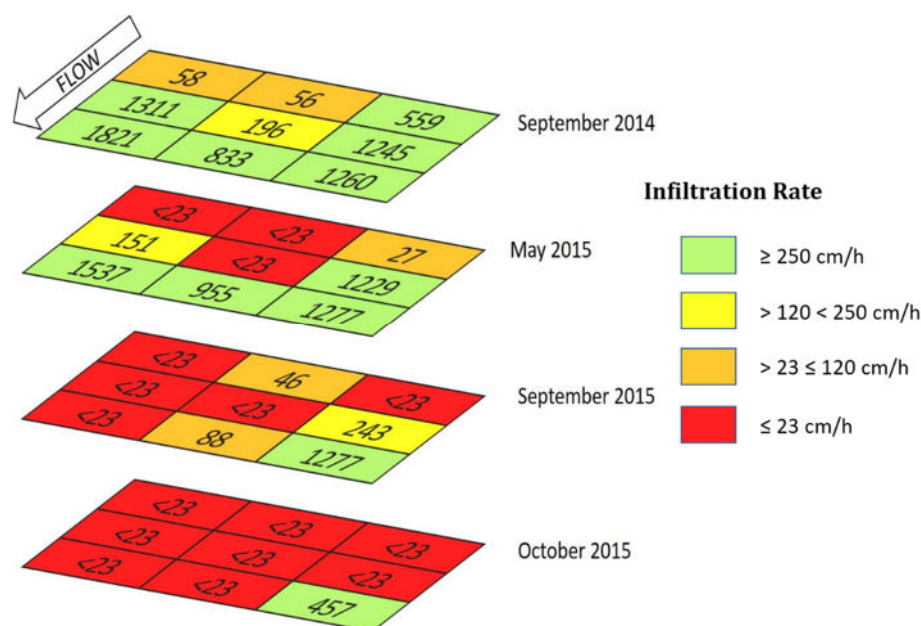
Figure 4. Heat map illustrating the progression of clogging across the permeable interlocking pavers surface over the first 14 months of the study when no restorative maintenance occurred. Adapted from Selbig and Buer [1] (cm/h, centimeters per hour).

Within 14 months of installation, prior to any maintenance activity, both PICP and PC had reached clogged status (six or more of the nine discrete infiltration test locations showed a rate of less than 23 cm/h). The PICP and PC average infiltration rates dropped to 71 and 84 cm/h, respectively (Figure 8). PA did not reach clogged status until one year later in October 2016, at which time its surface infiltration rate was 218 cm/h.

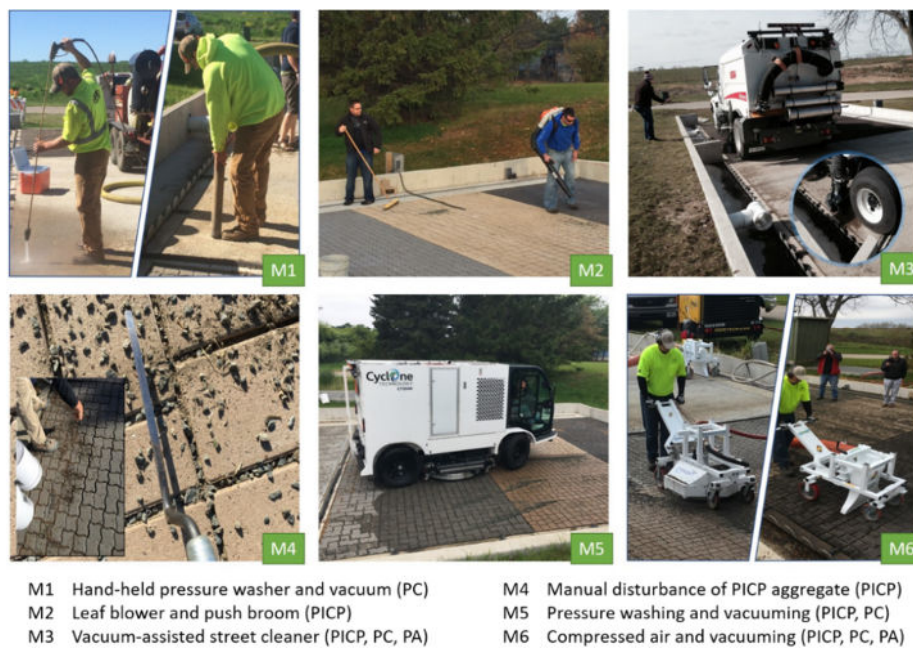
Figure 5. Images of the six different maintenance practices that were evaluated for use on permeable interlocking pavers (PICP), pervious concrete (PC), and porous asphalt (PA) test plots.

In May 2015, the high-powered pressure washer followed by high-powered vacuum suction features of a Ditch Witch FX30[®] (Charles Machine Works, Perry, OK, USA) vacuum excavator were applied to a portion of the PC surface to remove any dislodged material (Figure 5, M1). The angle of the washer spray was applied at approximately 90° to the PC surface with a pressure of 207 bar (3000 psi). The suction velocity of the vacuum was 15.3 m³/min. The machinery used for this exercise is typically meant for removal of accumulated sediment from catch basins and sumps and not restoration of permeable pavement; however, this cleaning targeted a 1.8 m swath on the north edge of the plot that clogged rapidly due to an installation defect, creating preferential flow across a narrow band of the PC test plot. The maintenance area included the discrete test locations 1, 4, and 7, as illustrated in Figure 3.

In November 2015, a manual cleaning was done on the PICP surface only. This process involved the clearing of surface debris using a high-powered leaf blower (Figure 5, M2). Any dislodged aggregate was removed using a bristled push broom and dustpan and replaced with new aggregate. The intent was to replicate what a typical homeowner may do to maintain their own PICP.

In April 2016, maintenance on all three permeable surfaces was done by use of an Elgin Whirlwind[®] vacuum-assisted street cleaner (Elgin Sweeper Company, Elgin, Ill, USA) (Figure 5, M3). The sweeper operator passed across each surface twice using only the vacuum feature of the street cleaner. The entire surface of PC and PA was treated; however, the concrete wall bordering the PICP test site prevented the vacuum portion of the sweeper from reaching approximately one-third of the PICP surface (discrete location numbers 1, 4, and 7 in Figure 3).

In June 2017, all the joints between pavers in the PICP were scraped by use of a 0.6 cm masonry trowel (Figure 5, M4). Any aggregate loosened by the scraping action of the trowel was removed by use of a push broom and dustpan and replaced with new aggregate. This method was very labor-intensive but was done to further confirm clogging of PICP due to shallow penetration of the sediment into joint aggregate, as described by Selbig and Buer [1]. It was also done to test if a non-mechanical means of PICP maintenance could result in similar improvements to infiltration rates as demonstrated by more sophisticated technologies.

In August 2017, a Cyclone Industries[®] CY5500[®] (Cyclone Technology, Tempe, AZ, USA) pressure washing machine was used to clean PICP and PC surfaces (Figure 5, M5). PA was not cleaned, due to removal of the surface 1 month prior. The Cyclone[®] uses a cleaning and recovery head that simultaneously pressure-washes the surface and recovers waste and water. Water heated to 71 °C

In October 2018, all three surfaces were treated with the TYPHOON[®] and PAVEVAC[®] by PaveTech[®] (PaveTech Inc., Prior Lake, MN, USA) (Figure 5, M6). The TYPHOON[®] is primarily intended to be used as an excavator of PICP joint aggregate by use of compressed air. Once the aggregate was dislodged, it was removed by the PAVEVAC[®], which uses a high-lift vacuum to remove the excavated material in preparation to refill the joints [22]. Although designed for restoration of PICP, both the TYPHOON[®] and PAVEVAC[®] were applied to PC and PA to determine the restoration potential for other permeable pavements. A portion of the PC surface received two passes of the PaveTech machinery (discrete location numbers 1, 2, 4, and 5 in Figure 3) to determine if the number of passes provided additional improvement over a single pass.

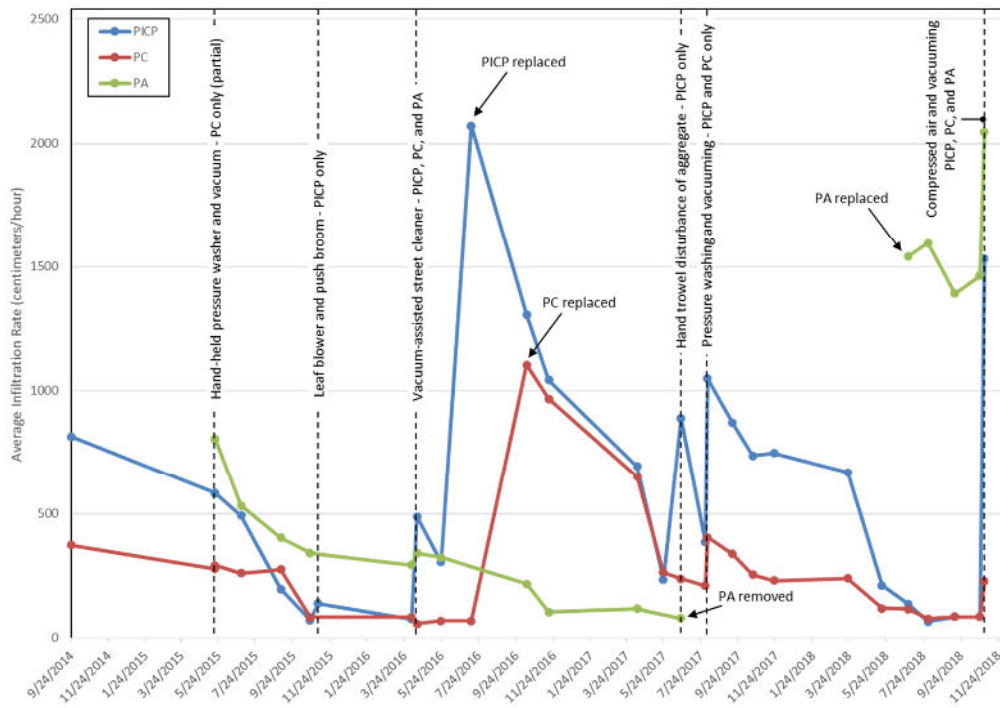
The first infiltration measurements were performed on 24 September 2014, approximately 1 month after installation. At that time, the surface infiltration rates for PICP and PC were 815 and 374 cm/h, respectively (Figure 7); PA results are not reported, due to measurement error. The first PA infiltration test recorded was 807 cm/h on 18 May 2015. These initial infiltration rates are above the rate of 254 cm/h (100 in/h) required by the WDNR conservation technical standard [20], but lower than findings reported from other studies, which, in many cases, exceeded 2500 cm/h [25,26]. This discrepancy may, in part, be due to clogging that occurred between installation and measurement; during this 1 month period for PC and PA, the site received 5 cm of rainfall distributed over seven events, two of which were greater than 1.27 cm.

Figure 7. Response of average infiltration rates to restorative maintenance practices and surface replacement at the permeable interlocking pavers (PICP), previous concrete (PC), and porous asphalt (PA) test plots (the dashed line intersects the date and identifies the type of maintenance practice tested).

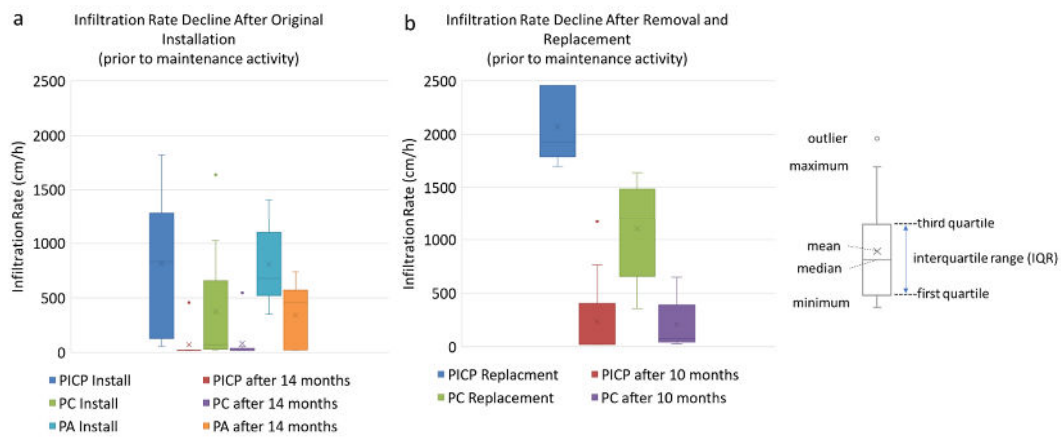
Figure 8. Decline in infiltration rates during the period without maintenance activity following (a) initial surface installation and (b) surface replacement of the permeable interlocking pavers (PICP), previous concrete (PC), and porous asphalt (PA) test plots (cm/h, centimeters per hour).

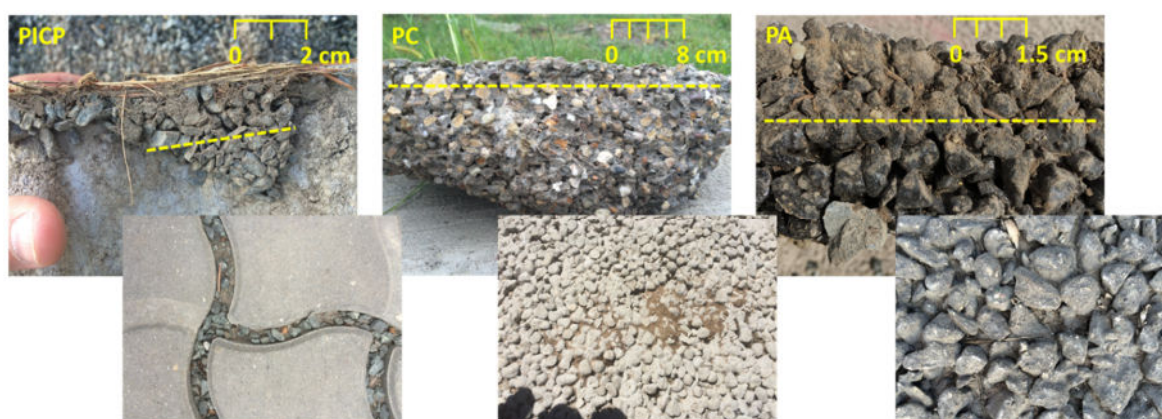
The surface structure of individual pavement types can influence the advancement of clogging, as well as the response to maintenance. Despite varying thickness during the construction process, the majority of clogging for permeable pavements has been shown to occur within the top 1.5 to 2.5 cm [1,17]. This was verified at each plot by visual examination of pavement surfaces and profiles upon removal (Figure 9). These findings were further confirmed by Kayhanian et al. [27] who scanned cores from 20 PC parking lots and found that clogging generally appeared to be limited to the upper 2.5 cm. Winston et al. [17] reported that milling of a 21 year old porous asphalt surface to a depth of 2.5 cm nearly restored the infiltrative capacity to like-new conditions. Results from this study and others [1,17,27] indicate that maintenance practices that penetrate deeper into a permeable surface will have a greater likelihood of restoring the infiltrative capacity.

Figure 9. Photographs of the sediment captured in the profiles and on the surfaces of the permeable interlocking pavers (PICP), pervious concrete (PC), and porous asphalt (PA) (the dashed line indicates sediment penetration depth; lower images not to scale).
