EVALUATING FIRE-EXPOSED CONCRETE MASONRY WALLS AFTER A FIRE

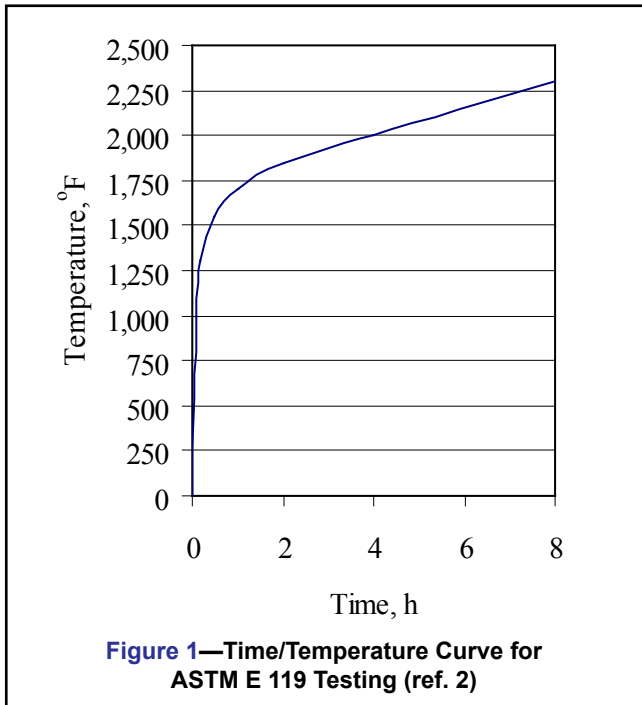
The ASTM E 119 fire test time/temperature protocol is shown in Figure 1.

There is a large body of data on concrete masonry walls tested according to the ASTM E 119 protocol. This test method evaluates walls subjected to the standard test fire. Performance criteria include: resistance to temperature rise on the unexposed side of the wall; resistance to the passage of hot gases or flames through the wall; structural stability during the test; and resistance of the masonry to deterioration under direct exposure to a fire hose stream immediately following the fire test. Research has shown that the fire resistance ratings of concrete masonry walls are invariably determined by the temperature rise on the cold (unexposed) side of the wall.
