Permeability Restoration of Permeable Interlocking Concrete Pavements

Recipient: University of Toronto Dept. of Civil & Mineral Engineering
Grant: Cdn\$63,300; Industry support: Cdn\$58,221; Cdn\$82,075 from the
Natural Sciences Engineering Research Council of Canada
Completion: 2020 Fact Sheet 19

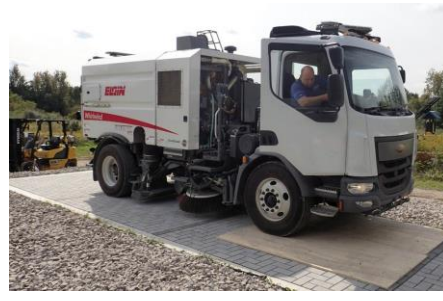
True vac machine

The regenerative air machine restored 20% of the surface permeability. This confirms the use of this equipment for routine cleaning to remove loose dirt, leaves, litter, etc. and not on clogged surfaces. The true vac produced the most variable results. On average, the PICP's surface infiltration capacity was

~7,500 mm/hr (295 in./hr) or 70% of post-construction surface infiltration. Measurements ranged from 1,280 mm/hr (50 in./hr) to 13,900 mm/hr (547 in./hr). Power washing and a Shop Vac improved surface infiltration by 25%. The waterless mechanical street sweeper restored the PICP's surface infiltration capacity to 35% of its original condition, or about 3,540 mm/hr (139 in./hr). The high pressurized-air and vacuum system fully restored the PICP to its baseline, post-construction surface infiltration. Average surface infiltration rates were 2 to 6 times higher than from other equipment, ~12,900 mm/hr or 508 in./hr for cohesionless soil mixed with jointing stone.

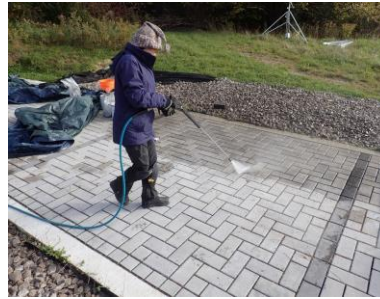
Power washing before applying a Shop Vac
