# Permeability Restoration of Permeable Interlocking Concrete Pavements

Recipient: University of Toronto Dept. of Civil & Mineral Engineering  
Grant: Cdn\$63,300; Industry support: Cdn\$58,221; Cdn\$82,075 from the  
Natural Sciences Engineering Research Council of Canada  
Completion: 2020 Fact Sheet 19

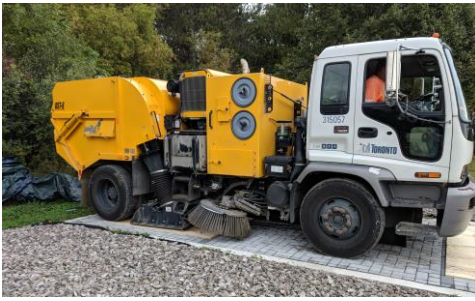
**Regenerative air machine**

The regenerative air machine restored 20% of the surface permeability. This confirms the use of this equipment for routine cleaning to remove loose dirt, leaves, litter, etc. and not on clogged surfaces. The true vac produced the most variable results. On average, the PICP's surface infiltration capacity was

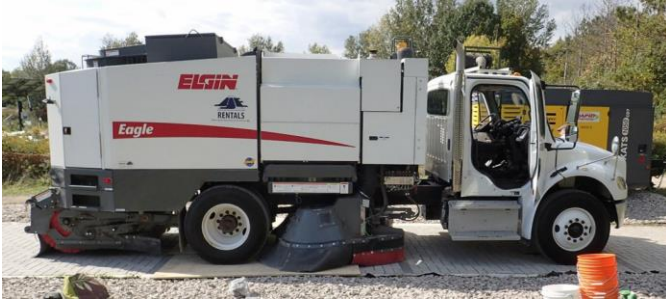
**Waterless Mechanical Sweeper**

~7,500 mm/hr (295 in./hr) or 70% of post-construction surface infiltration. Measurements ranged from 1,280 mm/hr (50 in./hr) to 13,900 mm/hr (547 in./hr). Power washing and a Shop Vac improved surface infiltration by 25%. The waterless mechanical street sweeper restored the PICP's surface infiltration capacity to 35% of its original condition, or about 3,540 mm/hr (139 in./hr). The high pressurized-air and vacuum system fully restored the PICP to its baseline, post-construction surface infiltration. Average surface infiltration rates were 2 to 6 times higher than from other equipment, ~12,900 mm/hr or 508 in./hr for cohesionless soil mixed with jointing stone.

- The depth of evacuation into joints was a strong indicator of overall maintenance effectiveness when clogged with similar materials, but not when clogged with different materials.
- Orientation of street sweeper suction/collection heads greatly influenced the amount of joint materials removed. Passes in all joint directions can likely provide the highest results.
- Cohesive soils in the joints significantly decreased the effectiveness of restorative maintenance. The high pressure-air/vacuum system was only able to restore the PICP's surface infiltration to approximately 50% of the pavement's original surface infiltration while removing cohesive sediment. In contrast, this equipment was able to fully restore infiltration when non-cohesive materials occupied the joints.

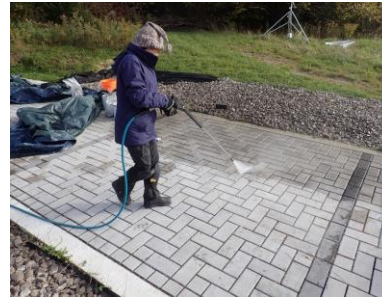
**Power washing before applying a Shop Vac**

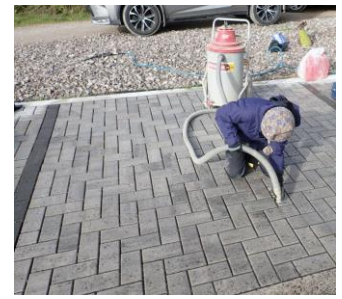
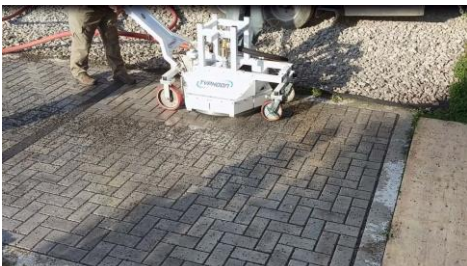
**High pressure air and vacuum system**
