ICPIF Paver Analysis Report:

Pittsburgh, Philadelphia/New Jersey, & Northern Virginia

**Report Prepared By: Eric Sinagra, CEO, pathVu,
eric.sinagra@pathvu.com**

August 30, 2018

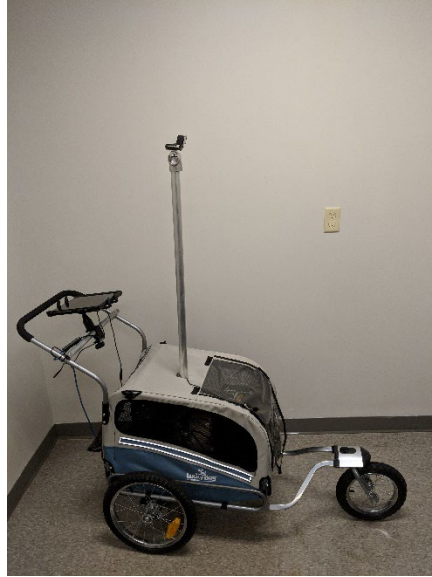
Figure 1: Picture of PathMeT

PathMeT is pathVu's proprietary device used to collect high-quality, high-resolution pathway data. PathMeT was used in data collection and testing to develop ASTM 3028. PathMeT is a manually propelled three-wheeled device (Figure 1). PathMeT contains numerous sensors, including laser displacement measurement tool, wheel encoder, 9 degrees of freedom inertial measurement unit, camera, and GPS. PathMeT's laser is a single-point laser, allowing the technician to accurately collect the correct centerline and complying with ASTM 3028 requirements. The profile is collected at a millimeter resolution or better in order to collect all of the details the surface, not missing any joint widths. Besides WPRI, PathMeT identifies tripping hazards, running slope, cross slope, and depressions.

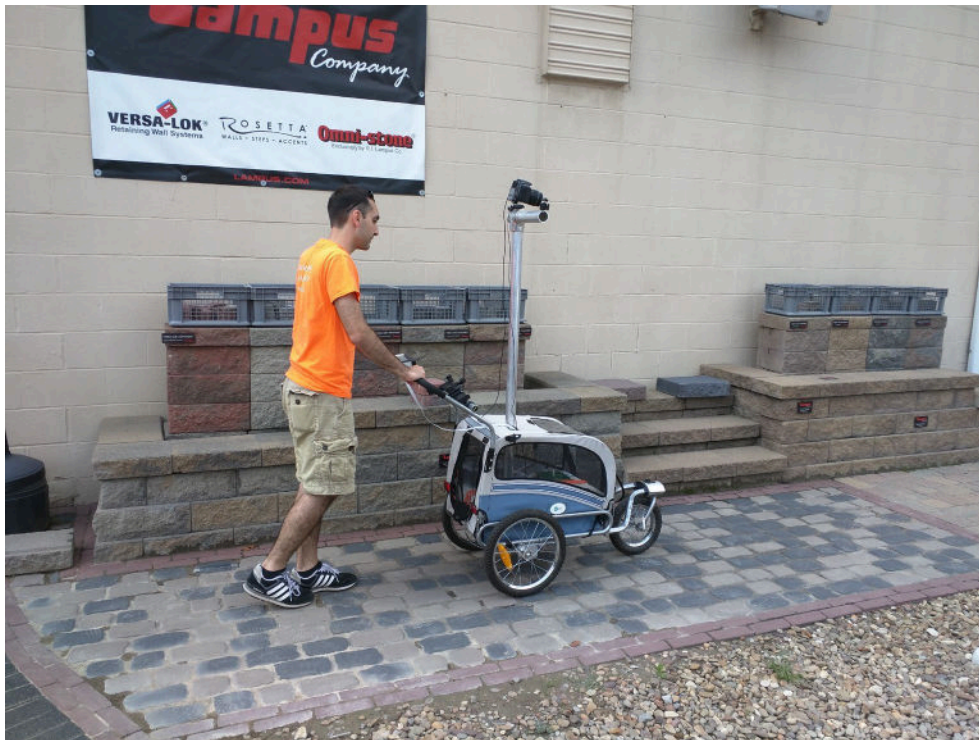
Figure 2: Picture of PathMeT Data Collection

For each surface, the pathVu technician (Eric Sinagra in each case) would follow the steps below. For PathMeT data collection, the technician would walk at a pace of approximately 1 m/s (2 mph) and made sure that the device laser never went in between lateral gaps. The technician would avoid any sticks, leaves, or debris if necessary. If possible, the technician cleaned the pathway ahead of time. Runs with errors were discarded and not included in analysis. Figure 2 shows an image of data collection with PathMeT.
