# Maintenance Equipment Testing on Accelerated Clogged Permeable Interlocking Concrete Pavements

Prepared for: Interlocking Concrete Pavement Institute Foundation for Education and  
Research

Jennifer Drake, Ph.D., P.Eng.  
Tahmineh Sarabian, M.A.Sc., P.Eng  
Jody Scott Ph.D. Student  
4-1-2020

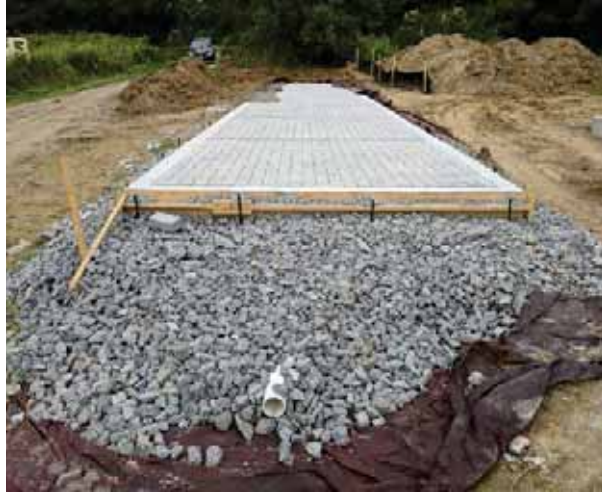
Figure 2-2: Test pad following construction (Aug 18<sup>th</sup>, 2017).

A 21 m by 3 m (69 ft by 10 ft) PICP test pad with a partial infiltration system was constructed at the Toronto and Region Conservation Authority (TRCA) Living City Campus (Kortright) in Vaughan, ON, during the summer of 2017. Coloured pavers subdivided the pad into seven 3 m x 3 m cells as shown in Figure 2-1 and Figure 2-2. A cross-sectional layout is provided in Figure 2-3. The pavers were 120 mm by 240 mm by 80 mm thick (4.75 in by 9.5 in by 3 in) Enviro Midori (supplied by OAKS by Brampton Brick) marble grey with a 7.5 mm (0.3 in) spacer bar and laid in a 90° herringbone pattern with site-cast concrete for edging. A drawing of the paver is provided in Appendix A. The construction followed the Interlocking Concrete Pavement Institute (ICPI) design guidelines and those in ASCE 68-18 on PICP. This included a 50 mm (2 in) thick ASTM No. 8 bedding layer, a 100 mm (4 in) thick ASTM No. 57 base layer, a 150 mm (6 in) thick ASTM No. 2 subbase layer, geotextile and an underdrain. The joints were filled with ASTM No. 8 aggregate and, on average, had widths of  $7.8 \text{ mm} \pm 1 \text{ mm}$  ( $0.31 \text{ in} \pm 0.04 \text{ in}$ ). Surface openings were 10% of the total PICP surface area. All the aggregate for the construction of PICP cells were washed. A 100 mm (4 in) diameter perforated underdrain was installed in an approximately 100 mm (4 in) deep sump below the subbase and bedded within ASTM No. 57 stone. A permeable geotextile (Mirafi RS380i) with a flow rate of 3,463 l/min/mm (85 gal/min/ft<sup>2</sup>), a permittivity of 1.2 per second and an apparent opening size of 0.30 mm was installed below the subbase and underdrain to separate the aggregates from the native soil. The PICP cells allowed for partial infiltration into the native low permeability soils, which had saturated hydraulic conductivity of approximately 2 mm/hr (0.08 in/hr). The pavement was covered and blocked from foot traffic in December of 2017 to avoid unmonitored transportation of sediment to the PICP surface.

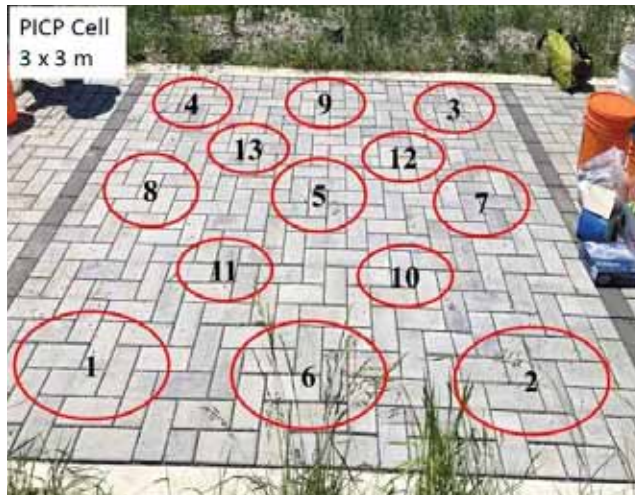
Figure 3-1: Surface infiltration test locations in each cell.

On each cell, SI was measured at five locations (Locations 1 – 5, Figure 3-1) after construction in November 2017 and re-checked in July 2018 before starting the accelerated clogging.

SIR was measured at Locations 1 – 5 following each application of clogging materials. Four additional tests (locations 6 – 9, Figure 3-1) were performed on each cell to assess the overall SIR of the cells better and to evaluate if the repeated SIR tests collected during the accelerated clogging had created any localized effects on SIR measurements.

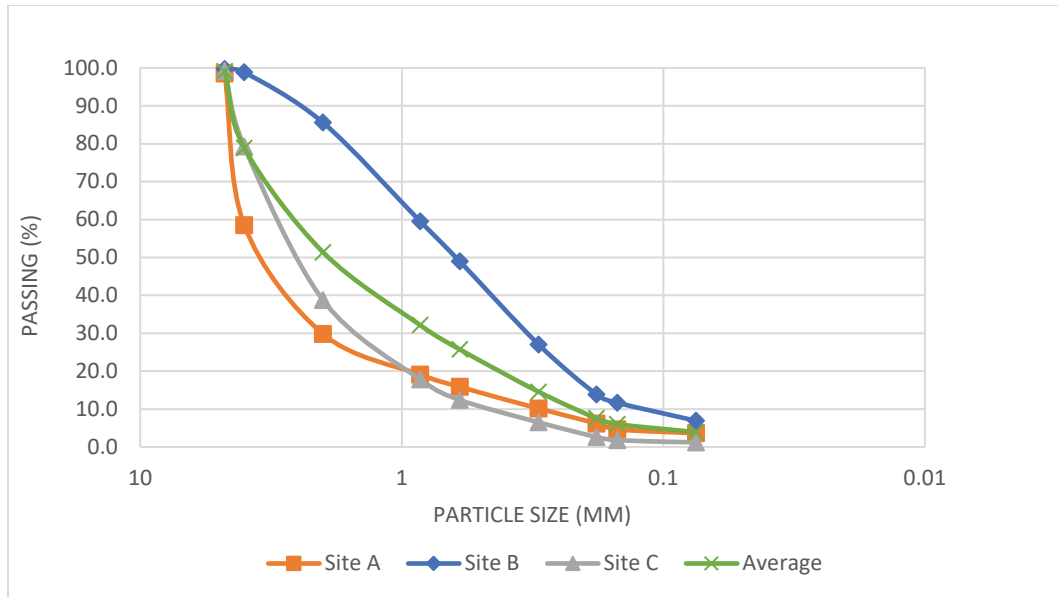
**Figure 3-2: Particle size distribution of the sediment collected from within PICP joints.**

The sampling procedure followed practices described in Gerrits and James [10] and Winston et al. [21]. At each sampling location, 600 – 800 g of sediment and aggregates were manually dislodged with a screwdriver from the top 3 cm of the PICP joints and collected with a canister vacuum cleaner. A new disposable vacuum bag was used for each test. Vacuum bags were weighed and labelled in the lab before use. Vacuum bags were placed in Ziploc bags and sealed to avoid loss of any fines during transportation to the lab. All sediment samples were analyzed for gradation as per the procedure outlined in ASTM C136 [25]. Clumped materials were not broken apart with a pestle and mortar because this process would damage organic material (twigs and leaf litter) that was also collected and mixed in the PICP joints. Figure 3-2 presents the gradation of the sediment found in the joints of the sampled PICP sites (Appendix B). The gradation results confirmed Hill and Beecham's [26] observation that although particles of all class ranges are involved in the clogging of PICP, courser particles play an important role in the process. An average of the gradation of the sediment found in the PICP joints at all three PICP locations (A, B and C) was used in preparing the clogging sediment used to clog the PICP test pad synthetically.

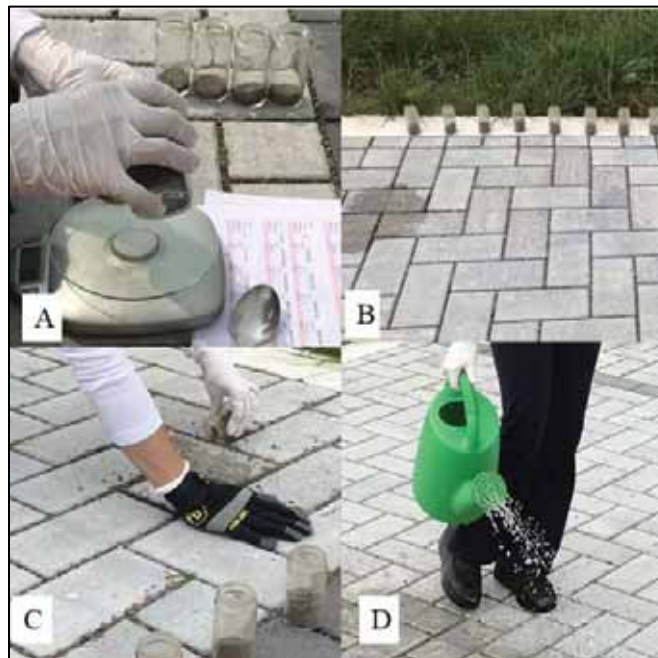
Figure 3-4: Clogging procedure: A) pre-weighing sediment before application; B) pre-weighed sediment for every row and column; C) application of sediment over joints; D) application of water to move sediment into the joints.

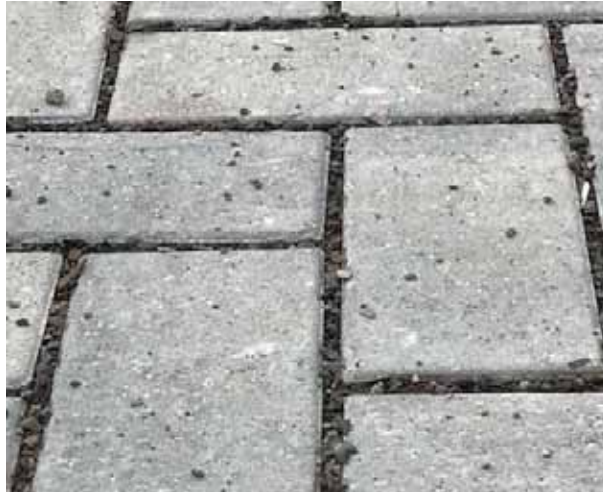
**Figure 3-5: Visual inspection of the PICP joints after the third round of clogging before compaction**

The final target SIR for the test pad was 250 mm/hr, as this is when restorative maintenance is recommended by ICPI. SIRs were measured 24 hours following each application of sediment. Appendix C summarizes the pavement synthetic clogging schedule. After three applications of sediment, it was observed that sediment was spilling out of the joints and onto the pavers (Figure

3-5). Since the target SIR had not yet been reached, a lightweight plate compactor was applied over the pavement to consolidate the sediment further into the joints. Immediately after, water was applied to facilitate the movement of sediment further down into the joints. SIRs were measured again before the next application of sediment.

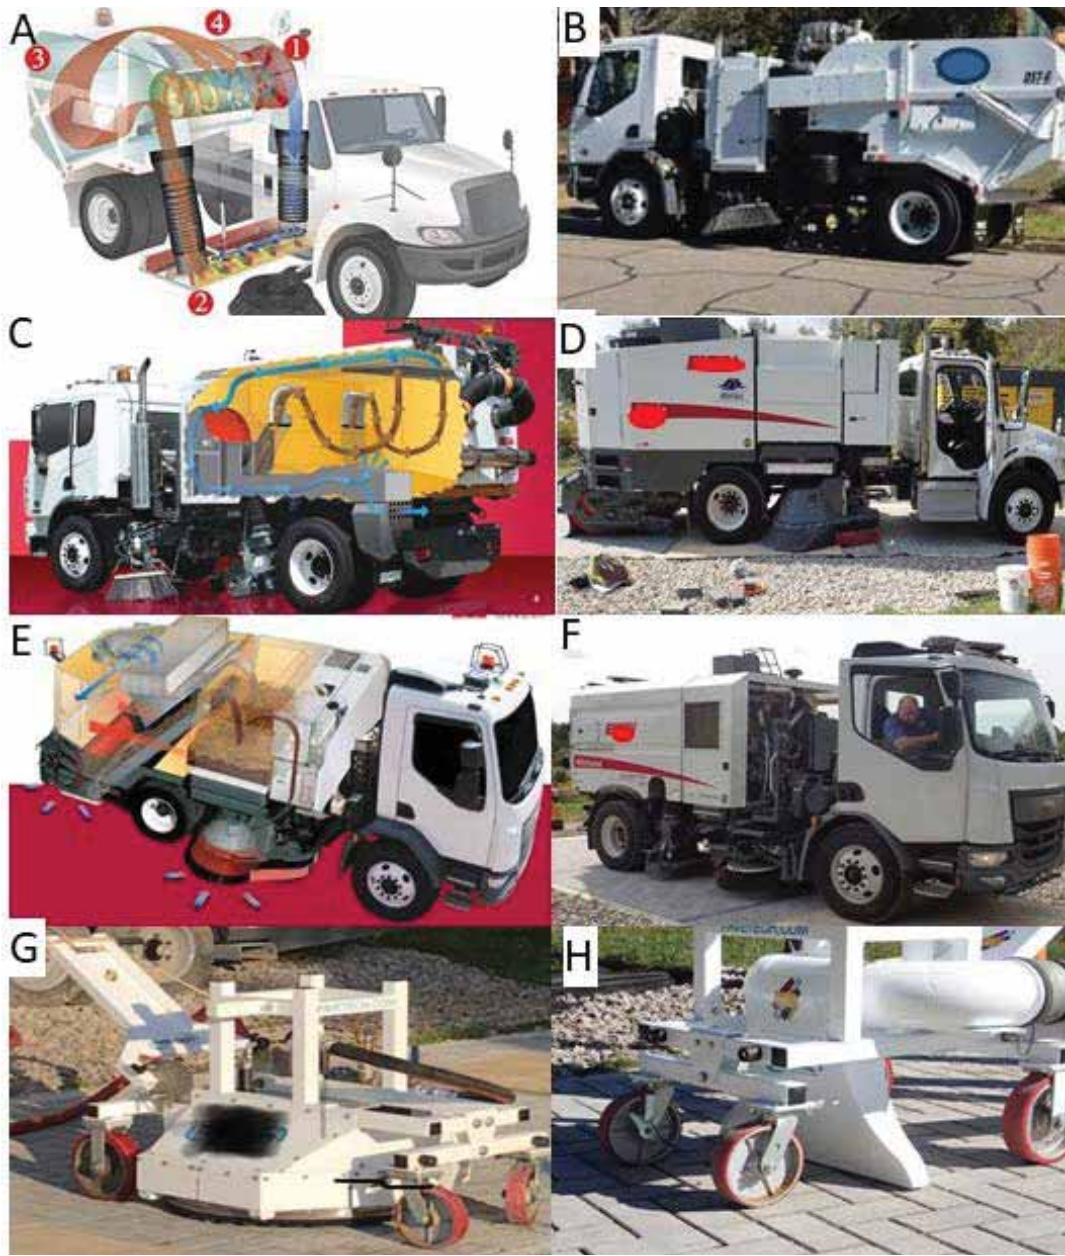
Figure 3-6: Street sweepers (A, B) Tymco® DST 6 regenerative air (Tymco Inc., 2019), (C, D) Elgin® Whirlwind vacuum (Elgin Sweeper Co., 2017), (E, F) Elgin® Waterless Eagle mechanical (Elgin Sweeper Co., 2019) and (G, H) Pavetech Typhoon and PaveVac.

Each PICP cell was treated by a different maintenance technique including three types of street sweepers: a regenerative air sweeper (Tymco DST-6®), a vacuum sweeper (Elgin WhirlWind®), a mechanical sweeper (Elgin Waterless Eagle®), pressure washing followed by manual vacuuming and specialized two-piece high pressurized-air and vacuum system (Typhoon® and Pavevac®). The Tymco DST-6® is a regenerative air street sweeper that operates by forcing pressurized-air to the pavement on one side and recycling the air through a suction head (2.2 m) on the other side. Tymco DST-6® has a 132 cm sweep path. The Elgin WhirlWind® is a vacuum street sweeper with a suction head (0.81 m) and a trailing arm broom on each side and has a sweep path of up to 366 cm. The Elgin Waterless Eagle® is a dry mechanical sweeper that includes two gutter brooms on each side and the main broom mounted at the rear of the vehicle. The sweeper has a conveyor belt as the primary collection mechanism and has a sweep path of 305 cm. The Typhoon® and Pavevac® are designed for the maintenance of PICP that consisted of a specialized blower head (0.61 m) and a vacuum head (0.71 m), that is connected to a trailered air compressor (200 psi) and a vacuum truck respectively. Figure 3-6 includes a picture of each maintenance technique, and Table 3-3 summarizes the tested maintenance techniques. During each test, adjacent cells were covered with plywood for protection. Only one pass was allowed for each technique.

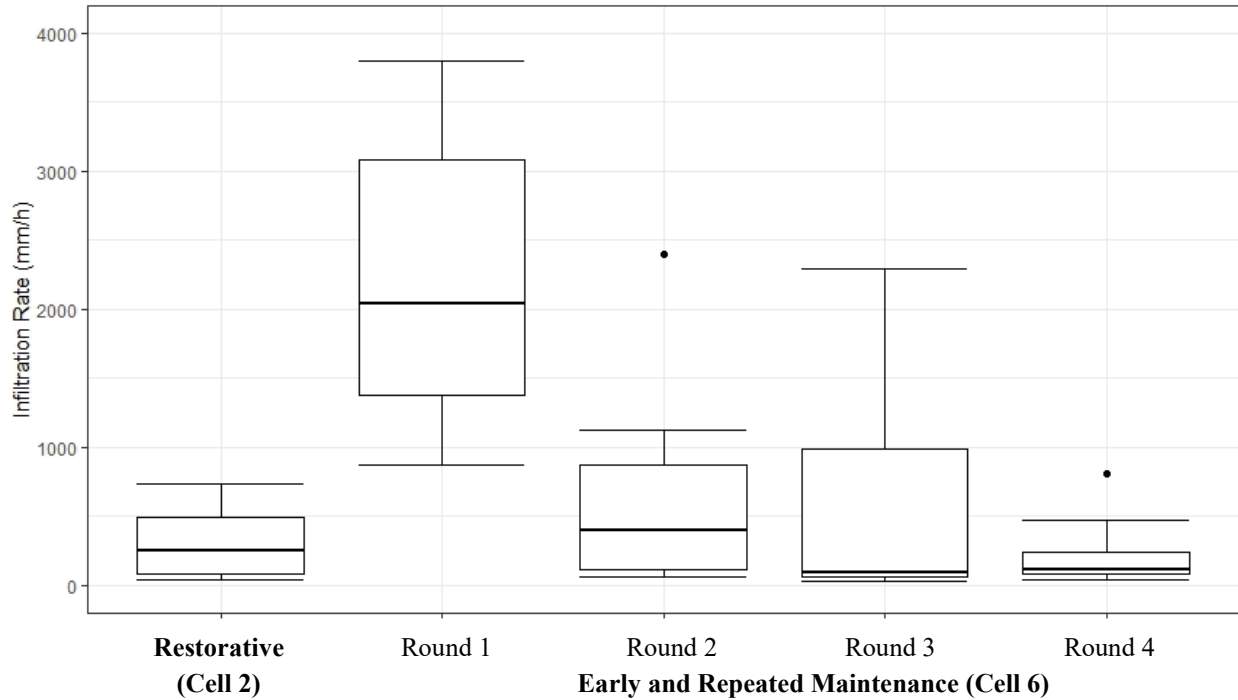
Figure 4-2: Pre-maintenance surface infiltration rates box plots of restorative (Cell 2) and early and repeated test cells (Cell 6)

Table 4-2 and Figure 4-2 present descriptive statistics and boxplots of the pavement’s pre-maintenance SIR, respectively. The benefits of early and repeated maintenance were evident in the test cell’s pre-maintenance surface infiltration data. Cell 2, which simulated restorative maintenance, was fully-clogged (i.e. average SIR  $\leq 250$  mm/hr) following the application of 9.3 kg of street sweepings. **In contrast, Cell 6, which had the benefit of early and repeated maintenance, only became fully-clogged after the application of 18.5 kg of street sweepings, a doubling of the total amount of clogging materials applied to the PICP surface.**

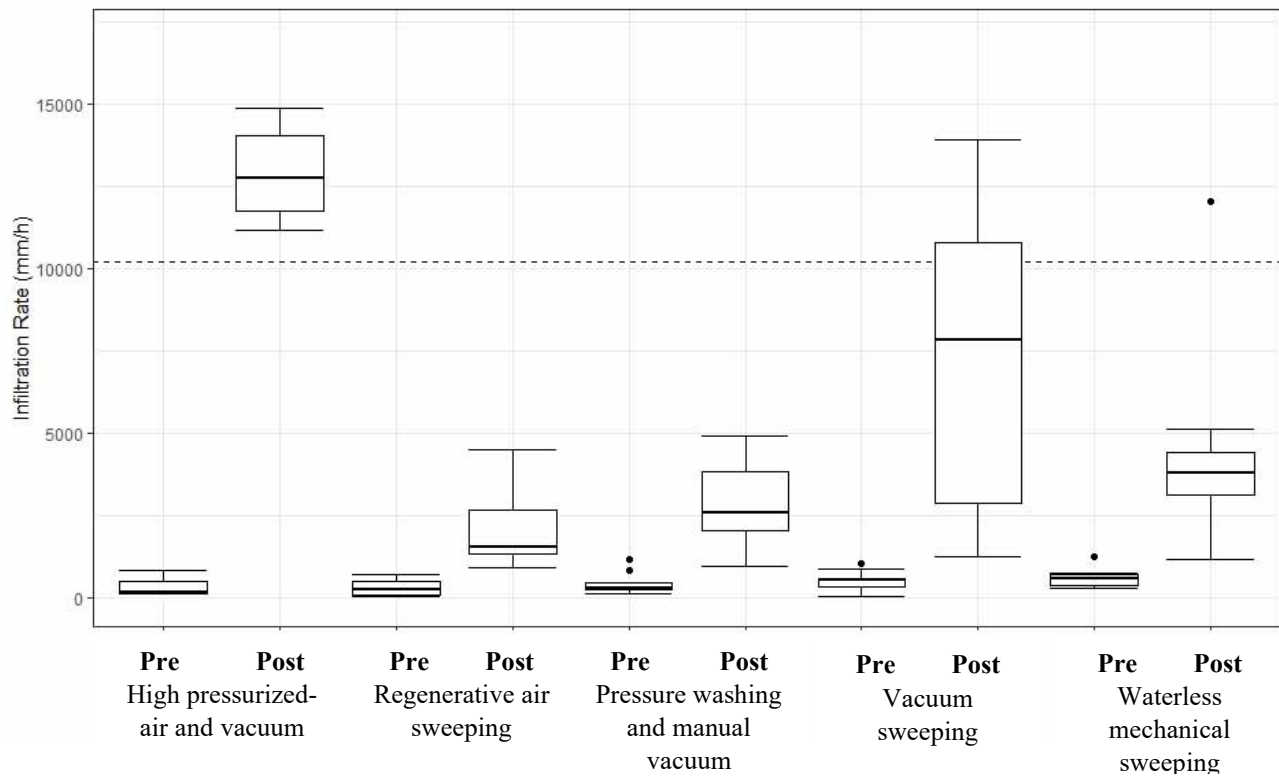
Figure 4-3: Box-plot presentation of the pre and post-maintenance surface infiltration rate for each surface treatment method.

Dashed line (---) indicated baseline conditions, average surface infiltration rate prior to clogging.

**All maintenance techniques significantly restored the pavement's surface infiltration capacity even when limited to a single pass over the pavement.** All post-maintenance SIR test results are provided in Appendix F. Table 4-3 and Figure 4-3 present post-maintenance descriptive statistics and boxplots, respectively. Statistical tests reported in Table 4-4 found that:

1. The high pressurized-air vacuuming provided the highest increase to PICP surface infiltration capacity than the other tested techniques;
2. Vacuum street sweeping provided a more significant increase to PICP surface infiltration capacity than the regenerative air street sweeper and the mechanical street sweeper;
3. Manual pressure washing followed by vacuuming provided similar levels of treatment as the regenerative air street sweeper and the waterless mechanical street sweeper;
4. And, the mechanical and vacuum street sweepers provided similar levels of treatment.

Although all of the surface treatments improved surface infiltration capacity, **only the high pressurized-air and vacuum system fully restored the PICP to its baseline, post-construction, condition.** The high pressurized-air and vacuum system produced mean surface infiltration measurements that were 2 – 6 times higher than all other tested techniques and restored PICP surface infiltration capacity to 109% of its original condition (approx. 12,900 mm/hr). Joint aggregates were replaced following maintenance but not compacted which likely caused the higher than post-construction SI measurements.

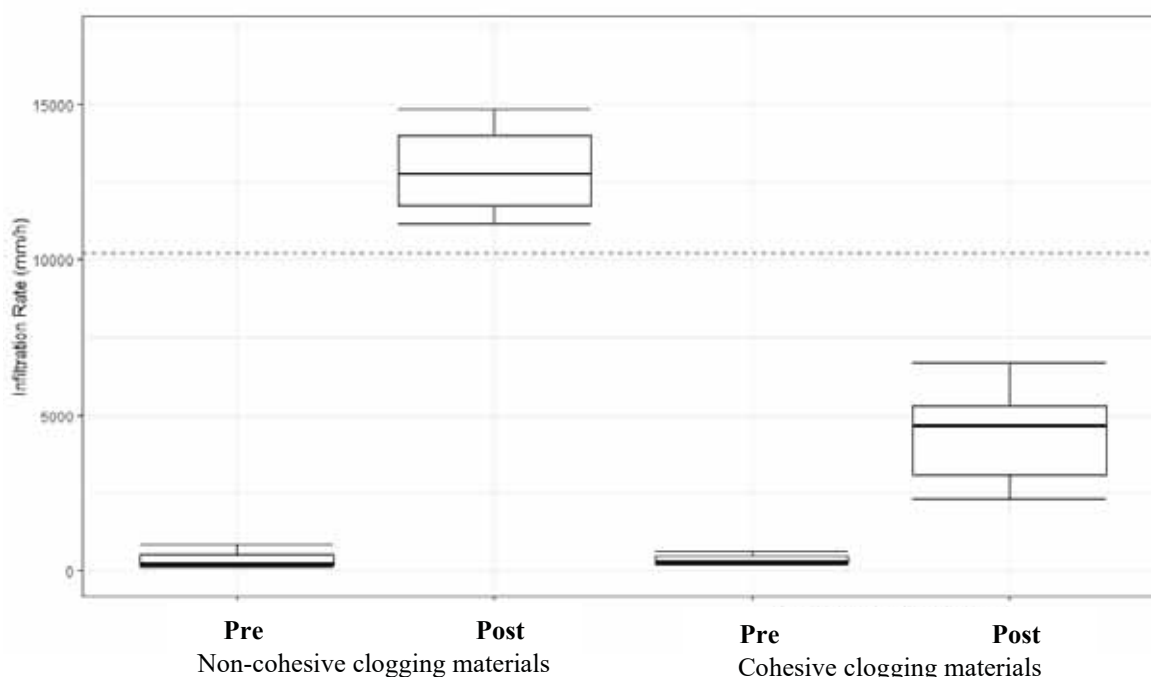
Figure 4-5: Restoration of surface infiltration capacity with and without cohesive soils in clogging materials using the high pressurized-air and vacuum system.

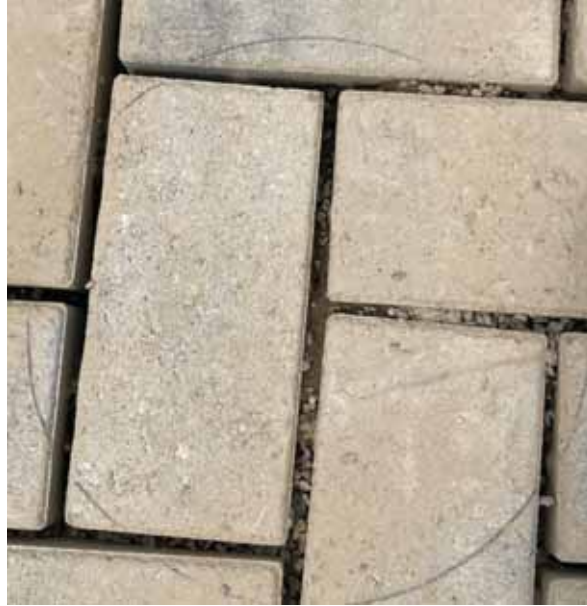
Figure 4-6: Example of sub-surface clay agglomerate left following maintenance

Joint penetration depths (Table 4-7) were statistically similar for both cells treated with the high pressurized-air and vacuum system. **Thus, joint penetration depth was not a good indicator for maintenance effectiveness when comparing pavement’s clogged with different source materials.** The addition of clayey soils to the clogging mixture allowed for compacted agglomerate to form within the joints. As shown in Figure 4-6, these clumps of sediments were very tightly adhered to the pavers and sometimes formed several millimetres below the pavement surface.

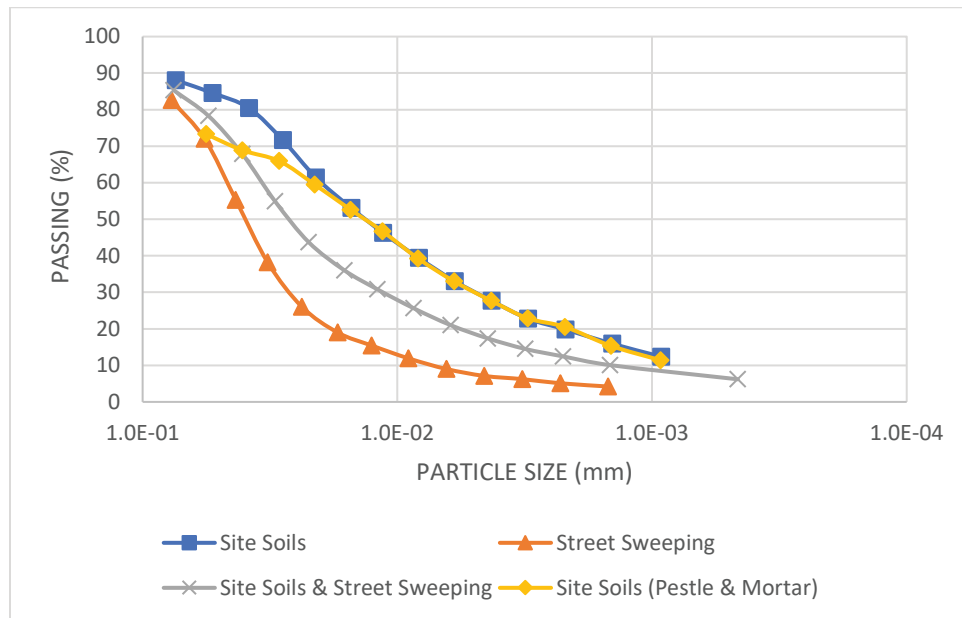
Figure D1: Gradation of fines passing No. 200 Sieve (Hydrometer data)

Additional hydrometer analysis was completed following the field experiments following ASTM D422 – 63 (Withdrawn) [29] . The gradation of the site soils was re-analysed breaking apart clumped material with a pestle and mortar. Gradation of fines passing the No. 200 Sieve is shown in Figure D1.

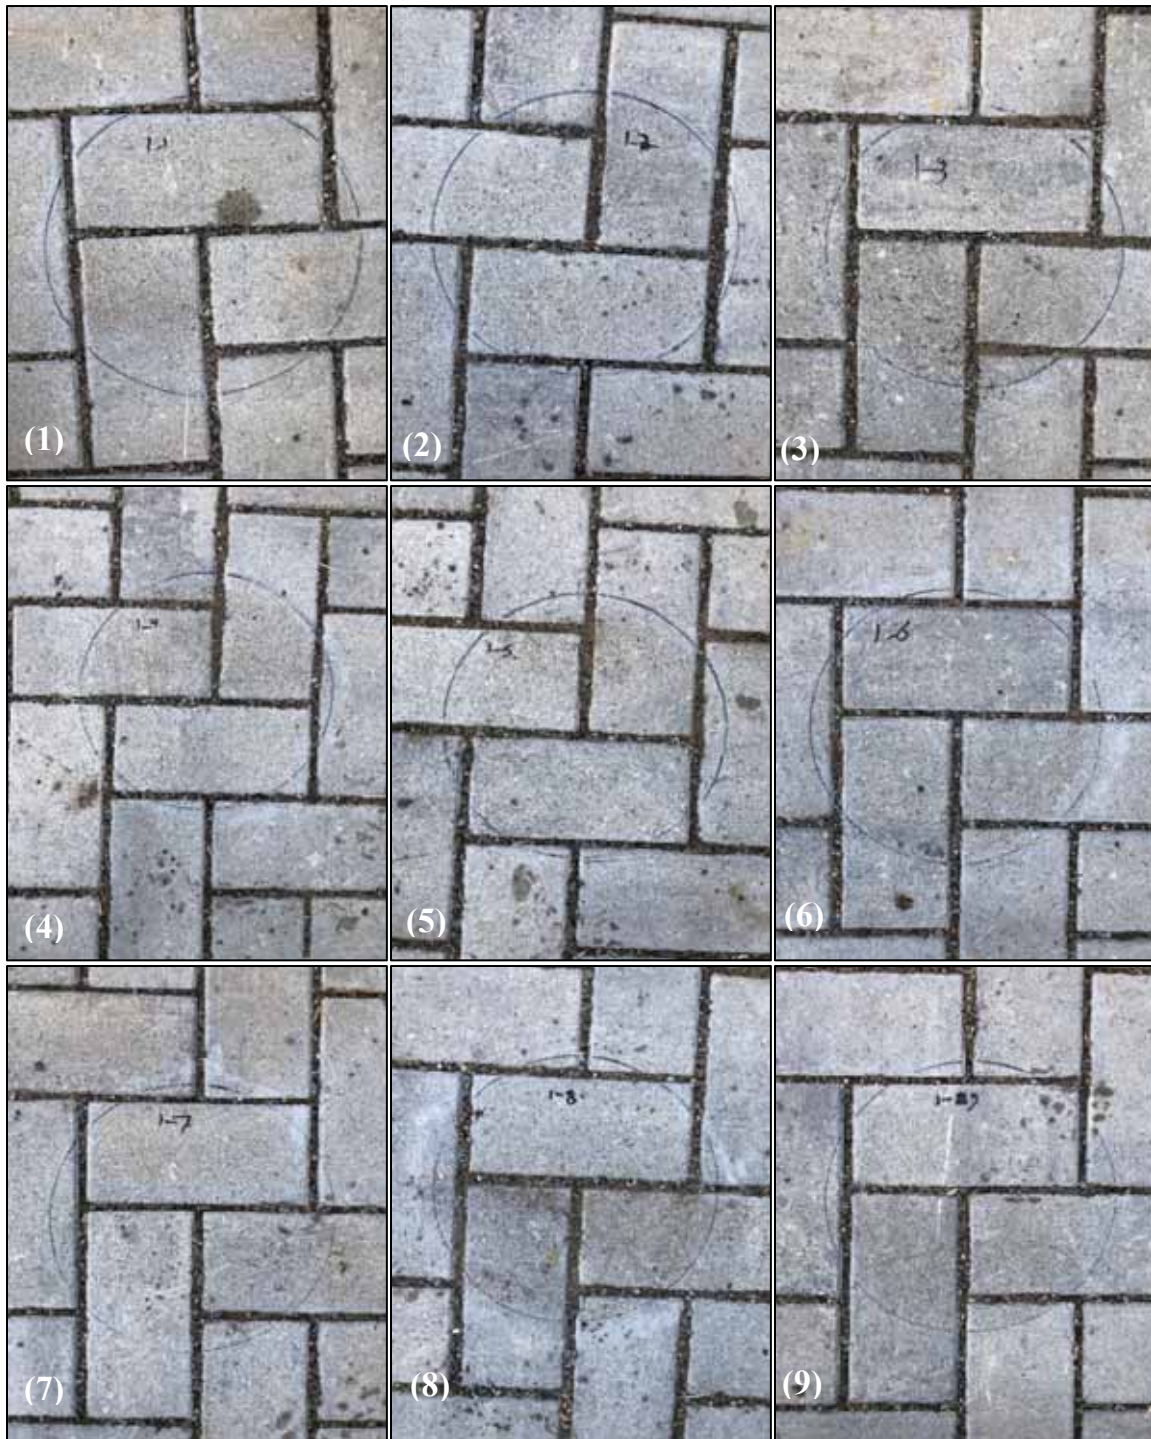
**Figure I1: Pre-maintenance photos of infiltration measurement locations (1-9) on Cell 1 (Pave-Tech Typhoon® and Pavevac®).**

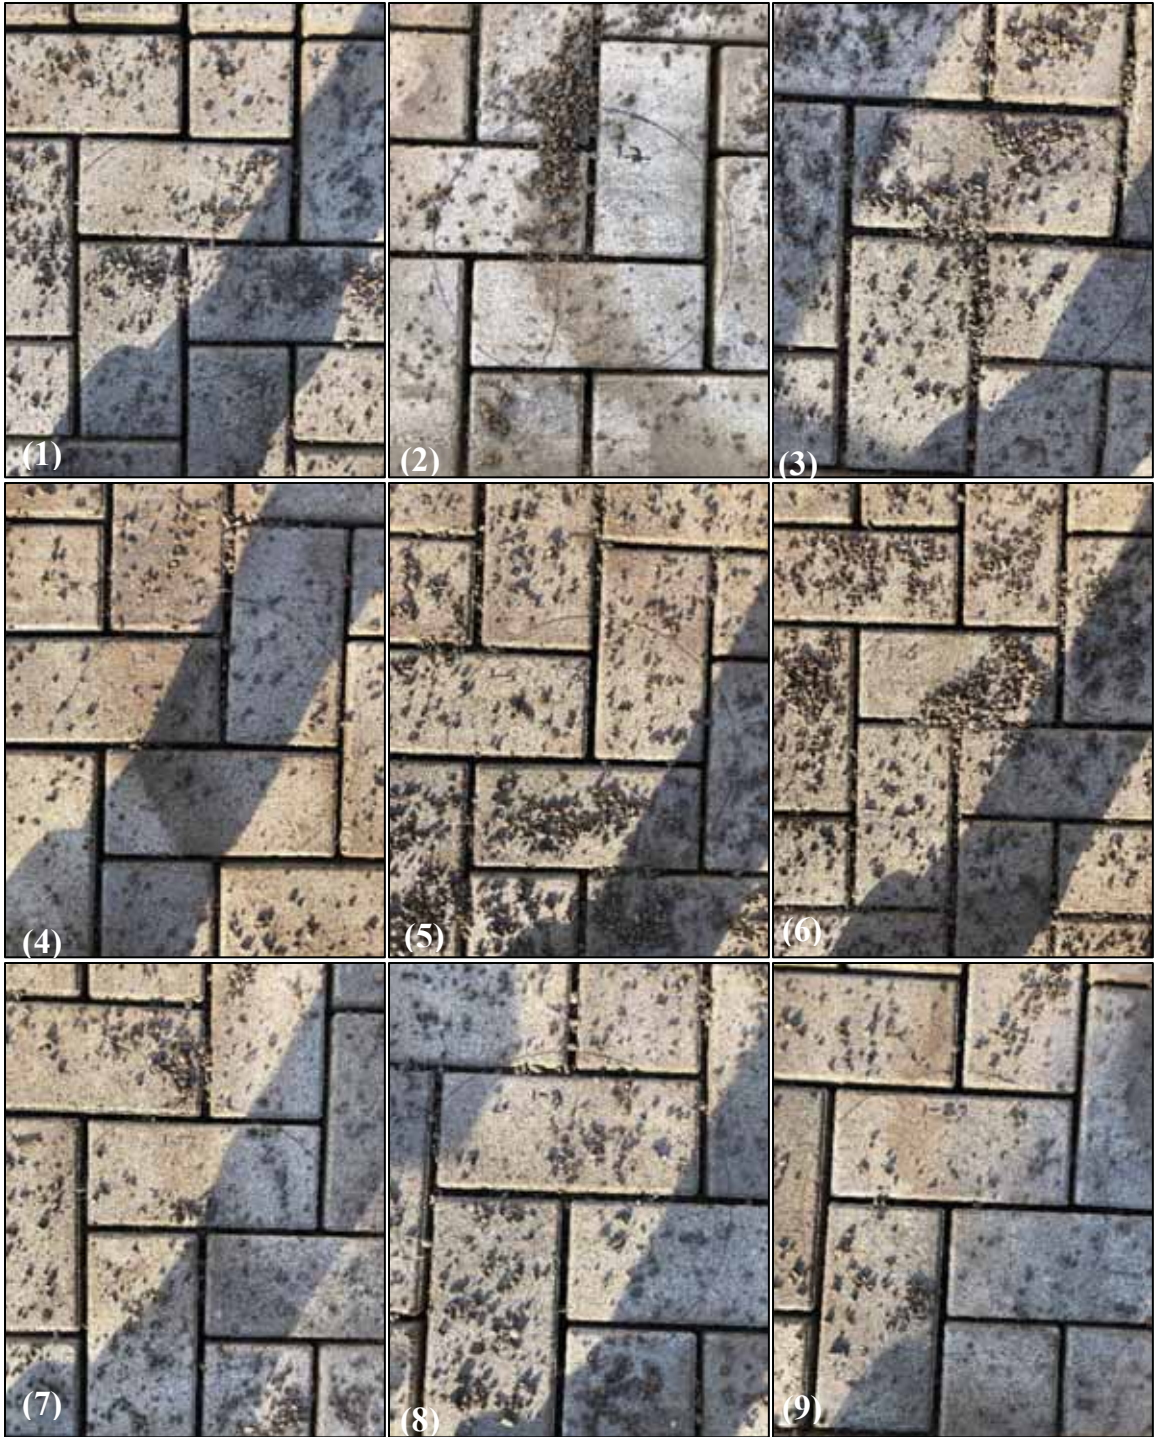
Figure I2: Post-maintenance photos of infiltration measurement locations (1-9) following high pressurized-air system on Cell 1 (Pave-Tech Typhoon®).

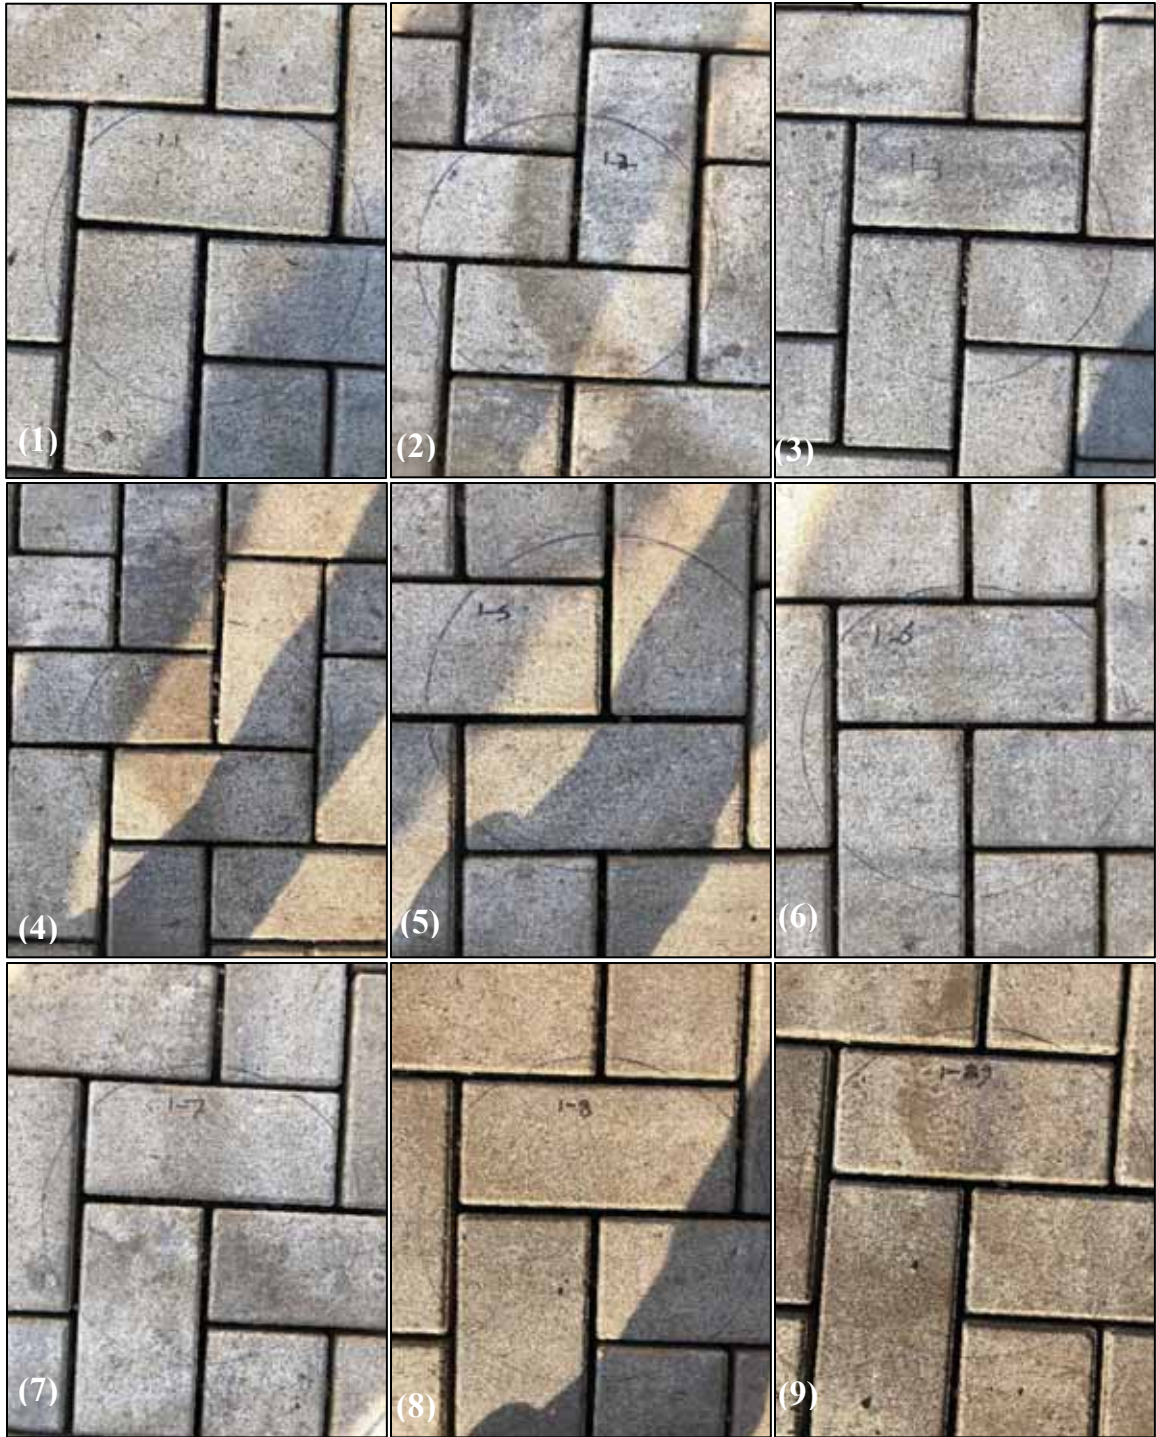
Figure I3. Post-maintenance photos of infiltration measurement locations (1-9) following a vacuum system on Cell 1 (Pavevac®).

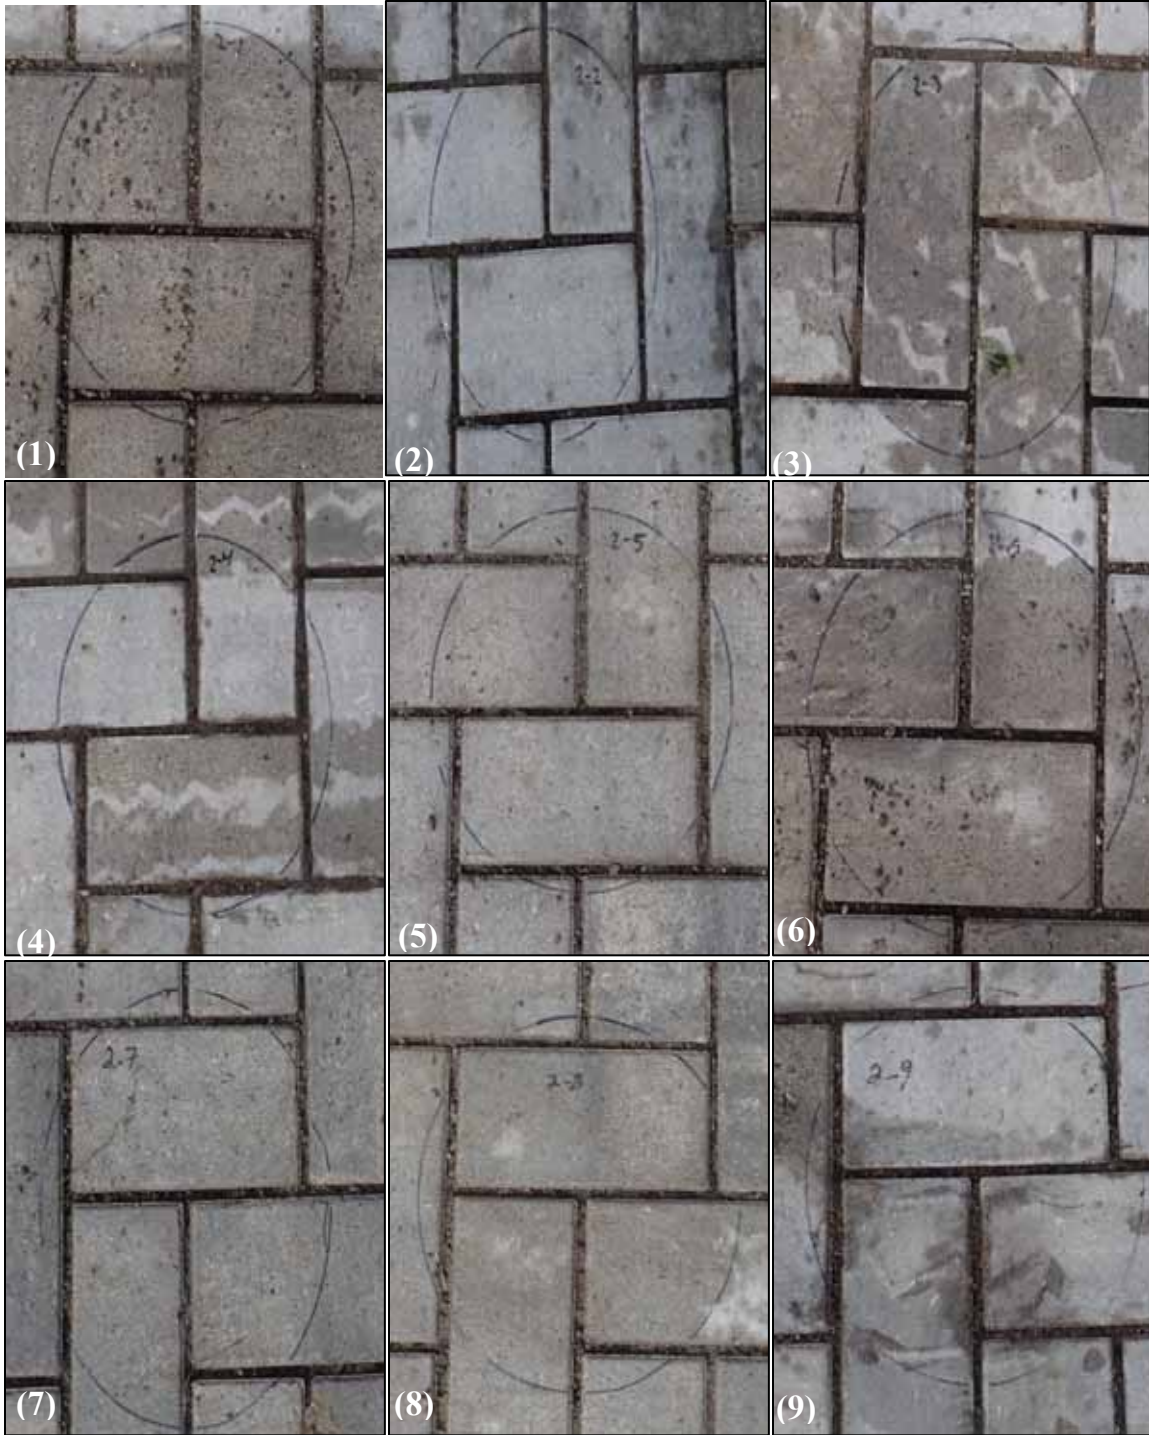
Figure 14. Post-maintenance photos of infiltration measurement locations (1-9) following a regenerative air street sweeper on Cell 2 (TYMCO DST-6®).

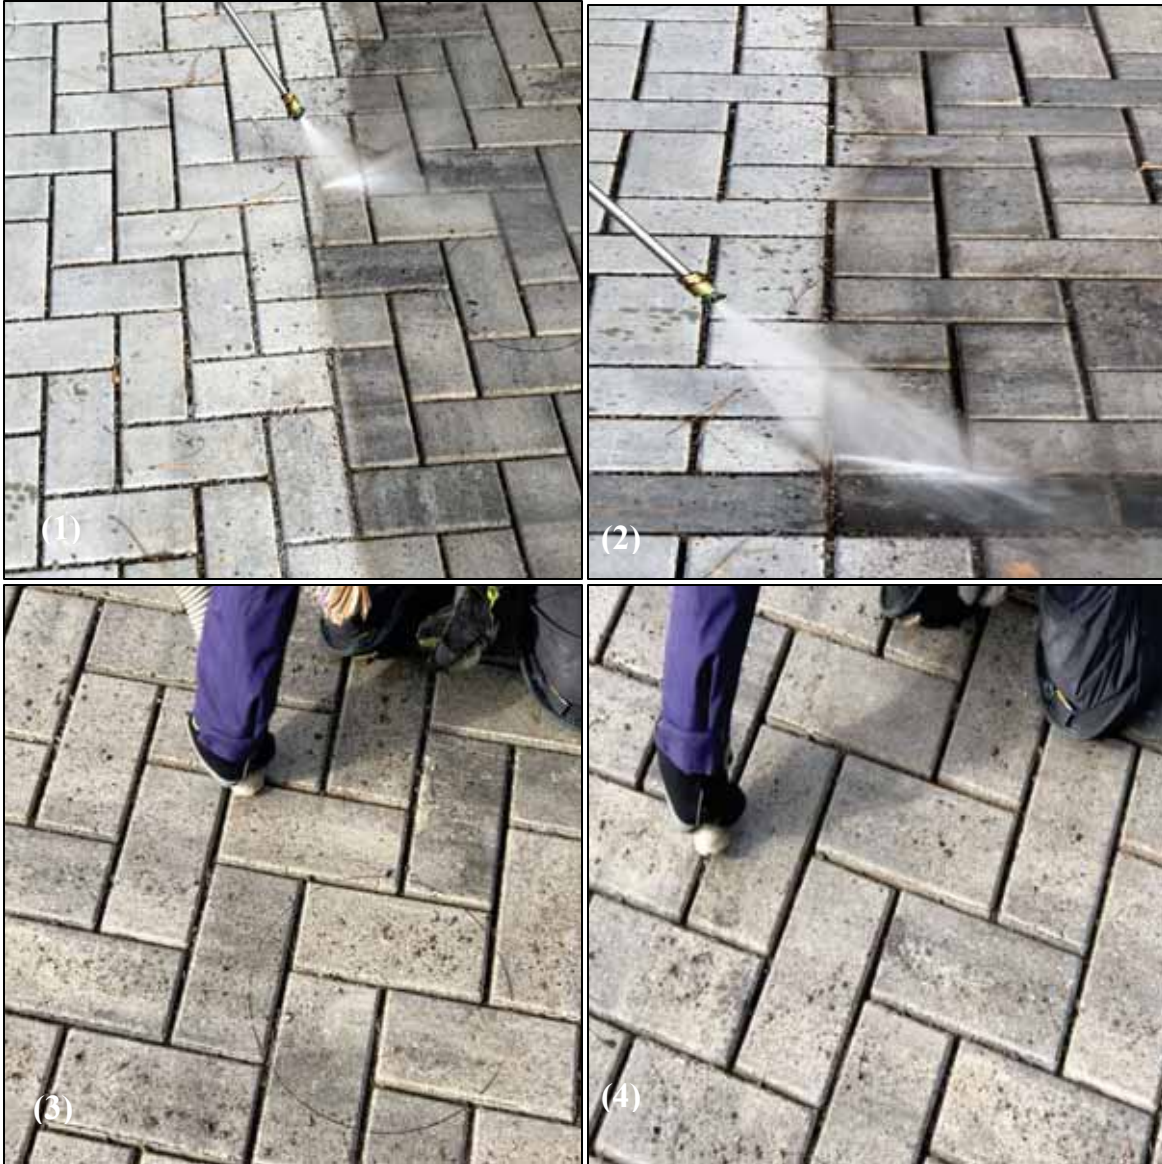
Figure I5. Pre- and post-maintenance following pressure washing (1,2) and vacuuming (3,4) on Cell 3.

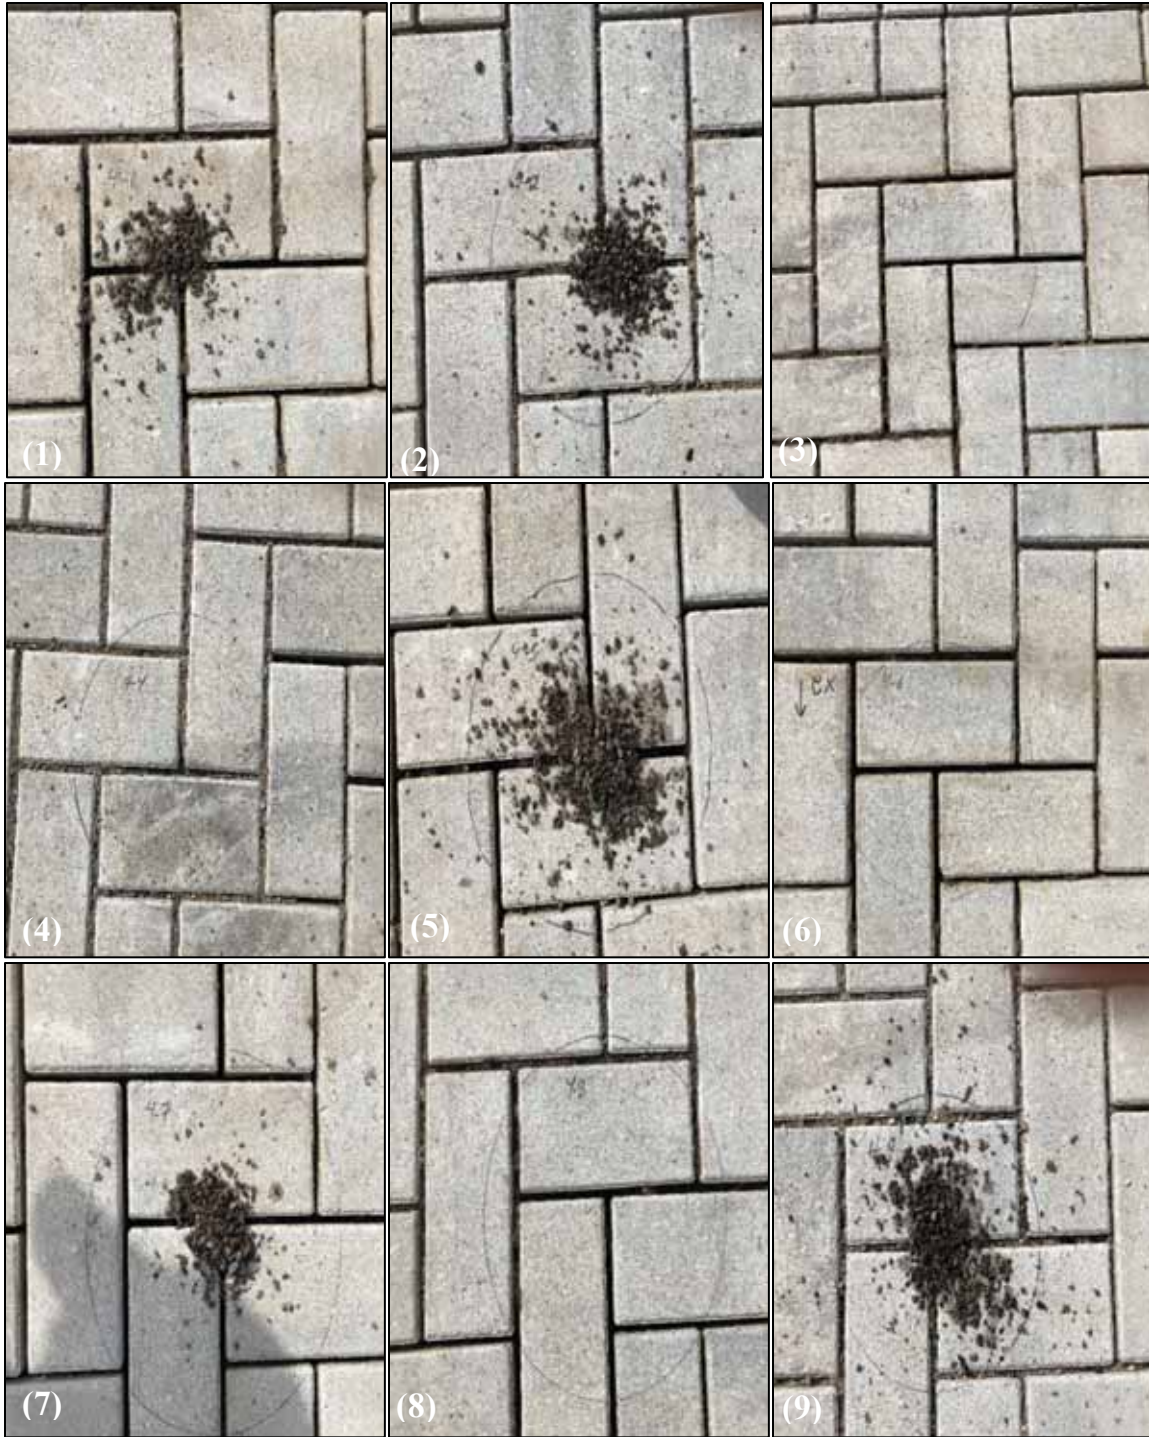
Figure 16. Post-maintenance photos of infiltration measurement locations (1-9) following a vacuum street sweeper on Cell 4 (Elgin Whirlwind).

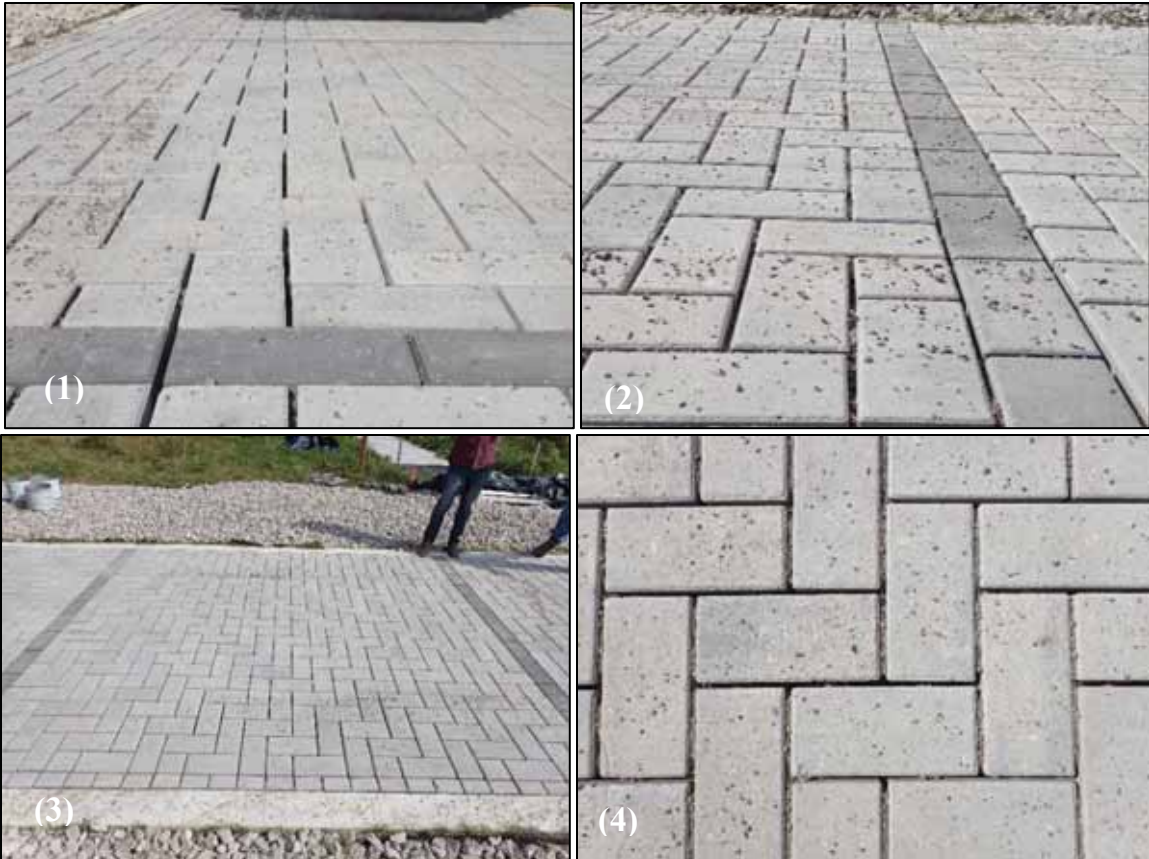
**Figure 17. Post maintenance photos following a waterless mechanical sweeper on Cell 5 (Elgin Sweepers Water Less Eagle<sup>®</sup>), where (1) and (2) are parallel and perpendicular to travel path respectively. (3) is an overview of the plot and (4) is a close up of parallel and perpendicular sediment removal.**

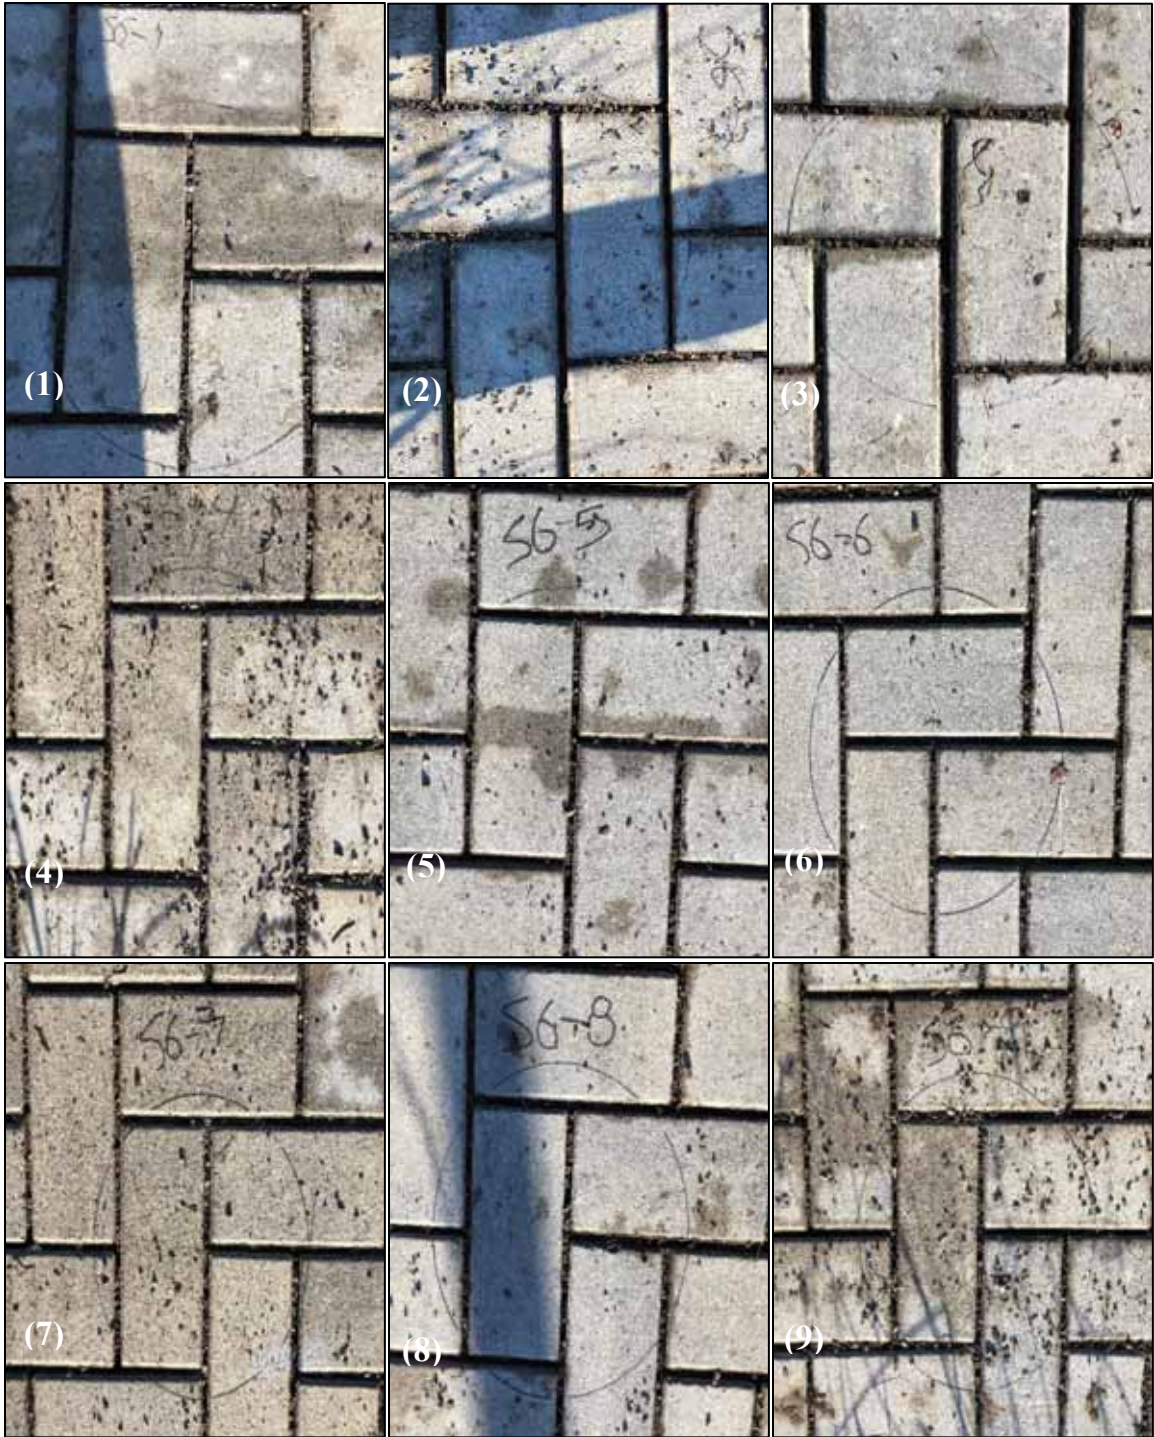
Figure J2. Post-maintenance photos of infiltration measurement locations (1-9) following a regenerative air street sweeper on Cell 6 for first early and repeated maintenance (TYMCO DST-6®).
