# Maintenance Equipment Testing on Accelerated Clogged Permeable Interlocking Concrete Pavements

Prepared for: Interlocking Concrete Pavement Institute Foundation for Education and  
Research

Jennifer Drake, Ph.D., P.Eng.  
Tahmineh Sarabian, M.A.Sc., P.Eng  
Jody Scott Ph.D. Student  
4-1-2020

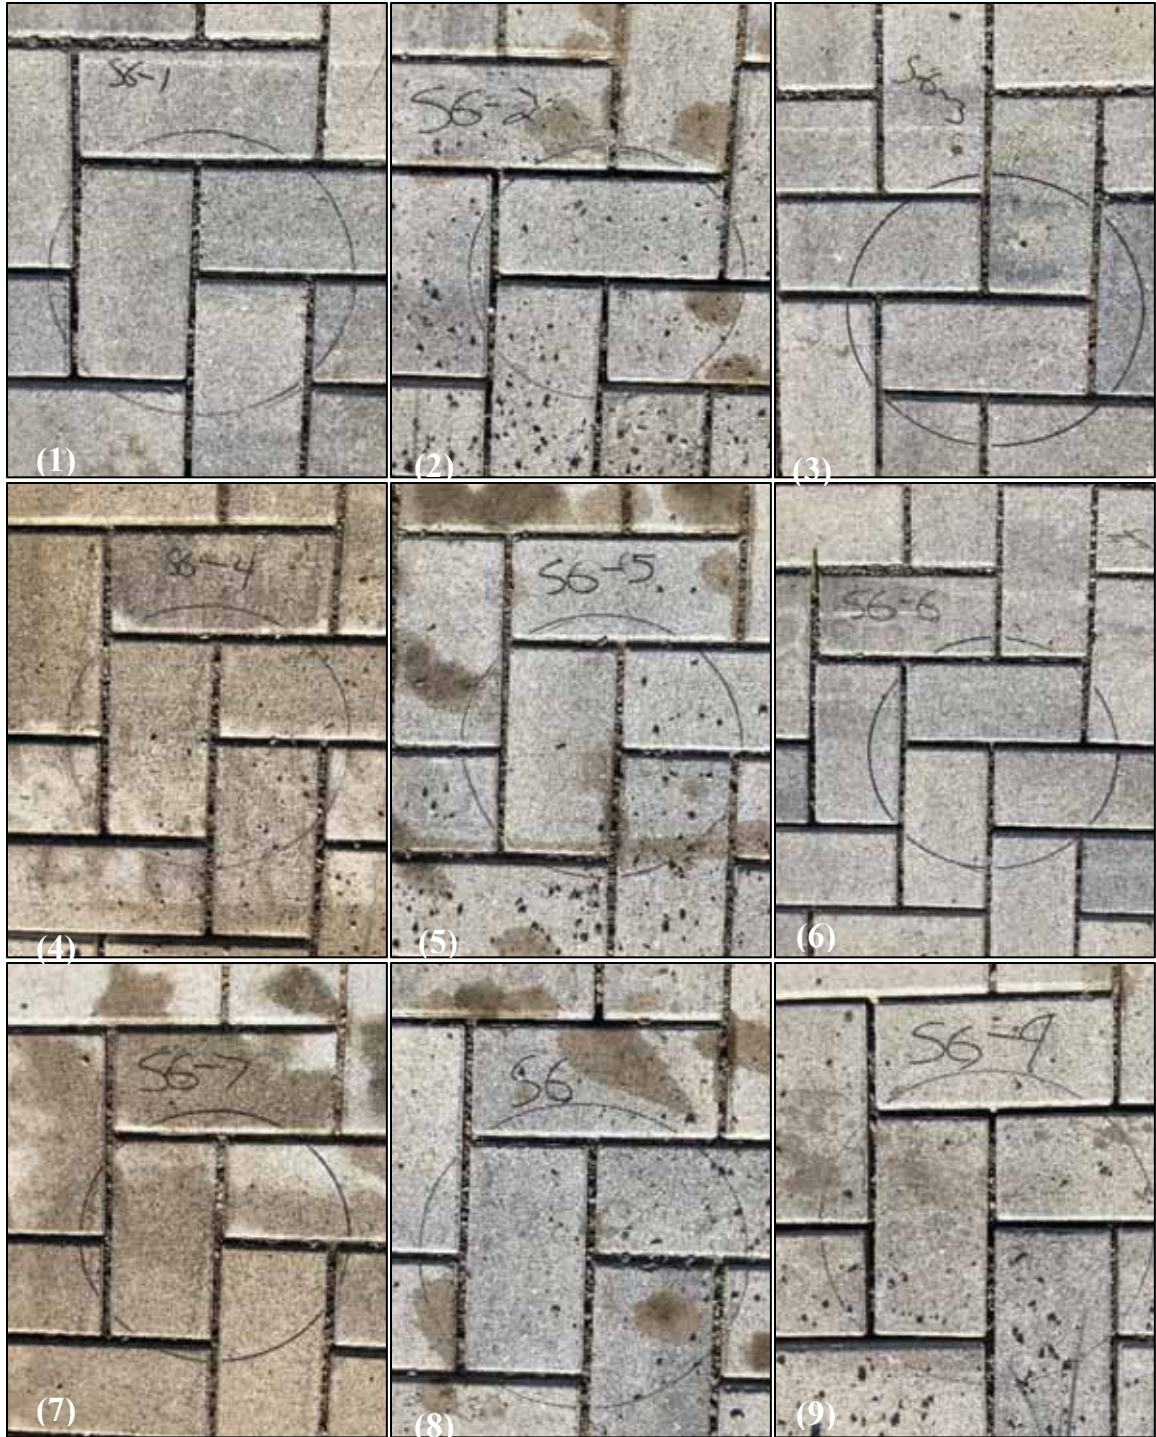
**Figure J4. Post-maintenance photos of infiltration measurement locations (1-9) following a regenerative air street sweeper on Cell 6 for second early and repeated maintenance (TYMCO DST-6®).**

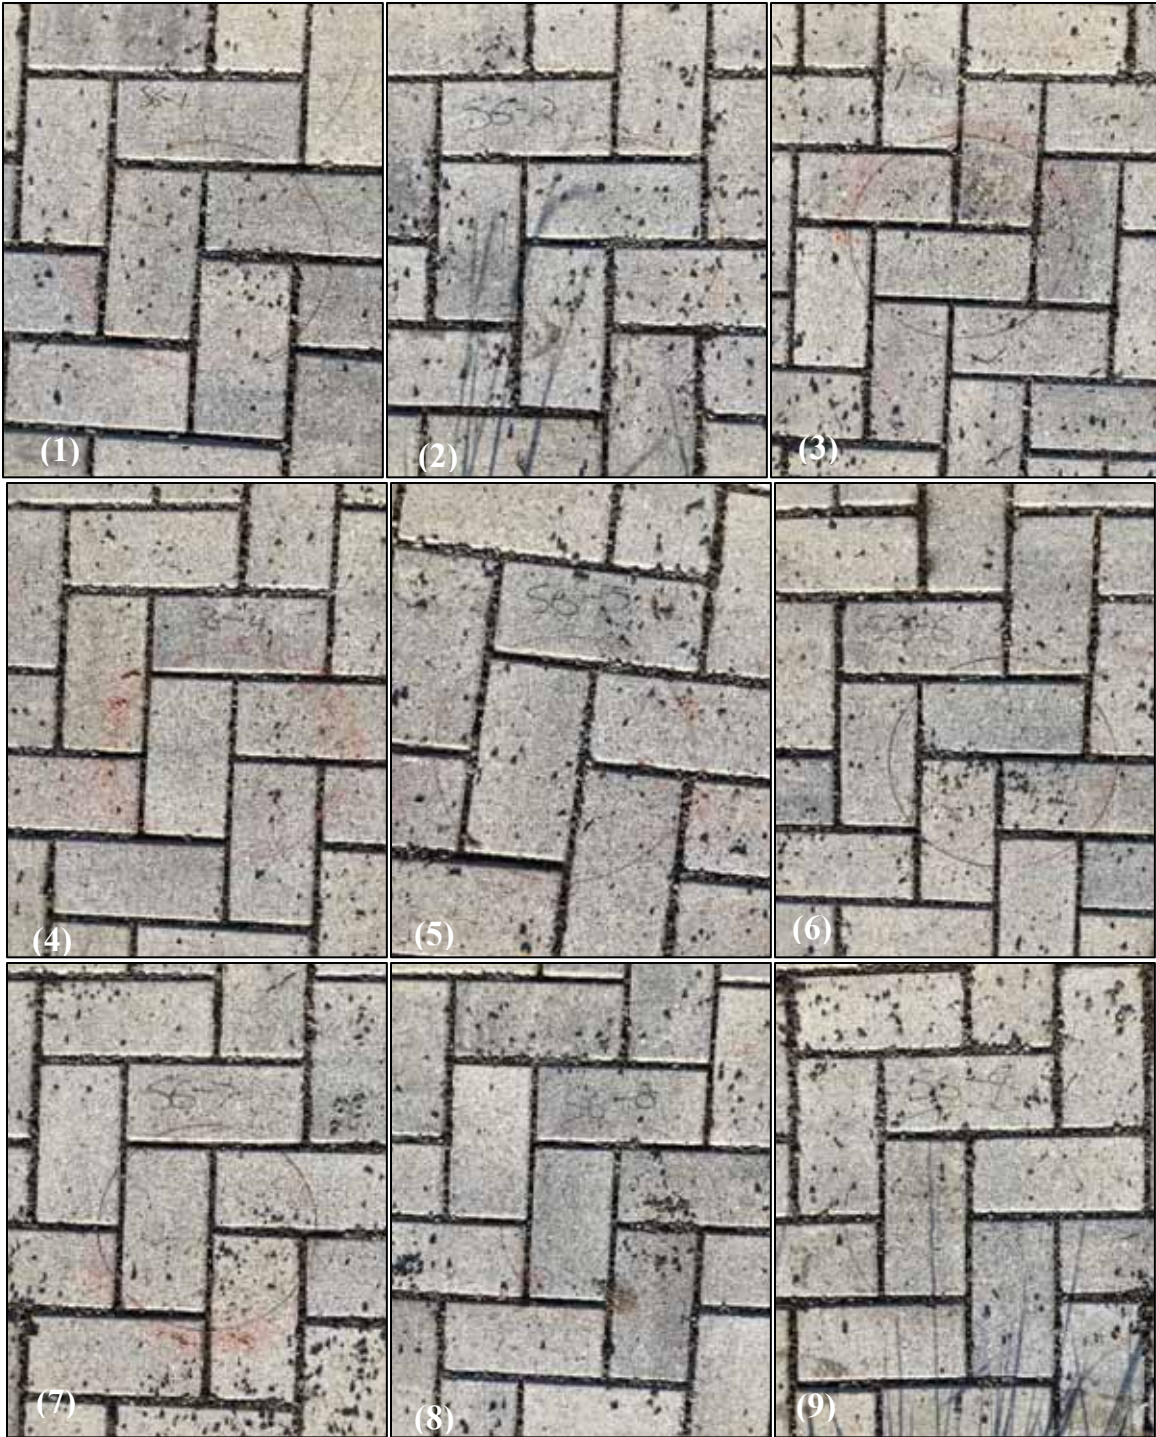
Figure J5. Pre-maintenance photos of infiltration measurement locations (1-9) on Cell 6 after second early and repeated maintenance (TYMCO DST-6®).

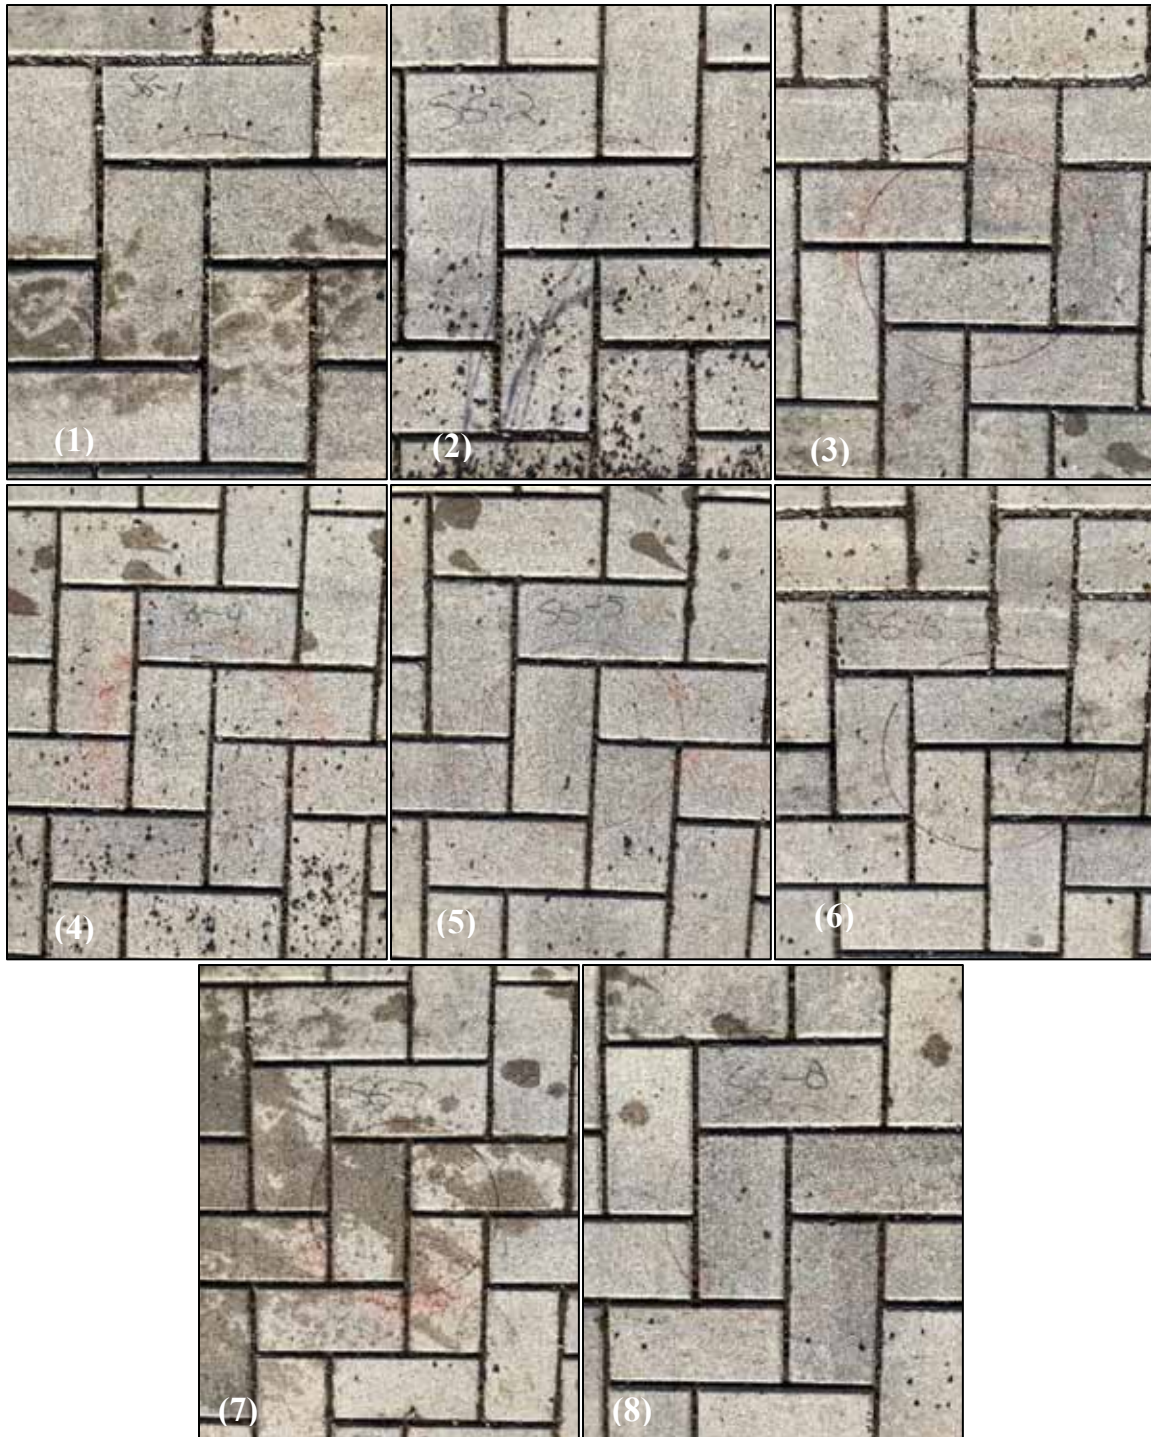
**Figure J6. Post-maintenance photos of infiltration measurement locations (1-8) following a regenerative air street sweeper on Cell 6 for third early and repeated maintenance (TYMCO DST-6®).**

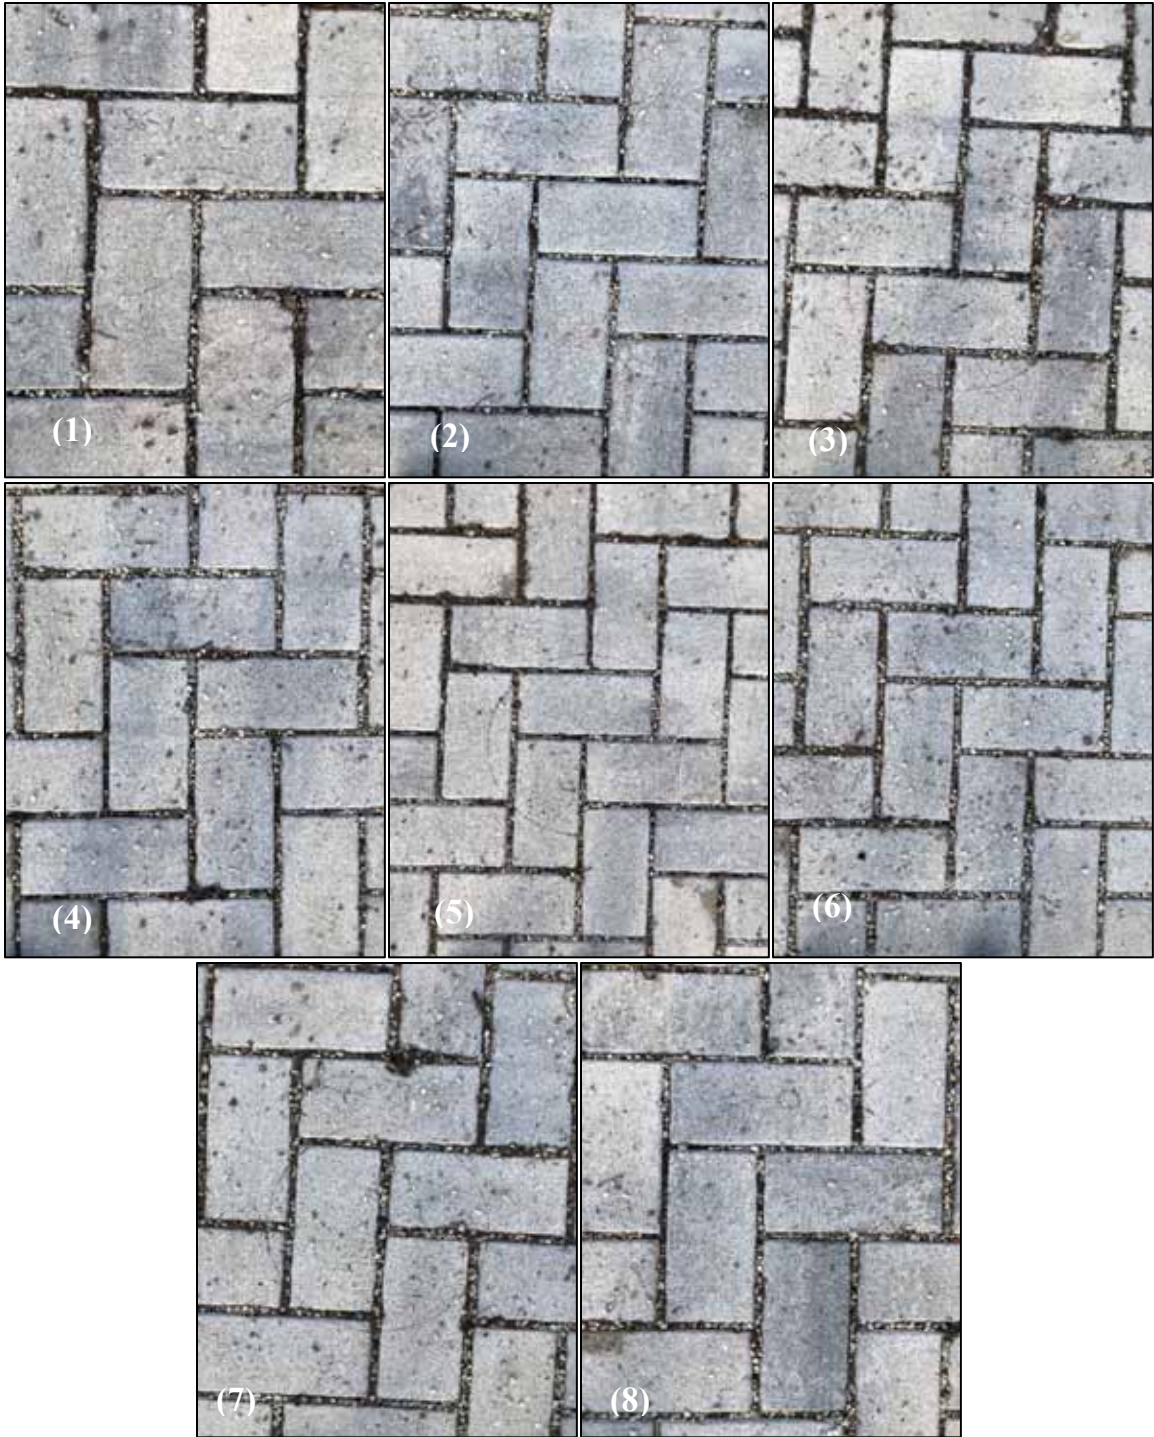
**Figure J7. Pre-maintenance photos of infiltration measurement locations (1-8) on Cell 6 after third early and repeated maintenance (TYMCO DST-6®).**

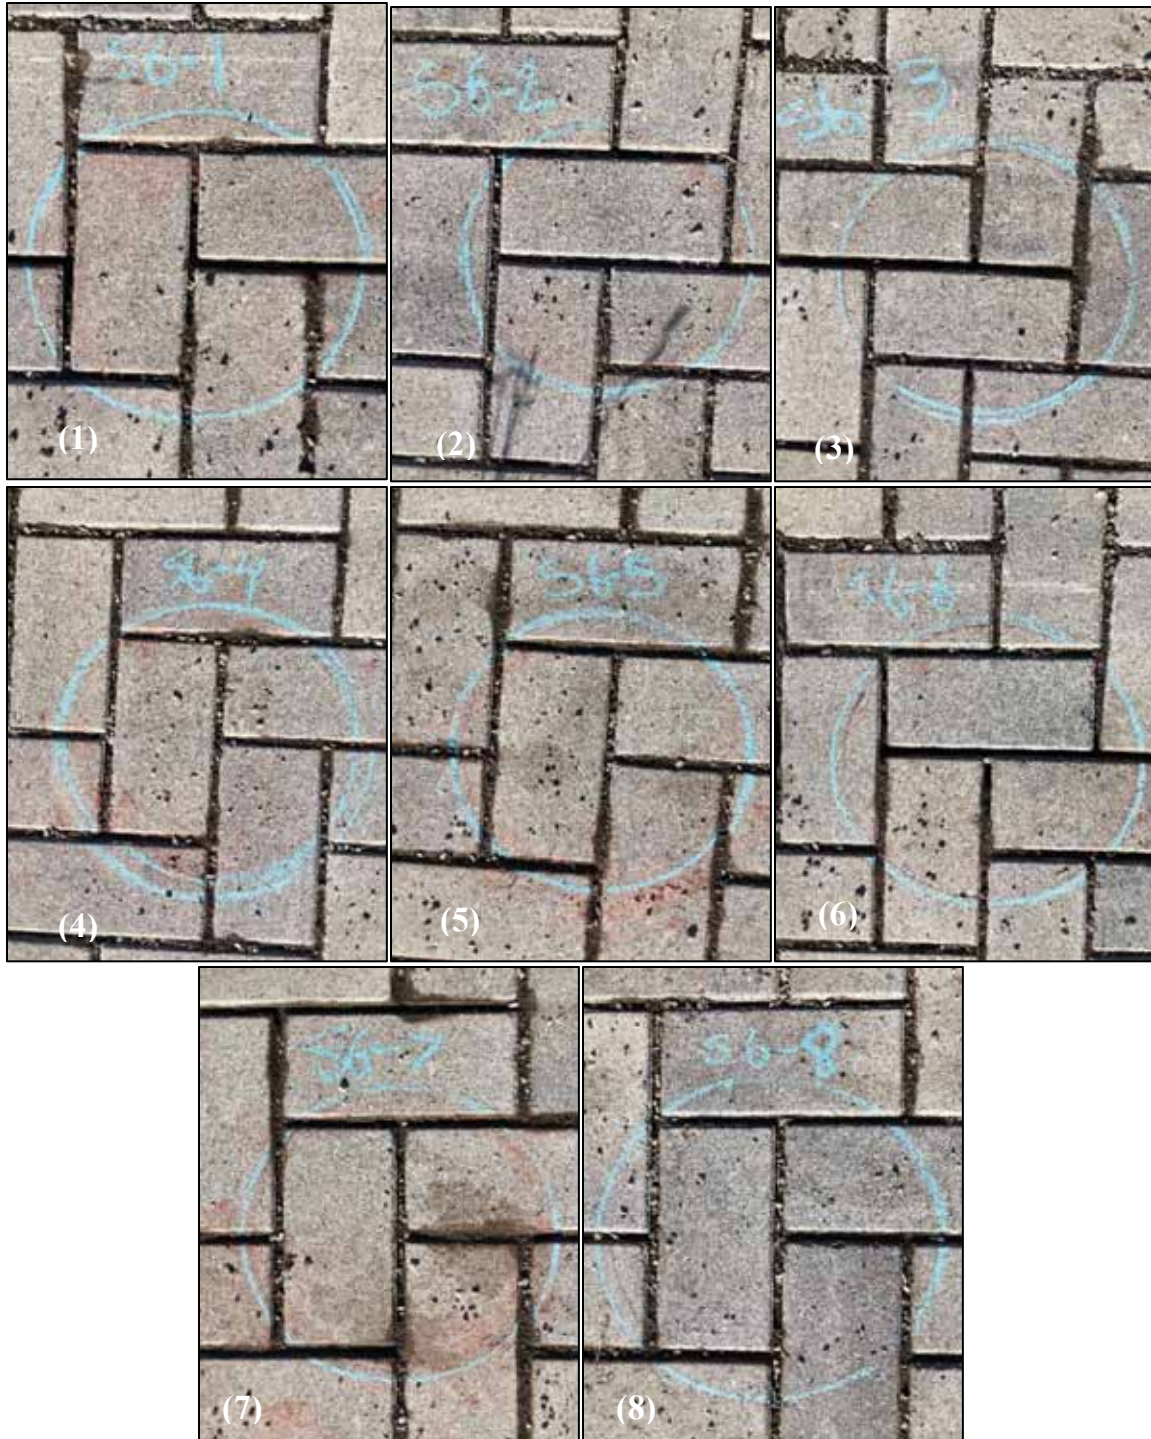
**Figure J8. Post-maintenance photos of infiltration measurement locations (1-8) following a regenerative air street sweeper on Cell 6 for fourth early and repeated maintenance (TYMCO DST-6®).**

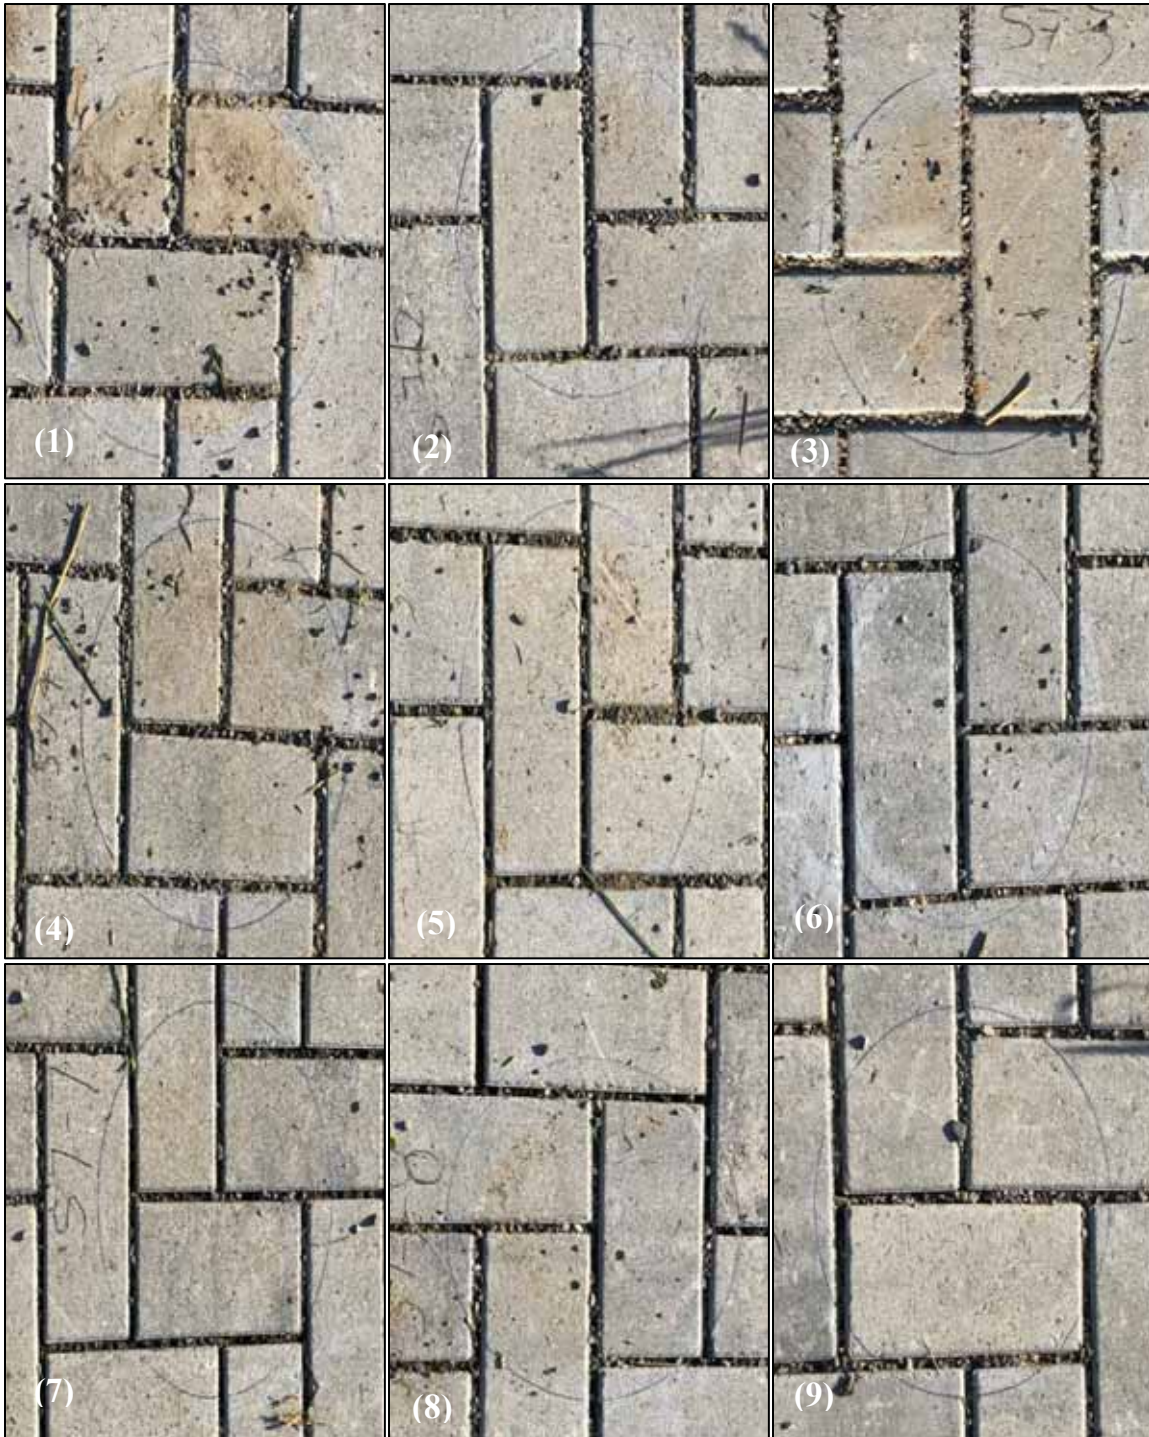
**Figure K1. Pre-maintenance photos of infiltration measurement locations (1-9) on Cell 7 (Pave-Tech Typhoon® and Pavevac®).**

Cell 7 was clogged with modified sediment that included 50% street sweeping materials and 50% silty clay soils collected from a construction zone near the site by weight. Following ASTM D4318 procedures, site soils had a liquid limit of 21%, a plastic limit of 16% and a plasticity index of 5. Material preparation methods were the same as those used for clogging Cells 1 – 5 (described in Section 3.2.). Clumped materials were not broken apart with a pestle and mortar. Street sweeping and soil materials were separated by size with sieves and then combined to construct the average PICP gradation shown in Figure 3-2. Clogging material gradation data is provided in Appendix D. The same clogging procedures, described in Section 3.2, were followed at the test site. The purpose of this modification is to illustrate the impact local soils may have on clogging processes and pavement maintenance requirements. Once the surface was clogged, the high-pressurized-air and vacuum system was used to restore surface infiltration. The equipment was limited to one pass over the pavement.

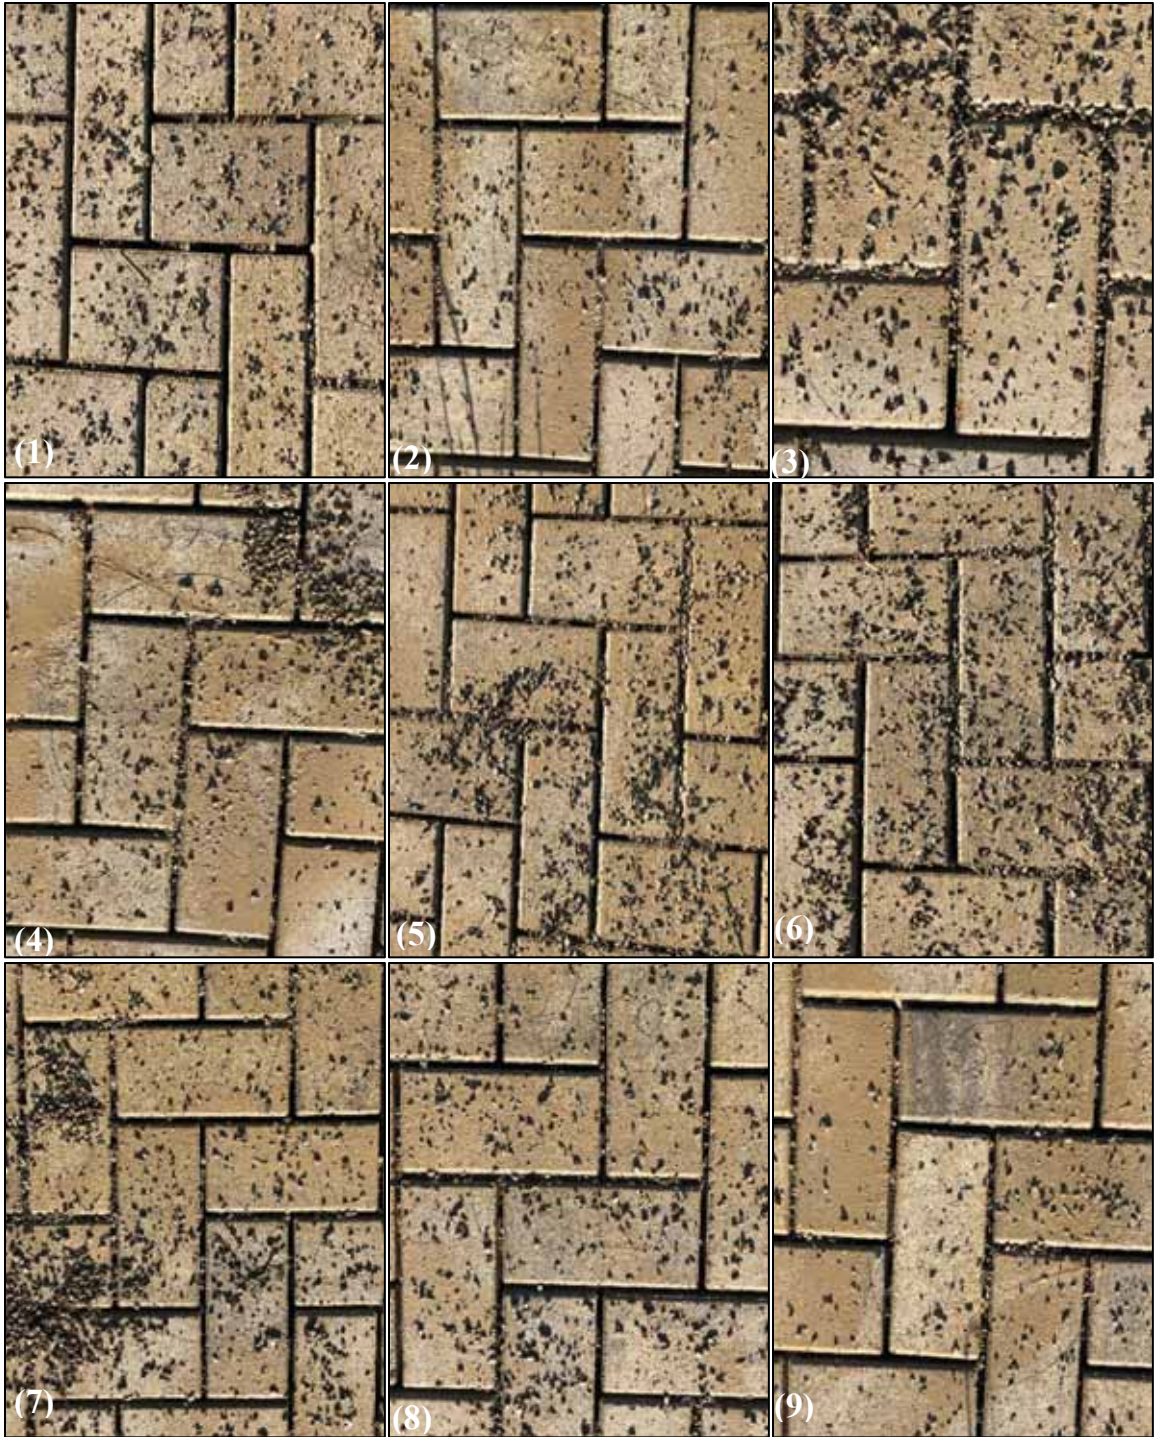
Figure K2. Post-maintenance photos of infiltration measurement locations (1-9) following high pressurized-air system on Cell 7 (Pave-Tech Typhoon®).

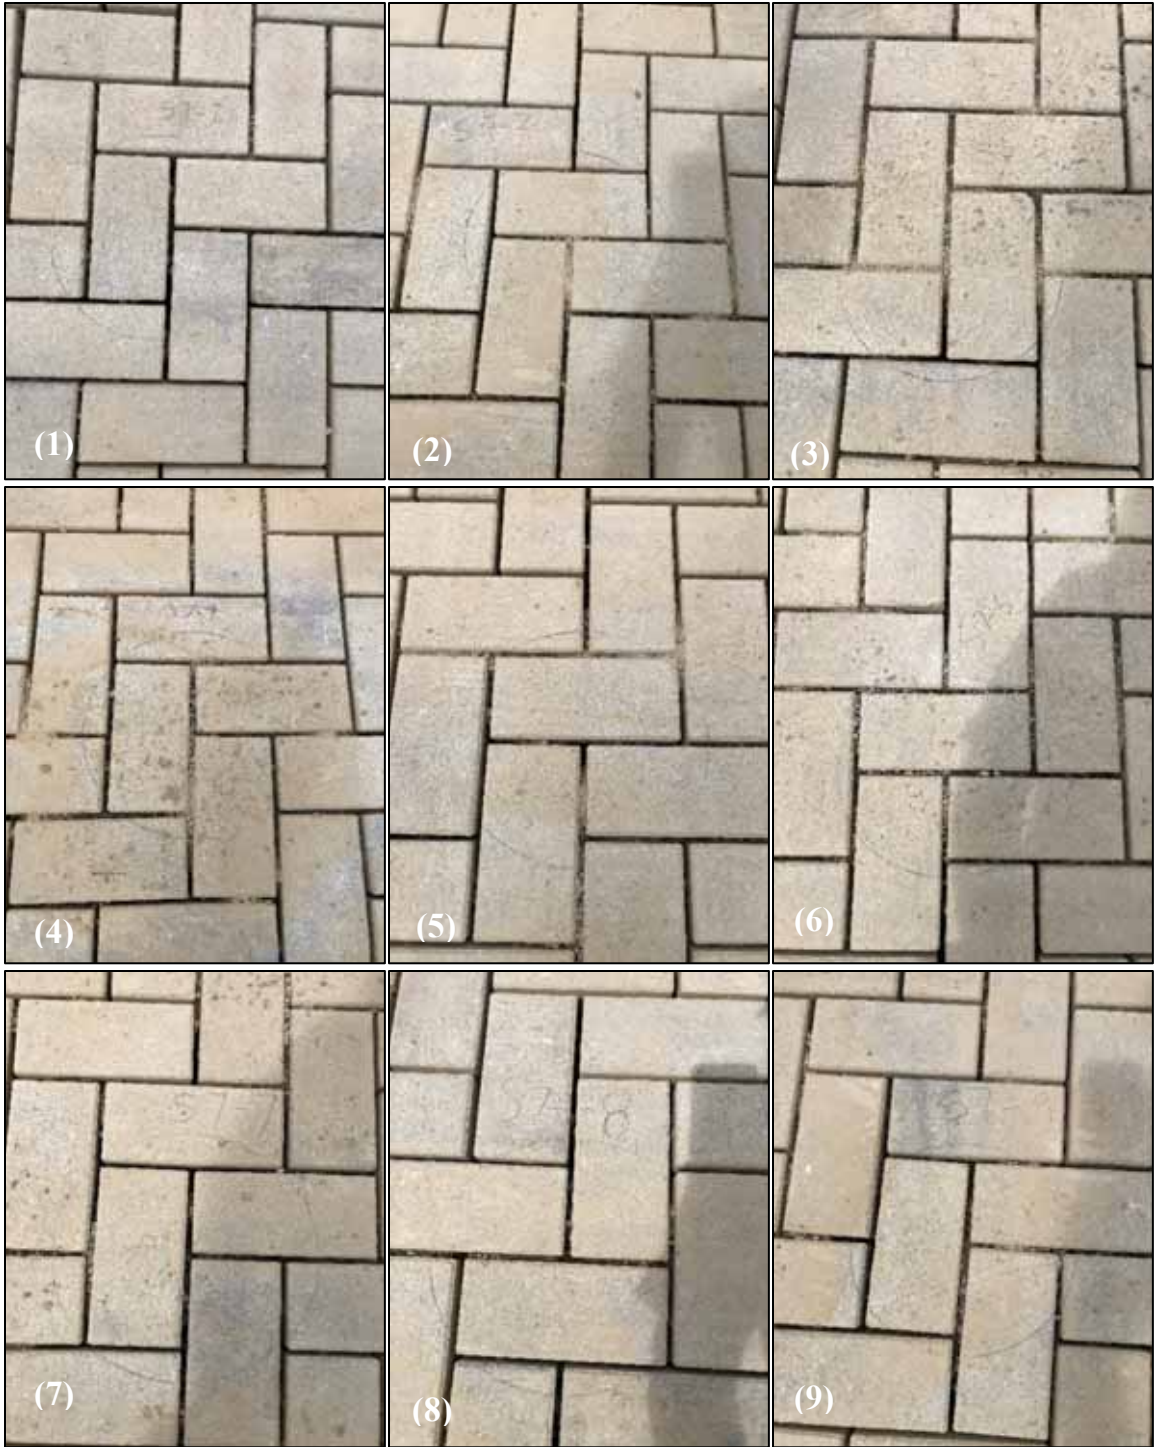
**Figure K3. Post-maintenance photos of infiltration measurement locations (1-9) following a vacuum system on Cell 7 (Pavevac®).**
