# FINAL REPORT ON A COLD CLIMATE PERMEABLE INTERLOCKING CONCRETE PAVEMENT TEST FACILITY AT THE UNIVERSITY OF NEW HAMPSHIRE STORMWATER CENTER

May 2013

#### BY THE UNIVERSITY OF NEW HAMPSHIRE STORMWATER CENTER

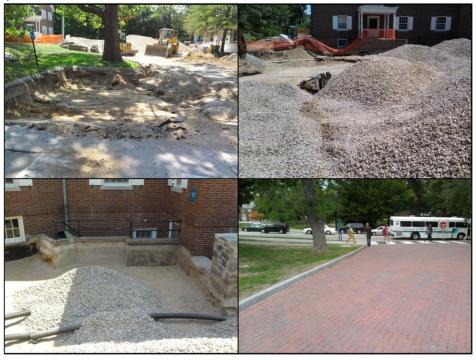
Figure 1: August 2010 installation of PICP system (clockwise from top left) demolition and excavation, placement of subbase aggregate, finished product, underdrain installation.

The UNH test site is a 13,500 square foot PICP system installed in the summer of 2010 on the UNH main campus in Durham, NH (Figure 1, Figure 2). The pre-existing Hood House Drive (7,000 square foot) and J Lot (6,500 square foot) were standard asphalt surfaces. The areas

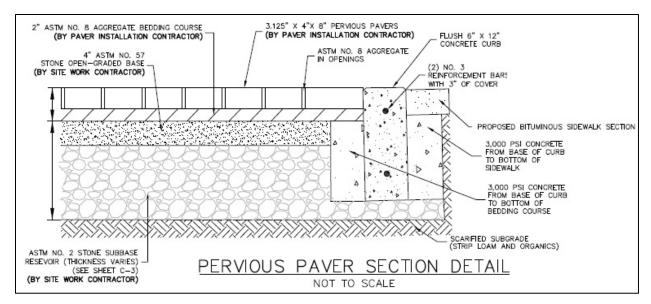
Figure 3: Typical PICP Hood House Drive Cross Section. The concrete haunches on both sides of the granite curbs are not typical to most PICP applications. The use of the concrete in this detail is specific to the University of New Hampshire.

Appendix A includes project construction drawings and details. System configuration is an ICPI recommended profile (Figure 3). Concrete pavers were placed on a 2-inch bedding course of ASTM No. 8 aggregate. Appendix H provides test results on the concrete pavers which conform to ASTM C 936. The No. 8 aggregate was also used to fill the joints between the pavers. The bedding course is supported by a 4-inch open graded base layer of No. 57 aggregate. This layer was placed on a stone subbase reservoir of variable thickness of ASTM No. 2 aggregate. The thickness of the No. 2 subbase was 20 inches in the J Lot (the upper portion) areas, and 17 inches thick along the drive portion leading to Main Street. Below the subbase are native soils of sandy loam which have a high infiltration capacity of approximately 3 in/hr., measured in a test pit location prior to installation. The subbase and surface slopes of the PICP system are 6% and designed with internal grade controls. Two check dam and perforated underdrain configurations (Figure 4) were installed in the reservoir layer; one draining J Lot and the other Hood House Drive into an underground monitoring chamber. The J Lot underdrains are installed downstream of the check dams while the Hood House Drive underdrains are installed upstream. The check dams are constructed of 30 mil (0.762 mm) impermeable PVC liner installed in a stepped pattern (Figure 4). The perforated underdrains are placed 4 inches above the native soils. The J Lot configuration is intended to retain stormwater between events to promote denitrification within the subbase. The Hood House Drive configuration is intended to allow high flow events to bypass through the system more quickly. Both configurations allow the design storm event to infiltrate into the native soils. Each configuration has a unique outlet into the monitoring chamber. To date monitoring efforts have focused on the main parking area (J Lot) of the PICP system.

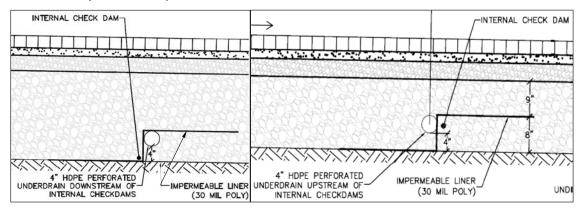
Figure 4: Check dam and perforated underdrain configurations. On the left is J Lot and the right is Hood House Drive. J Lot is the section being monitored for this study.

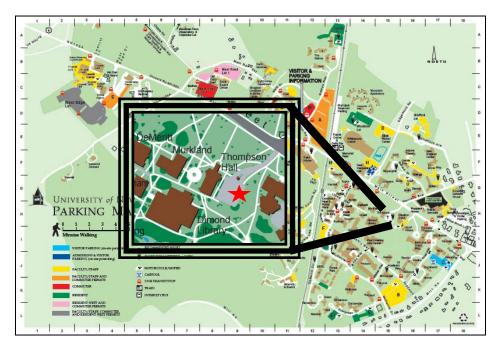
Figure 5: T Lot – PICP influent monitoring location

The reference influent monitoring and rain gauge were located off T Lot (Figure 5), which is approximately 400 feet from the PICP effluent monitoring location. T Lot is adjacent to Thompson Hall and Dimond Library on the main University campus and is similar in size, usage, and rainfall characteristics. T Lot is a 12,000 square foot standard asphalt lot with approximately 50 parking spaces, granite curbing, and traffic consisting of both passenger vehicles and routine bus traffic. The area, like Hood House Drive and J Lot, is subject to frequent plowing, and deicing (salting) throughout winter months. Literature reviews indicate that pollutant concentrations from T Lot are above or equal to national norms for parking lot runoff. T Lot is drained by a typical catch basin and piping network. A 12 inch HDPE pipe conveys a portion of T Lot runoff to a surface location (Figure 6) where monitoring equipment is installed to collect data, gather samples, and monitor flow and rainfall depths.

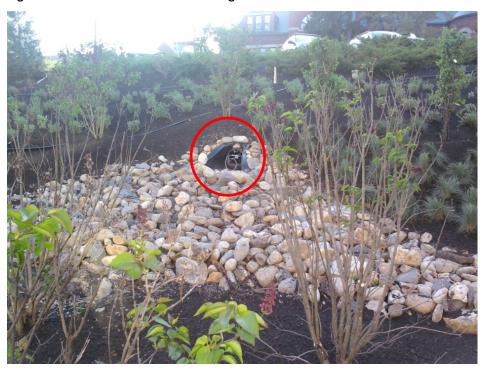
Figure 6: Picture of T Lot effluent location. T Lot is to the upper right in this picture.

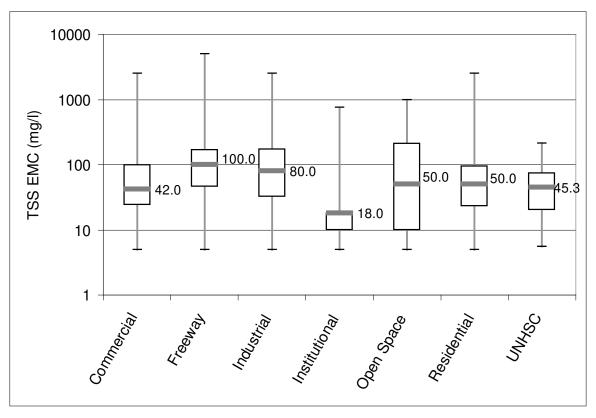
Figure 7: Total suspended solids (TSS) concentrations for varied land uses and at UNH Stormwater Center (Source: National Stormwater Quality Database, 2005, UNHSC, 2007)

Comparisons of the TSS concentrations for varied land uses are presented in Figure 7. Urban highway pollutant concentrations tend to be twice the mean concentration measured for parking lots and residential uses. Historical data collected from the UNH facility is within the national norm for commercial parking lots and is within the range of typical concentrations observed for a range of land uses. Occasional storms are monitored that have exceptionally high solids concentrations.

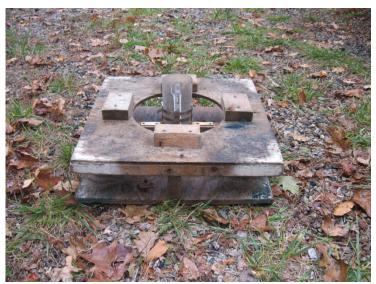
Figure 8: Surface Inundation Test Equipment; A variation on ASTM C 1701 and D 3385-03

Infiltration rate (IR) measurements are developed using a modified surface inundation (SI) device. The modified SI is a falling head test that measures the time to infiltrate a known volume of water (0.56 gallons) through the permeable surface (Figure 8). SI measurements were taken at three separate locations on the PICP lot over 11 times throughout the study. The SI test is a modification of an ASTM Standard D 3385-03 (ASTM, 1988) in which the falling head SI test involves placing a cylinder of known diameter onto the pavement surface which is then sealed to the pavement surface (Briggs, 2006). The UNHSC SI test is similar to ASTM C 1701 for pervious concrete in which both methods measure the infiltration rate of a known volume of water through a pervious pavement. The difference is that the SI is a falling head test that starts time zero when the full volume of water is delivered to the infiltration device. C 1701 specifies that the known volume be delivered to the device at a rate that maintains a surface depth between 10mm to 15mm and starts time zero as soon as water contacts the pavement surface. Another difference is that the SI uses a closed-cell foam foot to seal the cylinder to the pavement surface and C 1701 specifies the use of plumbers putty as a sealant. Also, C 1701 generally requires at least 5 gallons of water to conduct, whereas the modified SI requires 0.56 gallons.

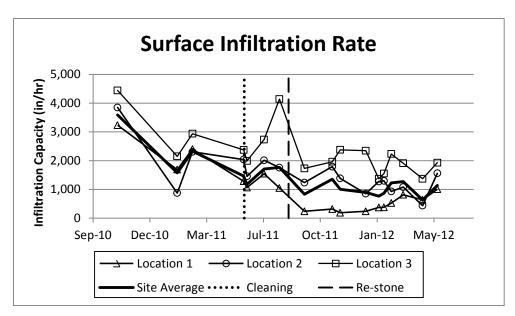
Figure 9: Infiltration rate monitoring over time of 3 separate locations representing different loading and usage characteristics.

SI tests were used to monitor the infiltration capacity of the PICP system through the duration of the study. Locations for infiltration capacity measurement were chosen to represent different use scenarios. Location 1 is located near the entrance to Hood House Drive and represents a high use area. This location receives run on from Memorial Union Building Drive, sediment tracking from vehicles entering the lot, and leaf litter from a pair of deciduous trees. Location 2 is subject to less vehicle traffic, less impervious surface run on, is located on a more gradual slope, and has an evergreen tree that drops needles onto the surface of the test lot. Location 3 is located in a level parking stall that receives little traffic, has no organic litter build up, and is representative of a low loading area. IR measurements over the research period are shown in Figure 9. A site average for the study area is plotted and based on relative area contributions and infiltration capacity.

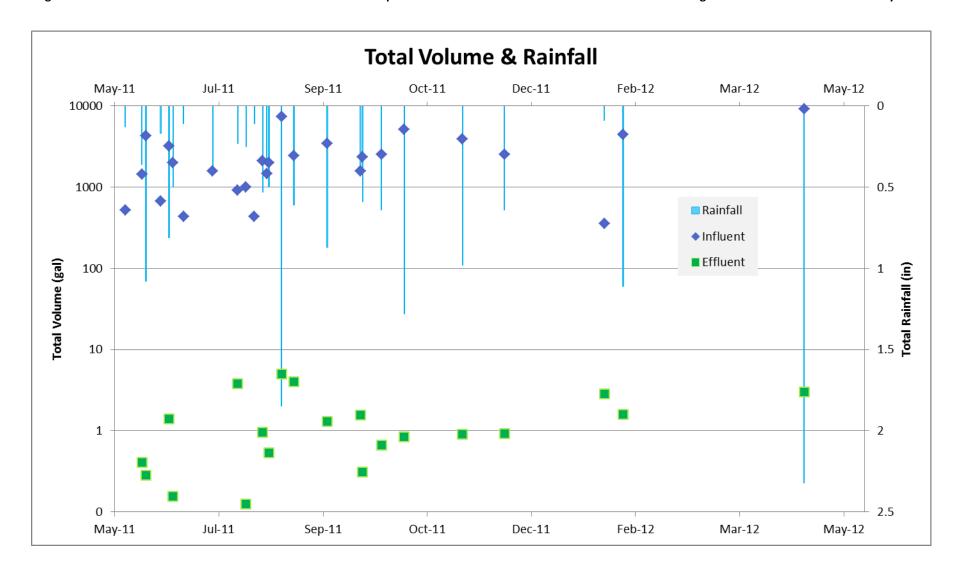
Figure 10: Total Volume of Influent and Effluent and Rainfall Depth for the Research Period of the Permeable Interlocking Concrete Pavement Treatment System.

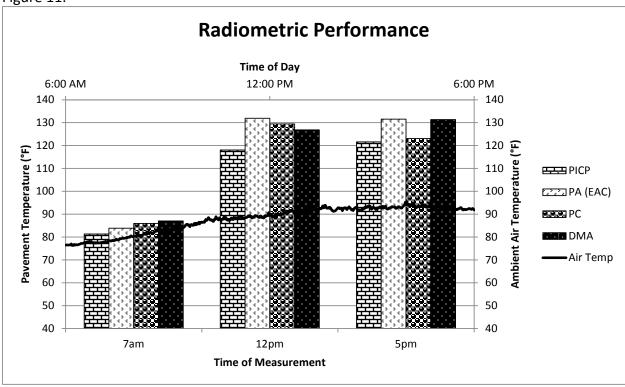
Figure 11: Thermal performance comparison of PICP, porous asphalt, pervious concrete and conventional asphalt. Measurements taken on June 21, 2012.

Thermal performance in the form of surface reflectivity was examined on June, 21, 2012 for the PICP lot in comparison with three other pavements types. Thermal performance examined the surface temperature of various pavements when exposed to direct sunlight throughout an entire summer day. Measurements were taken on each surface at 7 a.m., 12 p.m., and 5 p.m. with an infrared thermometer, Mastercool model #52224-A. The device measures near infrared or 750 to 2,500 nm wavelengths, and emissivity is set at 0.95. Pavement types selected to compare with PICP are porous asphalt, pervious concrete, and conventional asphalt. This nm range is similar to that used to determine solar reflective index or SRI. Results can be found in Figure 11.

The thermal performance of the PICP surface was compared to porous asphalt, pervious concrete, and standard dense mix asphalt on June 21, 2012. The weather was sunny all day and the measurement locations were exposed to direct sunlight throughout the study period. The average ambient air temp was 88°F. The PICP consistently remained cooler than each of the other pavement types indicating the potential for thermal buffering. Previous studies have demonstrated that that stormwater control measures like PICP that provide treatment by infiltration and filtration can moderate runoff temperatures by thermal exchange with cool subsurface materials (Roseen et al 2011). Numerous agencies and locales are beginning to consider the thermal impacts of stormwater management upon cold water streams.

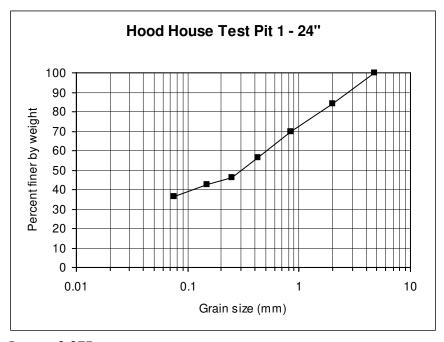
• Soil Sample taken at 24" depth

D<sub>10</sub> = < 0.075mm

$D_{30} = < 0.075$ mm

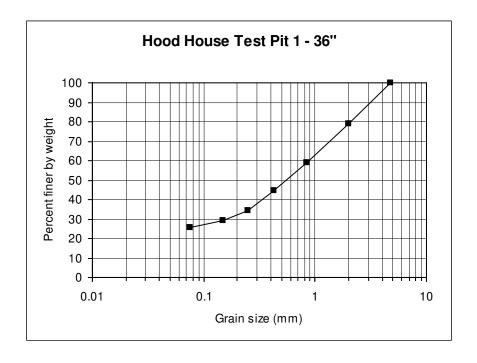
# • Soil Sample taken at 36" depth

$D_{10} = < 0.075$ mm

$D_{30} = 0.160 \text{ mm}$

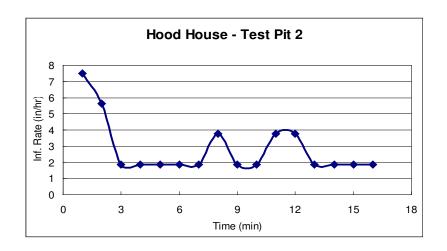
• IC test was conducted using a Turf Tech infiltration device. Results are as follows.

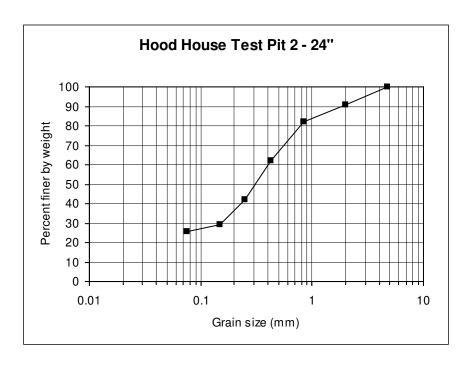
• Soil Sample taken at 24" depth

D<sub>10</sub> =< 0.075mm

$D_{30} = 0.160 \text{ mm}$

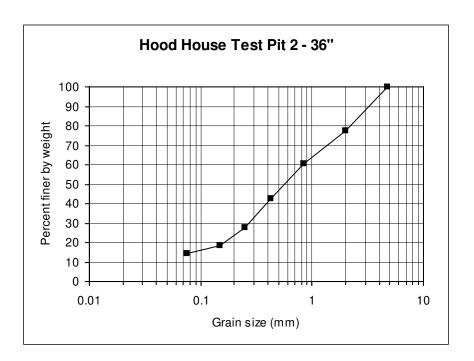
- 6.99% moisture content as a percentage of oven-dried mass. Determined using ASTM Designation: D 2974-00.
- Soil Sample taken at 36" depth.

$D_{10} = < 0.075$ mm

$D_{30} = 0.270 \text{ mm}$

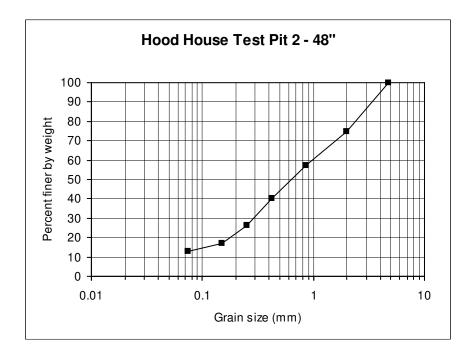
8.57% moisture content as a percentage of oven-dried mass. Determined using ASTM Designation: D 2974-00. Soil Sample taken at 48" depth.

$D_{10} = < 0.075$ mm

$D_{30} = 0.290 \text{ mm}$

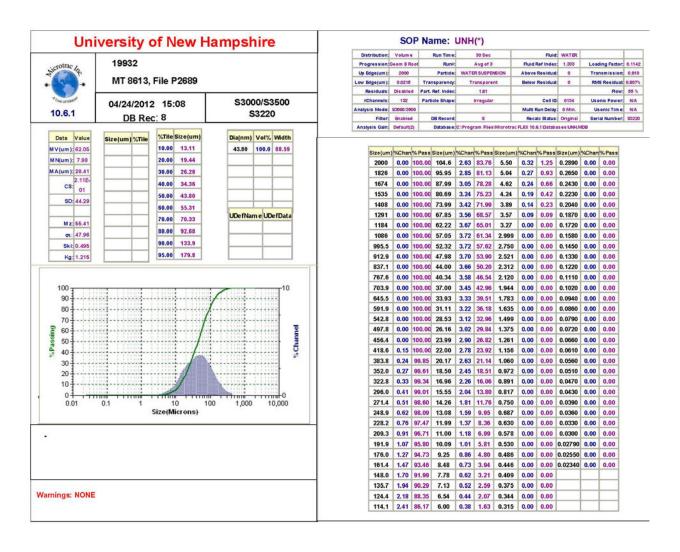
#### Influent Sample

# APPENDIX F: Results of particle size distribution analysis by laser diffraction.
