Development, Testing, and Data Collection of a Pathway Measurement Tool (PathMeT)

July 2014

University of Pittsburgh

Human Engineering Research Laboratories

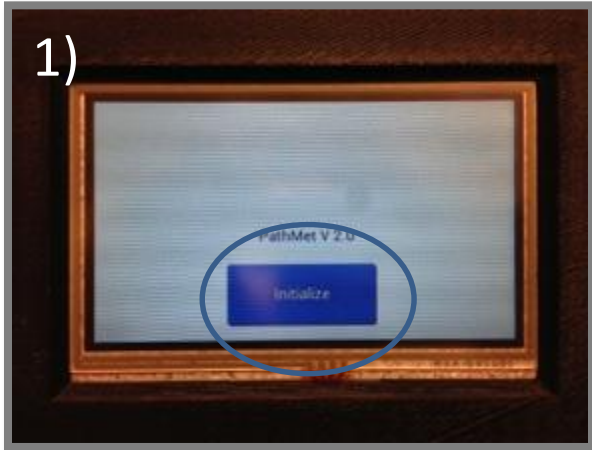
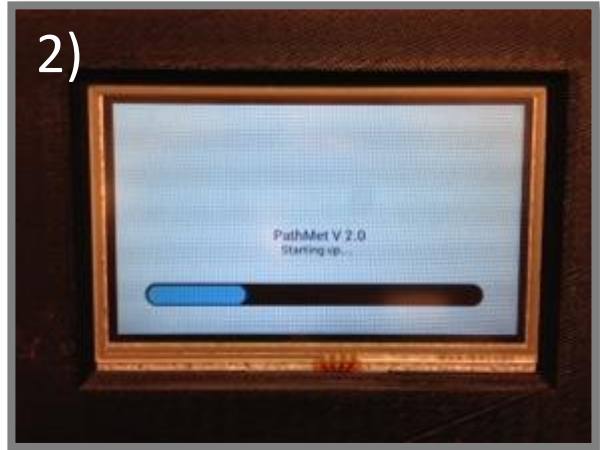
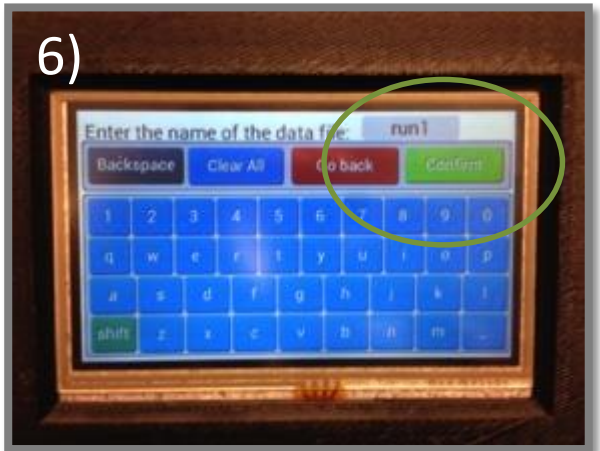
Figure 17: PathMeT interface

Figure 17 shows the user interface for PathMeT and the step-by-step process for data collection. Step 1 shows the display upon powering the device. When ready, the user presses the “Initialize” button to initialize the system. Step 2 shows the loading bar after Step 1. This loading screen takes twenty seconds, allowing the laser to warm up and initialize. Step 3 shows that the system is waiting for a command. When ready, the user presses “Start sampling” to ensure that all the sensors are sampling properly. Step 4 shows PathMeT in “sampling mode”. In order to progress, the user first selects “Stop sampling,” then “Logging Mode.” Before data can be collected, the user creates a folder in which to save data for that specific data collection run. The user does this by selecting “Create a Folder” (Step 5), entering a file name up to six characters and pressing “Confirm.” Data collection begins in Step 7 when the user selects either Rolling Mode (RL) (shown in the picture) or Inchworm Mode (IW), presses “Start Profiling” and begins propelling the device, if in Rolling Mode. Step 8 shows the four instantaneous outputs that are displayed: A) Running Slope, B) Profile of the surface, C) Speed, D) Cross Slope. When

the user is propelling PathMeT at an appropriate speed, the speedometer is green; otherwise, the speedometer is red. When data collection is complete, the user presses the “Stop Profiling” button. Step 9 shows that the camera must finish transferring data before proceeding to the next run. Finally, Step 10 shows a summary of the run, including time elapsed, distance travelled, file name, last instantaneous speed, and average speed. The user can then select “new profile” to begin a new run, “About” to learn about the previous run, or “Help” for help in proceeding. These are the steps required for data collection.
