# Comparison of Utility Cut Impacts on Pavement Performance

**Prepared for:**

Interlocking Concrete Pavement Institute  
14801 Murdock Street, Suite 230  
Chantilly, Virginia 20151-1037

Applied Research Associates Inc.

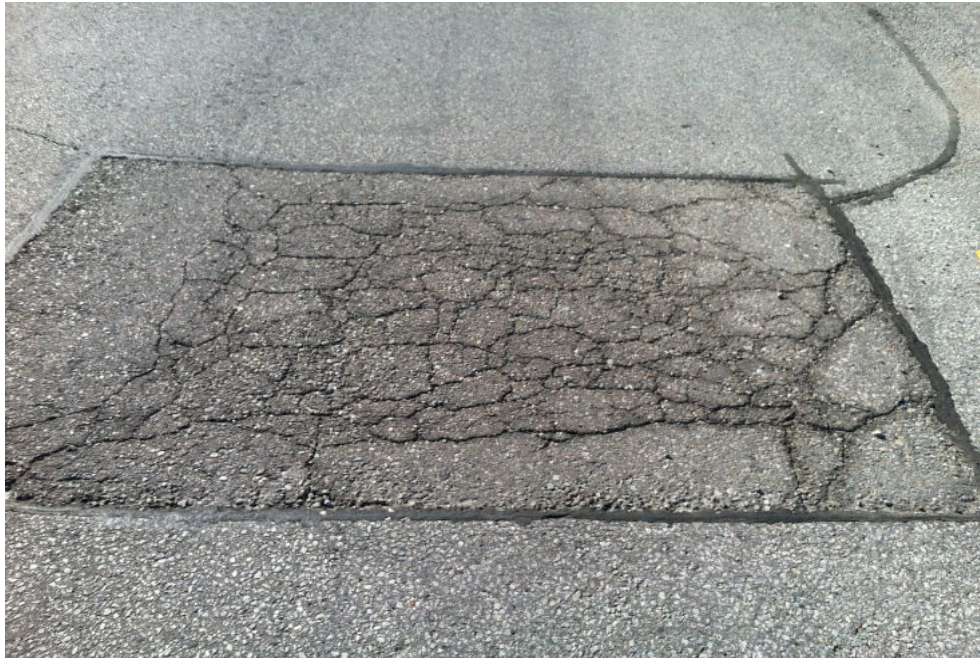
**Figure 1-1. Poor Quality Restoration Resulting in Settlement and Alligator Cracking.**

Most municipalities have rigid specifications for utility cuts and pavement restoration [1]. However, in most cases, the pavement restoration does not achieve the same quality as the original pavement as shown in Figure 1-1 and Figure 1-2. In some cases, this may be due to lack of enforcement of specifications in the field.

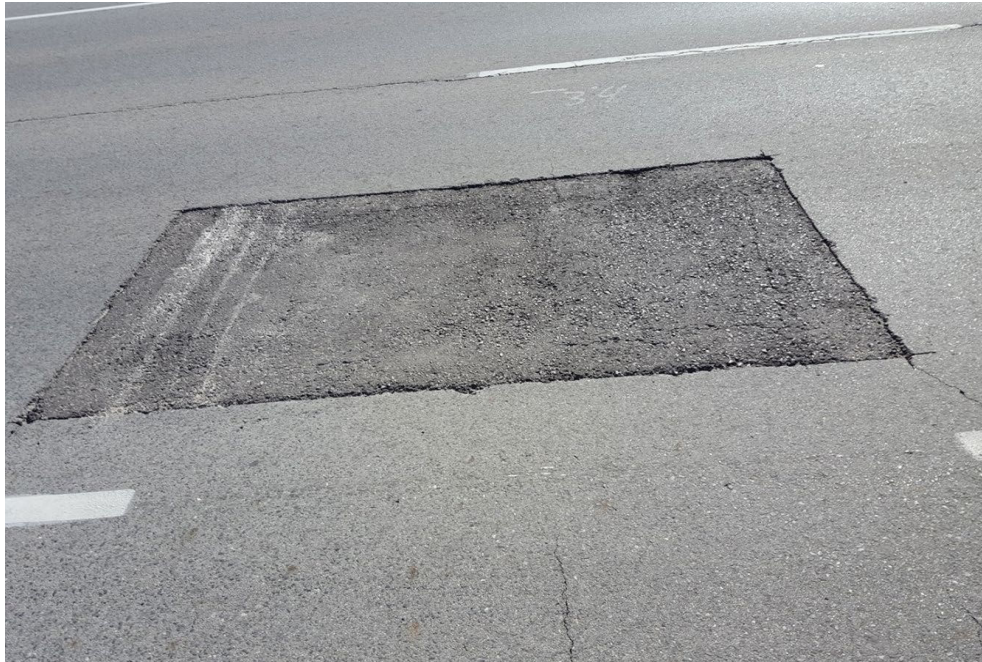
**Figure 1-2. Poor Quality Restoration Resulting in Settlement, Cracking and Asphalt Segregation.**

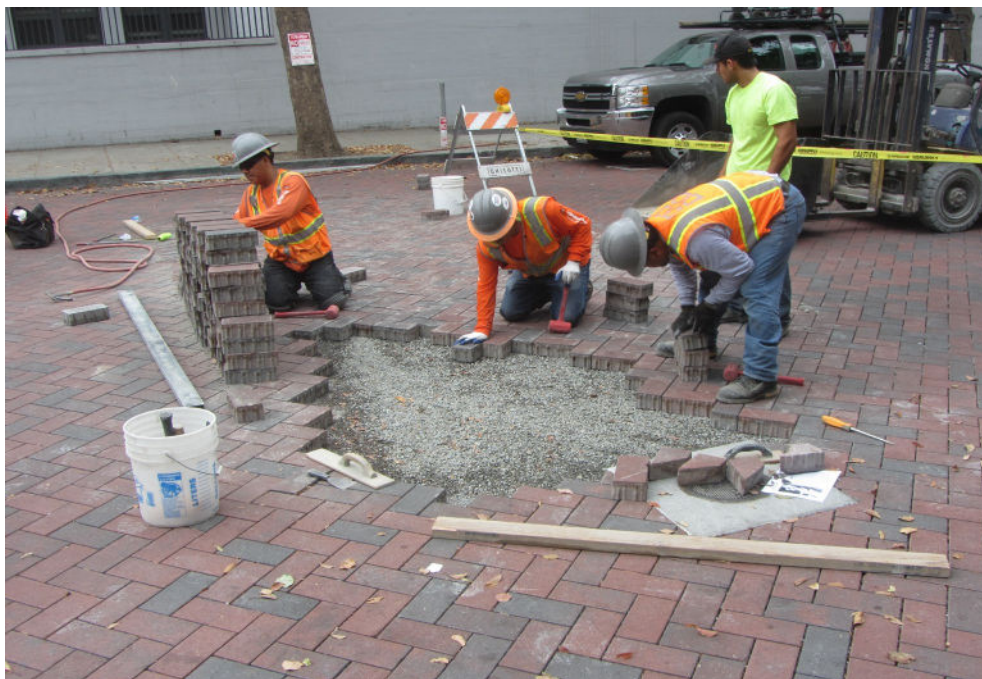
**Figure 1-3. Utility Cut Repair of Interlocking Concrete Pavement.**

Unlike HMA surfaced pavements, the surface of an ICP can be removed and replaced using the same material [2]. The pavers can be removed, stacked, and then replaced in the utility cut area once the utility repairs are completed as shown in Figure 1-3.

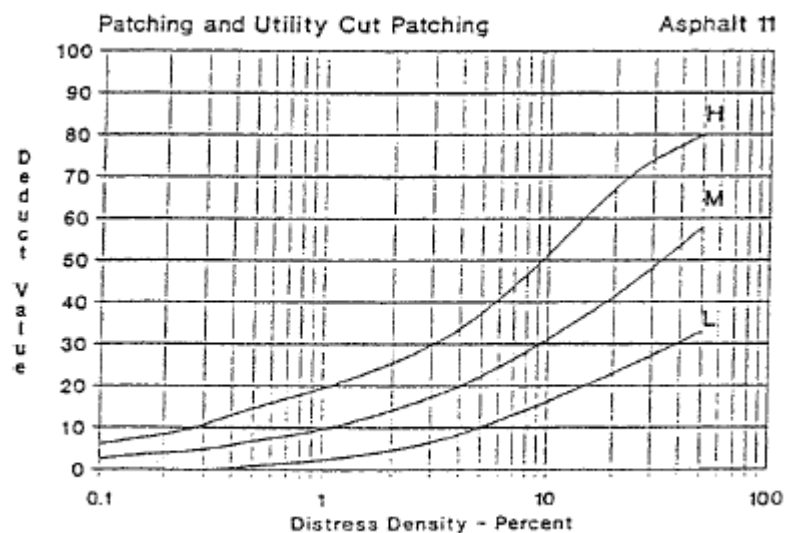
**FIG. X3.16 Patching and Utility Cut Patching**

**Figure 1-4. Deduct Curves for Patching and Utility Cut Patching – HMA Pavement [4].**

ASTM D6433 *Standard Practice for Roads and Parking Lots Pavement Condition Index Surveys* assesses the impact of defects such as utility cuts on the overall condition of flexible and rigid pavements. The impact of patching and utility cut patching on the pavement condition index for HMA pavements is shown in Figure 1-4. The Pavement Condition Index (PCI) procedure uses the distress type, extent and severity to calculate the PCI of the pavement. For patching and utility cut patching, the areas of patched pavement are rated in terms of condition severity in accordance with the criteria in the standard. The sum of the areas of patched pavement are divided by the area of pavement surveyed to obtain the distress density in terms of a percentage of pavement area. Using the distress density and severity, the deduct value is obtained from the deduct curve shown in Figure 1-4. The deduct value is subtracted from a perfect pavement rated at 100 to determine the PCI for the pavement section. For example, if 5 percent of the pavement is patched with a severity of medium, the deduct value for the section would be 22 which results in a PCI of 78. A PCI of 78 would be representative of a municipal pavement with an age of about 12 years.

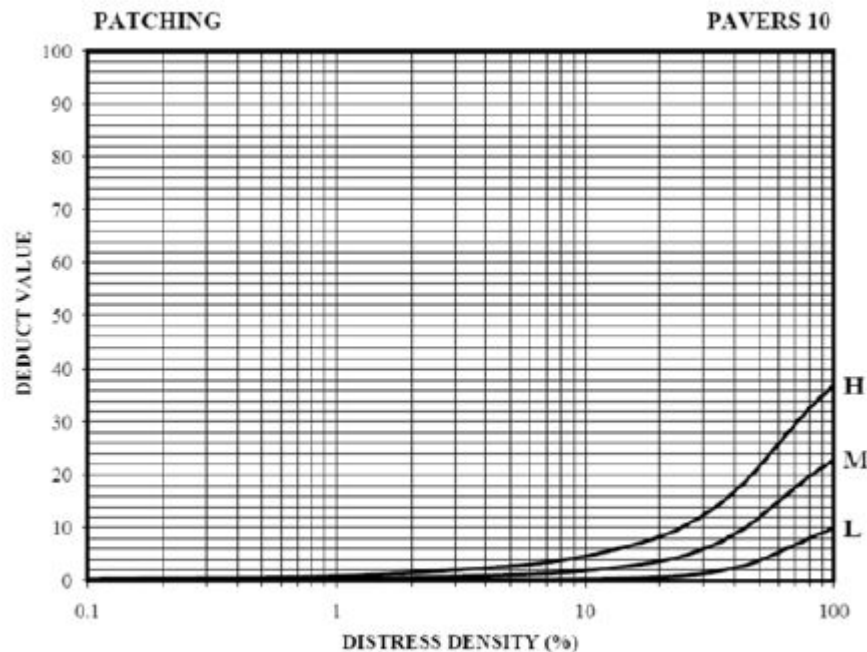
**FIG. X3.10 Patching (10)**

**Figure 1-5. Deduct Curves for Patching – Interlocking Concrete Pavement [5].**

ASTM E2840 *Standard Practice for Pavement Condition Index Surveys for Interlocking Concrete Roads and Parking Lots* [5] outlines the procedures for assessing the impact of defects such as patching and utility cuts patching on the overall condition of interlocking concrete roads and parking lots. Figure 1-5 shows the deduct curves for ICP. From the figure, it can be seen that the impact of patching for ICP is much less pronounced than for HMA pavement because the surface can be reinstated to similar conditions before the utility cut. Using the same example from above, 5 percent of medium severity patching results in a deduct value of 2 which results in a PCI of 98 which is representative of a municipal pavement with an age of about 1 to 2 years. While the impact of utility cut patching can be substantial for HMA pavements, a properly completed utility cut repair for an ICP will have very little impact on the future performance of the pavement. However, as all pavements requirement

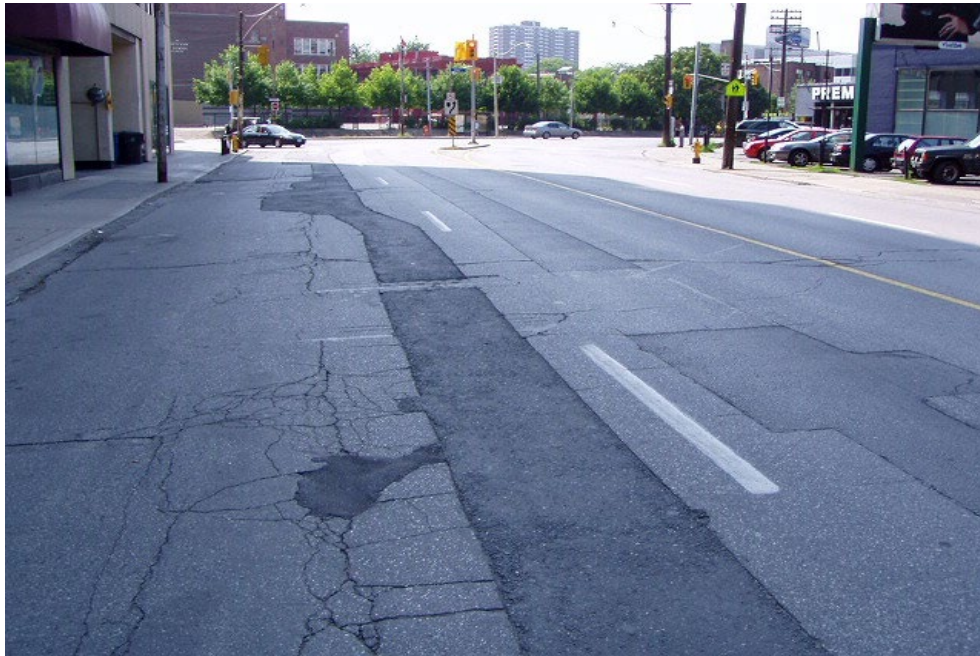
**Figure 2-1. Example of an Extensive Longitudinal Utility Cuts.**

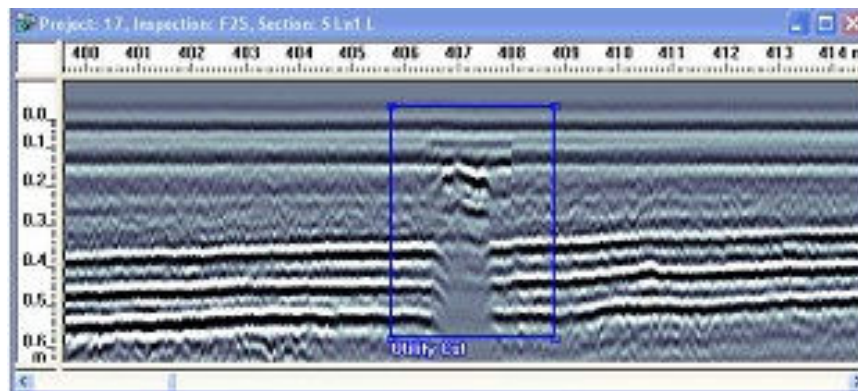
Figure 3-1. GPR Cross Sections showing a Utility Cut Reflection.

In a 2009 study completed for the City of Toronto [6], pavement condition data was gathered for roadways with and without utility cuts to determine the impact of utility cuts on the degradation of pavements. A total of 94 sections of roadway of similar construction consisting of 2,635 segments were surveyed using ground penetrating radar (GPR) and a detailed pavement surface distress survey. The GPR survey determined if a utility cut was located beneath a surface patch or if the surface patch was from a regular pavement maintenance operation only. An example of the results of the GPR testing shows a reflection of a utility cut in Figure 3-1.

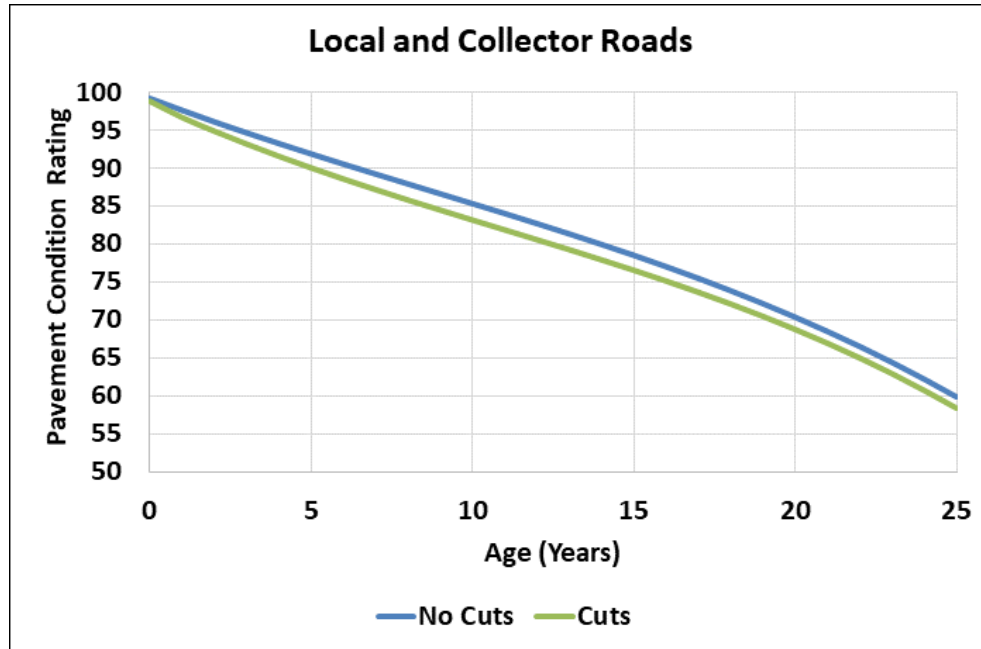
**Figure 3-2. Pavement Performance Curves for Local and Collector Roads.**

The pavement sections were then separated into segments with utility cuts and segments without them. Detailed pavement surface condition inspections were then completed for each of the segments. The surface distresses were then used to calculate the pavement condition index (PCI) of each segment. The weighted average PCI of all segments was found to be 75.6 for pavements without any utility cuts and 71.4 for those with utility cuts. The study indicated that utility cuts reduce the life of a typical municipal pavement in Toronto by 5.5 percent. Over a 25-year initial service life, this represents a service life loss of 1.4 years. This is represented by the pavement performance curve for local and collector roadways shown in Figure 3-2.
