Permeability Restoration of Permeable Interlocking Concrete Pavements

Recipient: University of Toronto Dept. of Civil & Mineral Engineering
Grant: Cdn\$63,300; Industry support: Cdn\$58,221; Cdn\$82,075 from the
Natural Sciences Engineering Research Council of Canada

Project Summary: 19

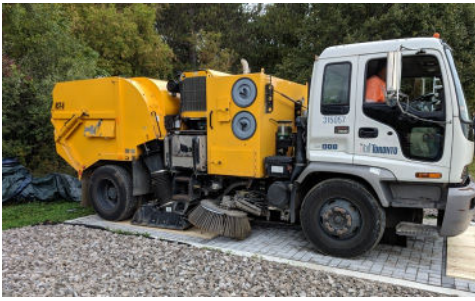
Regenerative air machine

The regenerative air machine restored 20% of the surface permeability. This confirms the use of this equipment for routine cleaning to remove loose dirt, leaves, litter, etc. and not on clogged surfaces. The true vac produced the most variable results. On average, the PICP's surface infiltration capacity was

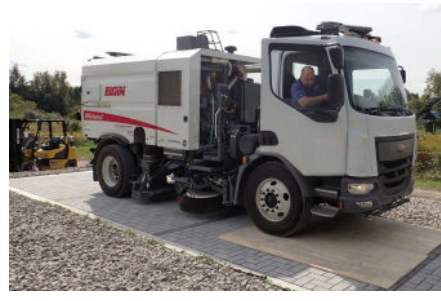
True vac machine

~7,500 mm/hr (295 in./hr) or 70% of post-construction surface infiltration. Measurements ranged from 1,280 mm/hr (50 in./hr) to 13,900 mm/hr (547 in./hr). Power washing and a Shop Vac improved surface infiltration by 25%. The waterless mechanical street sweeper restored the PICP's surface infiltration capacity to 35% of its original condition, or about 3,540 mm/hr (139 in./hr). The high pressurized-air and vacuum system fully restored the PICP to its baseline, post-construction surface infiltration. Average surface infiltration rates were 2 to 6 times higher than from other equipment, ~12,900 mm/hr or 508 in./hr for cohesionless soil mixed with jointing stone.

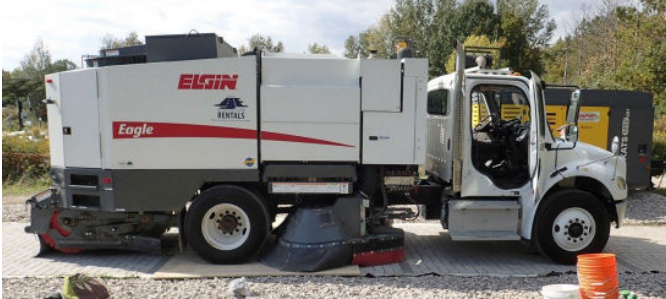
Waterless Mechanical Sweeper

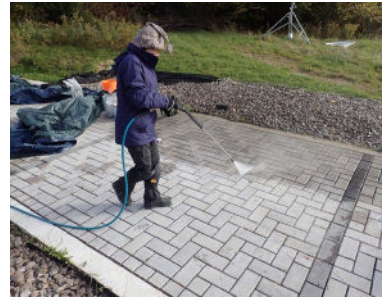
Power washing before applying a Shop Vac

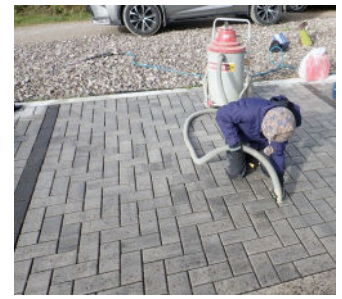
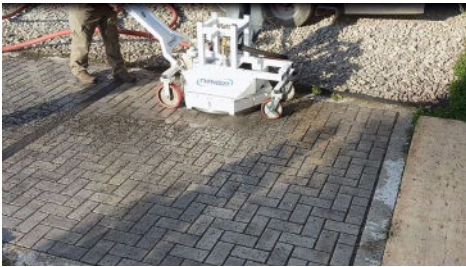
High pressure air and vacuum system

- The depth of evacuation into joints was a strong indicator of overall maintenance effectiveness when clogged with similar materials, but not when clogged with different materials.
- Orientation of street sweeper suction/collection heads greatly influenced the amount of joint materials removed. Passes in all joint directions can likely provide the highest results.
- Cohesive soils in the joints significantly decreased the effectiveness of restorative maintenance. The high pressure-air/vacuum system was only able to restore the PICP's surface infiltration to approximately 50% of the pavement's original surface infiltration while removing cohesive sediment. In contrast, this equipment was able to fully restore infiltration when non-cohesive materials occupied the joints.
