OPERATION AND MAINTENANCE GUIDE FOR INTERLOCKING CONCRETE PAVEMENT

Interlocking concrete pavement (ICP) provides an attractive, durable, low maintenance pavement system. However, like any pavement system, if one of the elements fails to perform, the entire system can be compromised. Performance issues can arise from inadequate design, inappropriate materials, ineffective construction techniques or absence of proper maintenance. This Tech Note provides best practices for maintenance and illustrates actions that should be taken when the system underperforms. The methods utilized apply to commercial and residential interlocking concrete pavement applications. Following the guidance provided in this Tech Note can help ensure the optimum performance.

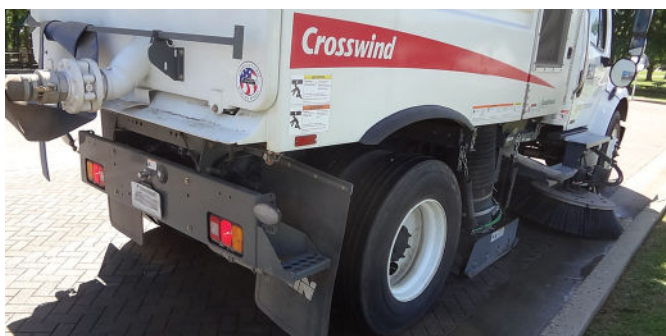
Figure 1. Typical street sweeper used to remove surface debris from large ICP areas in the spring and fall.

This can be done using a mechanical street sweeper, as shown in Figure 1, or push broom depending on the size of the area. A spring sweeping to remove any remaining deicing chemicals and winter sand and a fall sweeping to remove accumulated dirt and leaves are recommended. A power washer or leaf blower can do this very effectively but be careful not to remove the joint sand.

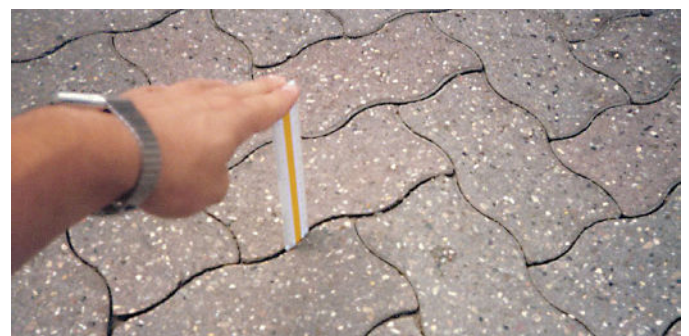
Figure 2. Refill joints with dry masonry sand if loss is greater than 1/2 in. (12 mm).

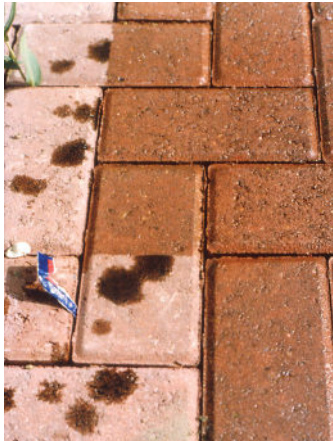
Figure 3. It is easier to remove oils stains from pavers that have been sealed.

paver surfaces as shown in Figure 3. Sealers are useful around barbecues, trash receptacles, fast food restaurants, driveways, other areas subject to stains, and where oil drippings are not wanted. Application of a sealer follows stain removal, efflorescence removal, and overall surface cleaning. Further detail is provided in CMHA Tech Note PAV-TEC-005–*Cleaning, Sealing and Joint Sand Stabilization of Interlocking Concrete Pavement*.

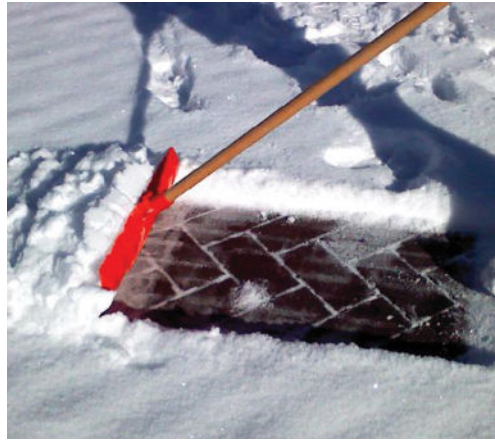
Figure 4. Shovel snow diagonal to the paver pattern to prevent catching edges.

Snow can be removed from interlocking concrete pavers using shovels, snow blowers or snowplows like any other type of pavement. Experience indicates easier snow removal by shoveling and plowing in a direction diagonal to the joints to prevent catching the edge of the pavers as shown in Figure 4. Prior to the winter season, heaved or slightly lifted units creating lippage of greater than 1/8 in. (3 mm) should be repaired.

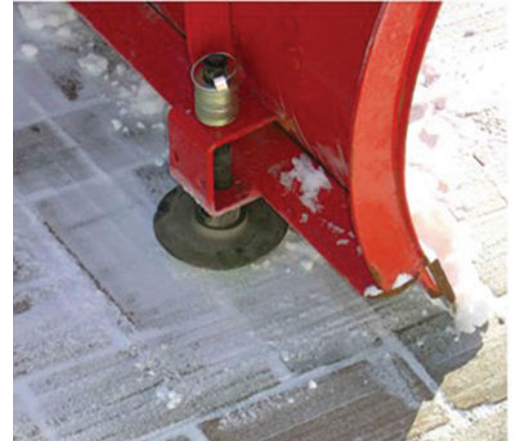
Figure 5. Shoes on plows need to be adjusted so the blade is not pushed across the surface and limits scratching the pavers.

Snow blowers and snowplows can have shoes under them that skid across the pavement surface and raise the blade just above the pavement surface. See Figure 5. Over time, these shoes wear and need to be adjusted to ensure the blade rides at a height that removes as much snow as possible without catching paver edges. Excessive snow blowing and snow plowing operations can embed metal filings from worn shoes into the paver surface that can lead to rust stains. These can be removed with rust removal cleaners. See *CMHA Tech Note PAV-TEC-005–Cleaning and Sealing interlocking Concrete Pavement–A Maintenance and Protection Guide*. Synthetic shoes are available which prevent rust staining created by shoe wear.

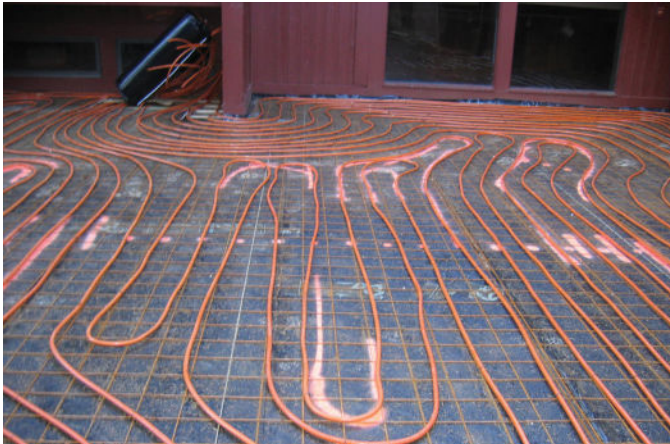
Figure 6. Radiant heating can be installed under the paver surface to melt snow and ice in the winter.

accumulation. Electric and hydronic snow melt systems can be incorporated into interlocking concrete pavement systems. See Figure 6 and 7. Further information can be found in CMHA Tech Note PAV-TEC-012–*Snow Melting Systems for Interlocking Concrete Pavements*.

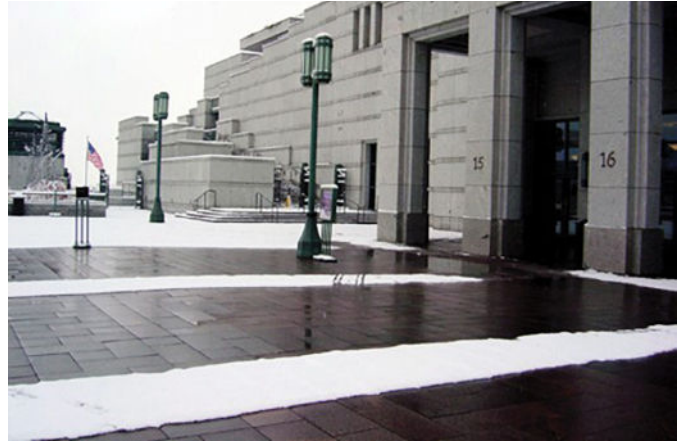
Figure 7. To conserve energy, the snow melt system is only installed directly under the high traffic areas where it is needed.

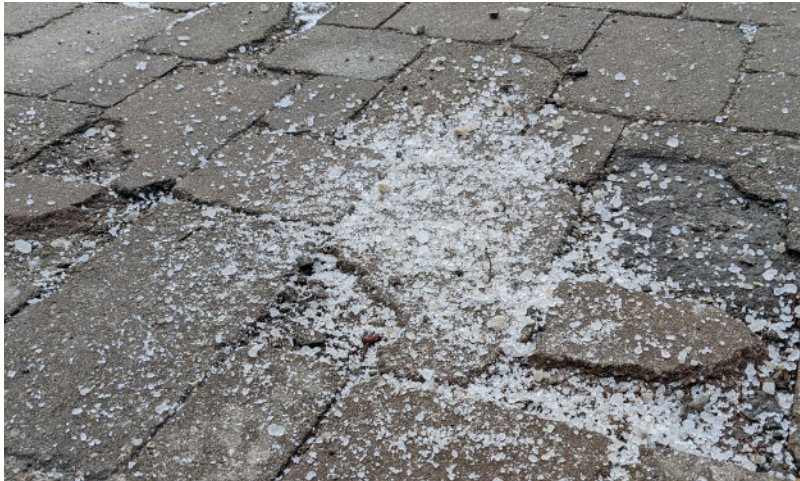
Figure 8. Use deicing chemicals sparingly and remove any excess after it has completed its job.

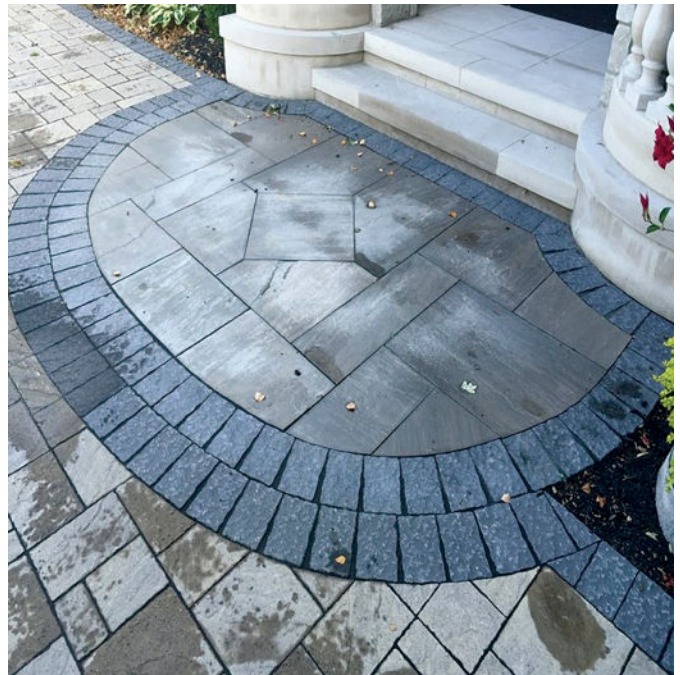
Figure 9. Efflorescence is only an aesthetic concern and can be removed with cleaners specifically formulated for this task.

Efflorescence is not a structural, but rather an aesthetic concern. The white haze may give the impression that the color of the pavers is fading but this is not the case. Efflorescence may occur randomly or be concentrated in certain areas. Dark colored pavers show efflorescence more than lighter colored ones.

If efflorescence occurs, it can be removed with cleaners specifically made for concrete pavers. Careless or improper cleaning can result in damage and discoloration to paver surfaces. Contact the paver supplier for further information on commercially available cleaners. CMHA Tech Note PAV-TEC-005–Cleaning and Sealing interlocking Concrete Pavement–A Maintenance and Protection Guide provides additional details.

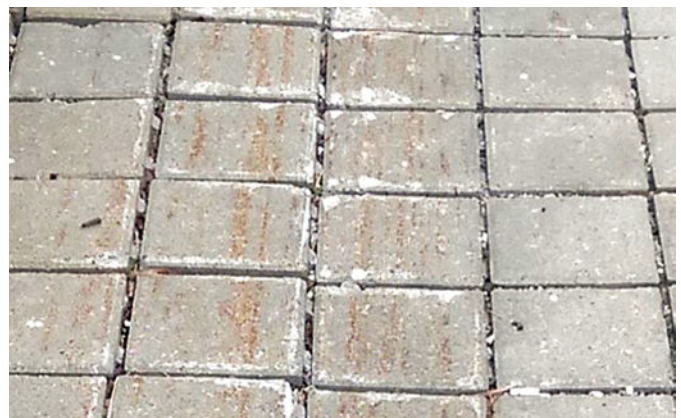
Figure 10. Excessive scratching from a snow plow can lead to rust stains.

Numerous companies sell products designed specifically to clean concrete pavers. Some are general cleaners and some are specific to the type of stain being removed. As an example, there are cleaners designed to remove only rust stains like those shown in Figure 10. Pressure washers, shown

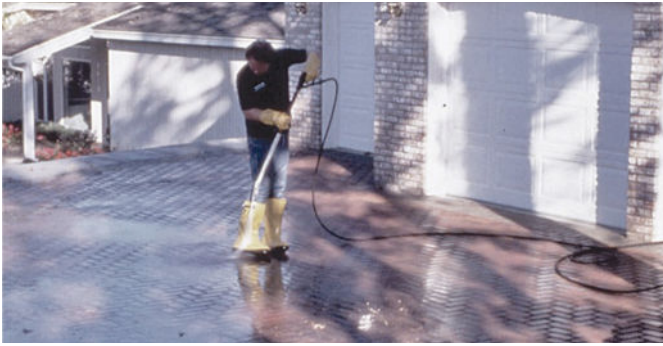
Figure 11. Pressure washers are commonly used to clean ICP. When using be careful not to remove joint sand.

in Figure 11, are a commonly used tool used to clean pavers. Professionals use specialized equipment shown in Figure 12 to maximize the cleaner’s effectiveness and minimize any damage to the pavement.

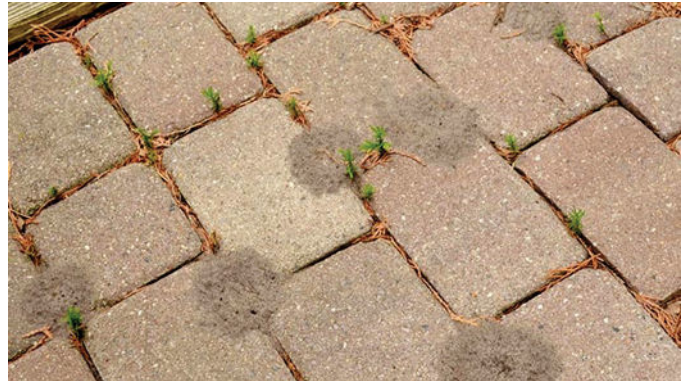
Figure 13. Joint sand stabilization could have been used to reduce the affects of weeds and ants.

Contrary to some views, weeds don’t grow from the bedding sand, base, or subgrade. Weeds can germinate between pavers from windblown seeds lodged in the joints. See Figure 13. Weeds can be removed by hand or killed using steam or a herbicide. Take care in using herbicides so that adjacent vegetated areas are not damaged. Use biodegradable products that won’t damage other vegetation or pollute water supplies when washed from the pavement surface. Besides stabilizing the joint sand, sealers can prevent seeds from germinating, and prevent ants from entering.

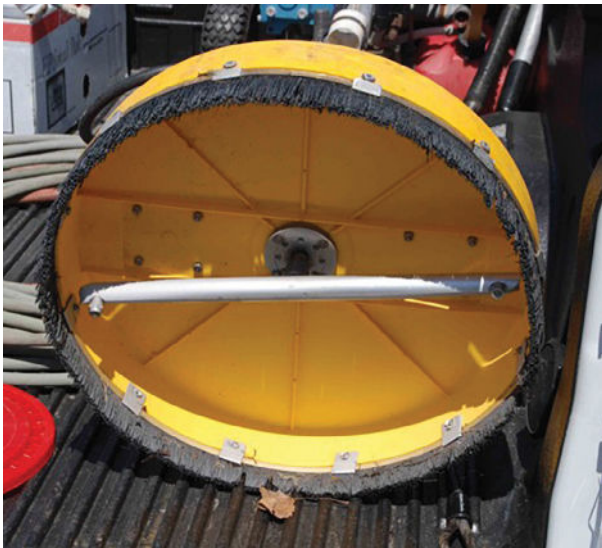
Figure 12. From the underside of the pressure washing attachment, it is possible to see the rotating pressure wand, which sprays the pavement surface.

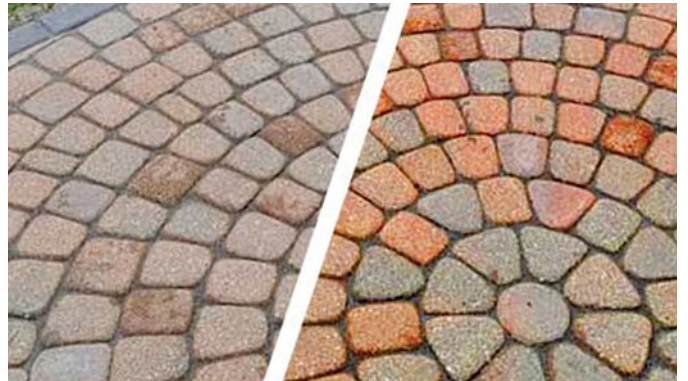
Figure 14. Cleaning the ICP surface can remove fine particles lodged in the pores of the concrete surface to rejuvenate the color.

Color in concrete pavers is achieved by adding pigment to the concrete mix during production. The cement in the concrete mix holds the pigments in place. Normal wear from traffic or weather gradually erodes the cement and pigment particles, exposing more of the aggregate and sand, causing a color change over time. Like all pavements, concrete pavers receive dirt from foot or tire traffic which changes the surface color. See Figure 14. Cleaning and sealing the surface of the concrete pavers can moderate the rate of color change. Besides enhancing the pavers’ color, sealers can help prevent dirt from lodging in their surface.

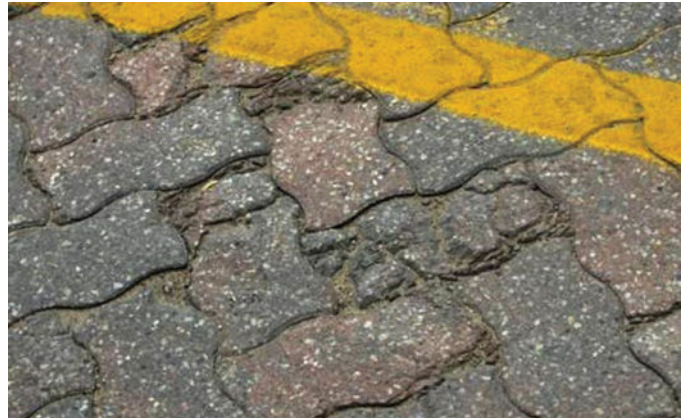
Figure 17. Damaged pavers can be caused by excessive movement of the base or excessive concentrated loads applied to the surface.

Description: Damaged pavers distresses such as chips, cracks, or spalls. Damage may indicate inadequate support causing shear breakage, etc. Figure 17

Identification: One or more chips, cracks, or spalls. Cracked pavers with little to no opening generally will not affect performance.

Repair: Replace with new pavers, compact, refill joint sand, compact.

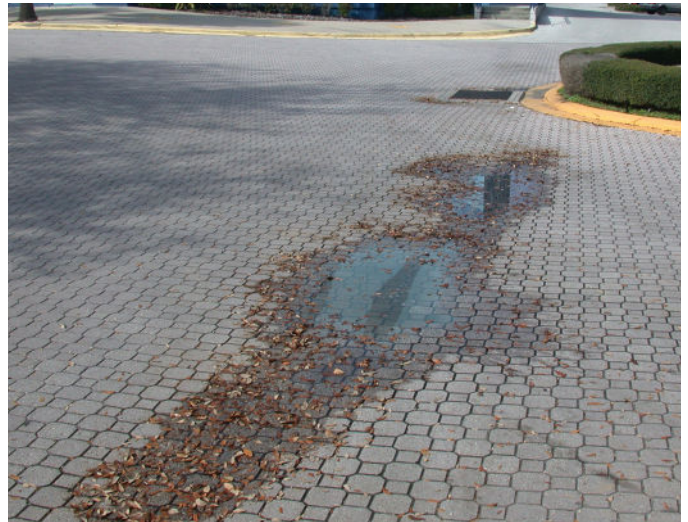
Figure 18. Depressions are caused by settlement of the base or subgrade and are easily spotted by the puddles formed after rain events.

Description: Depressions are lower areas than those around it. Depressions are caused by settlement of the underlying subgrade or granular base, often from inadequate compaction. Other factors can be a saturated base or soil, excessive bedding sand thickness deformed from wheel loads, or washed out bedding and joint sand. Loose or inadequate edge restraints will cause pavers to move apart. Settlement is common on utility cut patches and adjacent to road hardware. Depressions can cause roughness in the pavement, and when filled with water, can cause hydroplaning of vehicles or slippery ice patches in the winter.

Identification: Depression are measured by placing a 3 m (10 foot) straight across the depression and measuring the high depth from it to the pavement.

Repair: Identify source (typically not load-related): Bedding, base or subgrade and repair per rutting distress described below. Pavers in uneven areas with low severity depressions can be removed, the settlement adjusted, and the units reinstalled with no wasted paving materials or unsightly patches.

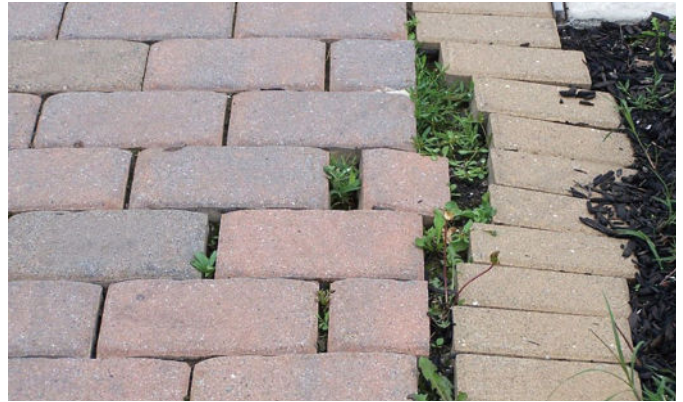
Figure 19. Lack of an effective edge restraint has allowed the pavers to separate and compromise the structural capacity of the ICP.

Repair: Repair/replace edge restraint/curb & adjacent pavers, compact, refill joint sand, compact.

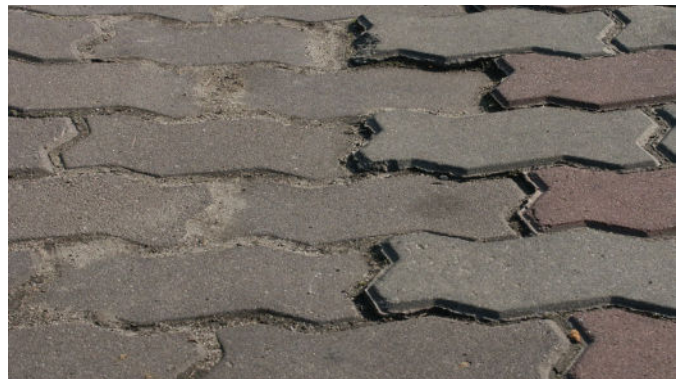
Figure 21. Faulting can be seen as a line of pavers being lifted above the neighboring units.

Description: Faulting happens when the elevation of adjacent pavers differs or have rotated. Faulting can be caused by surficial settlement of the bedding sand, poor installation, pumping of the joint or bedding sand. Local roughness can reduce the ride quality. Faulting can pose a safety hazard for pedestrians.

Identification: Faulting is characterized by small areas of individual units standing slightly proud above their neighbors. This can be seen in Figure 21. This distress is often associated with more severe distresses such as settlement, heave, rutting, etc.

Repair: Faulting may be corrected by resetting the blocks. However, faulting may be caused by differential base movement. In this case repair base, replace bedding, reinstate pavers, compact, refill joint sand, compact.

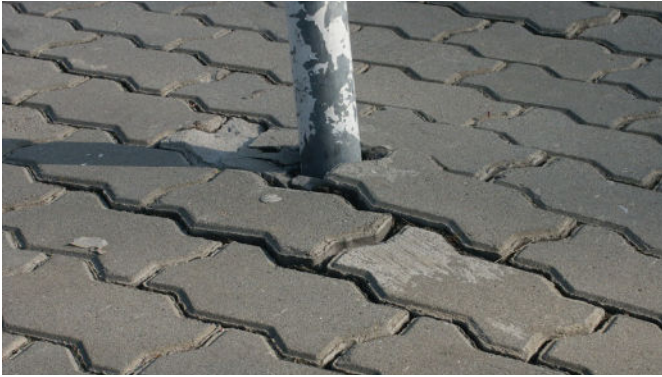
Figure 22. Heave is typically seen near structures that have moved due to freeze-thaw action.

Description: Heaves exhibit elevations higher than surrounding areas. Heaves are typically caused by frost heave of the underlying soils as shown in Figure 22. Heaves can also occur because of subgrade instability and can also occur in conjunction with settlement / rutting.

Repair: If from frost, install frost-resistant subbase materials. Consult w/ geotechnical engineer if not frost related.

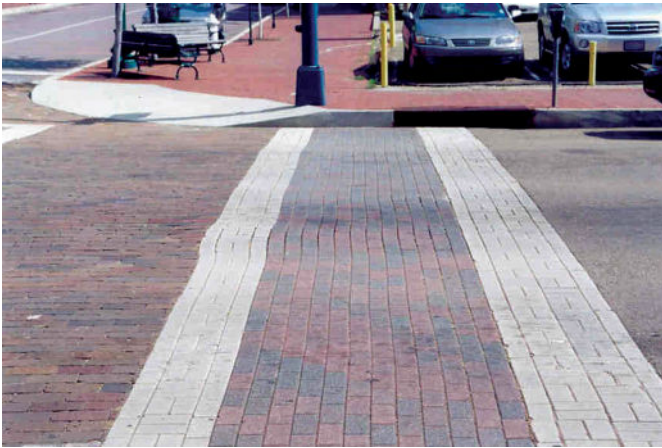
Figure 23. Horizontal Creep is easily spotted in ICP areas that were constructed straight, but over time develop a wave in the pattern.

Description: Horizontal creep is the longitudinal displacement of the paving pattern caused by repeated braking, accelerating, or turning tires.

Repair: Remove and reinstate pavers in original laying pattern. Apply steel, anti-creep reinforcement under the pavers in severe cases. Compact, refill joint sand, compact.

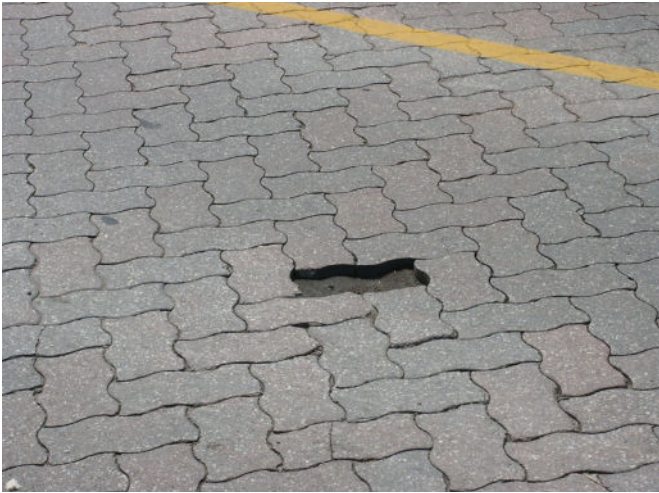
Figure 25. Missing pavers should be replaced as soon as possible to avoid damage to the surrounding units.

Description: Missing pavers, as the name implies, refers to sections of pavement without pavers resulting from removal or disintegration/damage. Missing pavers compromise the integrity of the pavement structure and promote surface roughness like potholes in flexible pavements.

Identification: One or more missing pavers as illustrated in Figure 25.

Repair: Replace with new pavers

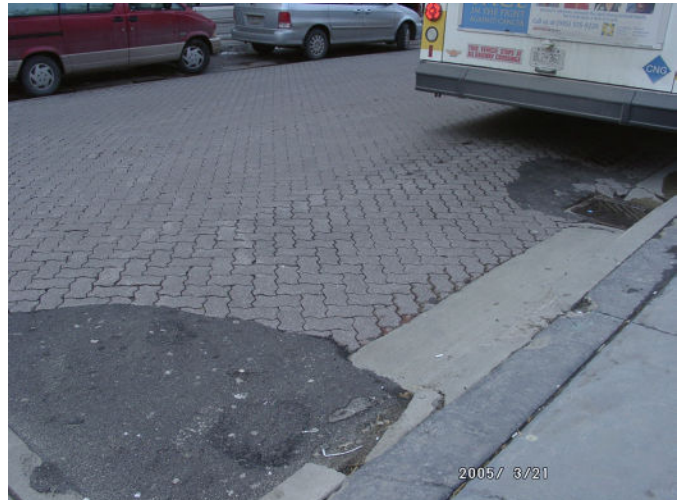
Figure 26. Patching compromises the structural integrity of ICP and occurs when proper maintenance techniques are not followed.

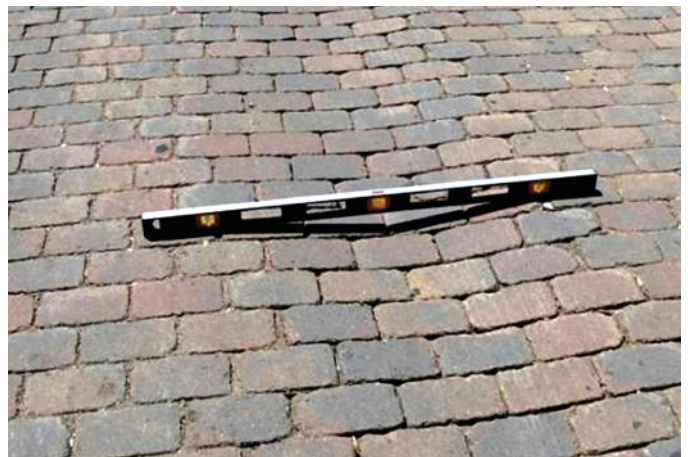
Figure 27. Rutting occurs when the underlying layers settle. The extent of rutting is easily measured by laying a straight edge across the rut.

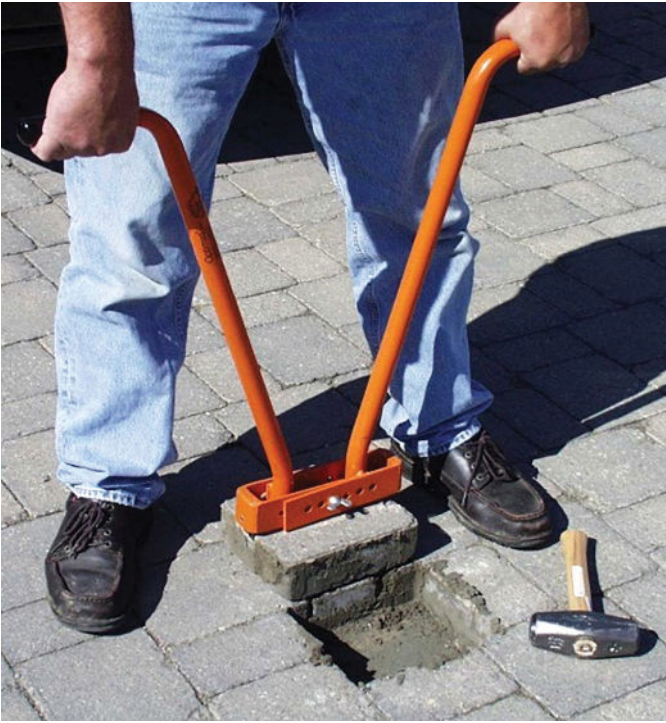
Figure 30. A paver extractor can be used to grab the first paver and wiggle it out.

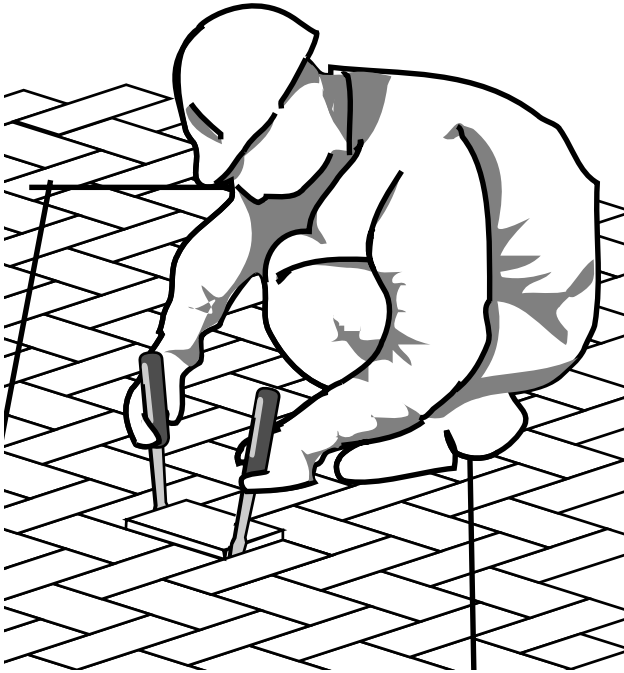
Figure 31. A pair of slot screwdrivers can also be used to wiggle out the first paver. Care must be used to slowly work the unit out and not damage the surround paver edges.

Alternately, it is possible to carefully pry each side of a paver upward with one or two large screwdrivers. Begin prying on the short ends of the paver. The paver will rise a small distance with each prying (Figure 31). When the paver is high enough to grasp, wiggle it loose, pulling upward. If necessary, pry with a screwdriver using one hand while pulling upward with the other. Sometimes, one end of the paver can be pulled above

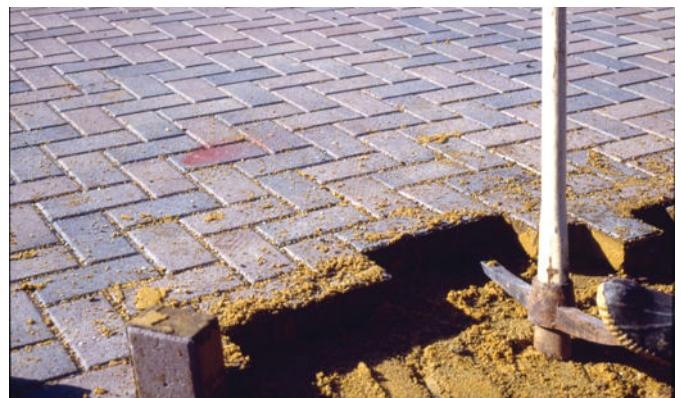
Figure 32. A pick or pry bar can be used to reach under the pavement edge and pry units out.

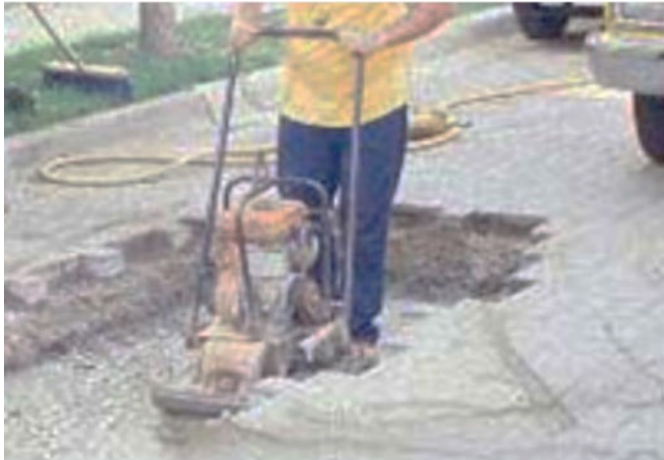
Figure 35. The subgrade should be re-established with a material that can be fully compacted and have little potential for settlement.

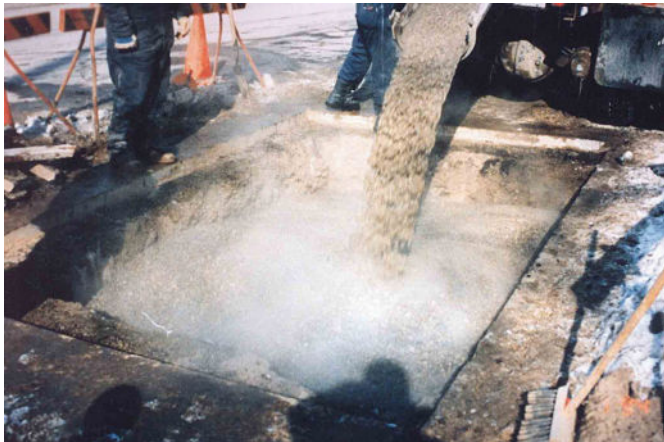
Figure 37. "Flowable Fill" can provide a subgrade or base with little potential for future settlement and not require compaction.

Low strength flowable fill requires a short curing time and can be used in freezing weather. It requires no compaction and with some mix designs, can be opened to traffic in 24 hours. Low-strength fill is stiffer than aggregate base and offers higher

resistance to settling and rutting. This reduces deterioration of the pavement surface over time. To facilitate re-excavation, flowable fill should be made with a small amount of cement. Check with suppliers on the strength of in-place fill that is at least two years old, and on ease of excavation of these sites. The strength of the fill should not exceed 300 psi (2 MPa) after two years of service. Low-strength fill has been used successfully in Toronto and London, Ontario; Colorado Springs, Colorado; Cincinnati, Ohio, Kansas City, Missouri; Peoria, Illinois; and many other municipalities. It is generally more cost-effective than using aggregate base by reducing job time and future pavement repairs. Local ready-mix suppliers can be contacted for available mixes, strengths, installation methods and prices. See CMHA Tech Note PAV-TEC-007–Repair of Utility Cuts within Interlocking Concrete Pavements for further information on low-strength fill.

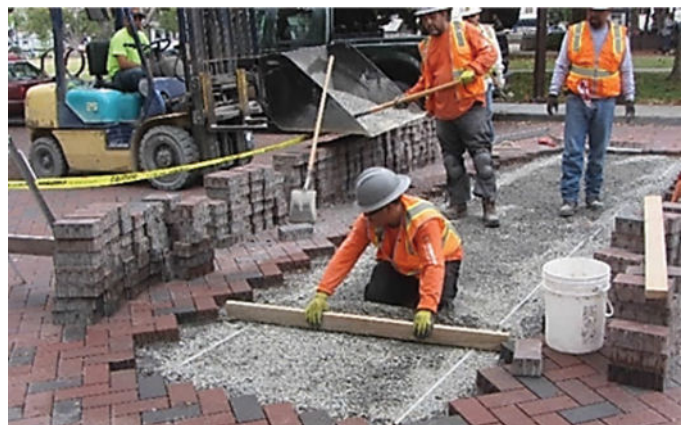
Figure 39. Alternately screed bar can be placed on the re-established base.

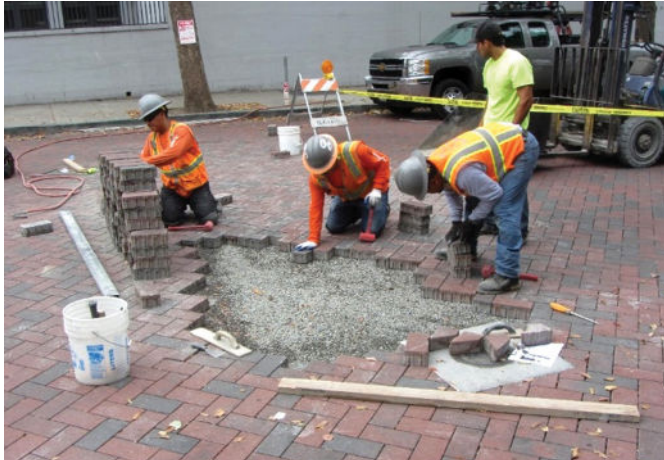
Figure 40. Pavers salvaged during the disassembly can be brought back and placed according to the original pattern. Care needs to be taken to ensure any remaining sand on the bottom or sides of the pavers is removed before placement.

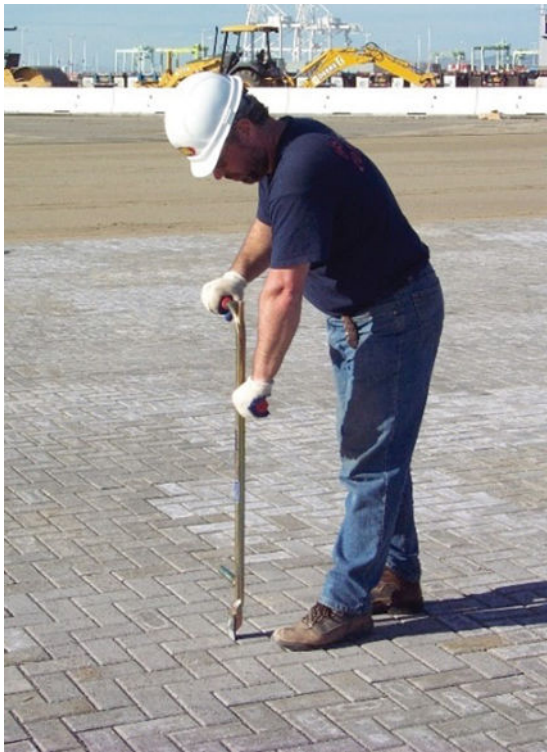
Figure 41. An alignment bar and string line can be useful to tweak the pattern and make it line up with the surrounding undisturbed paver.

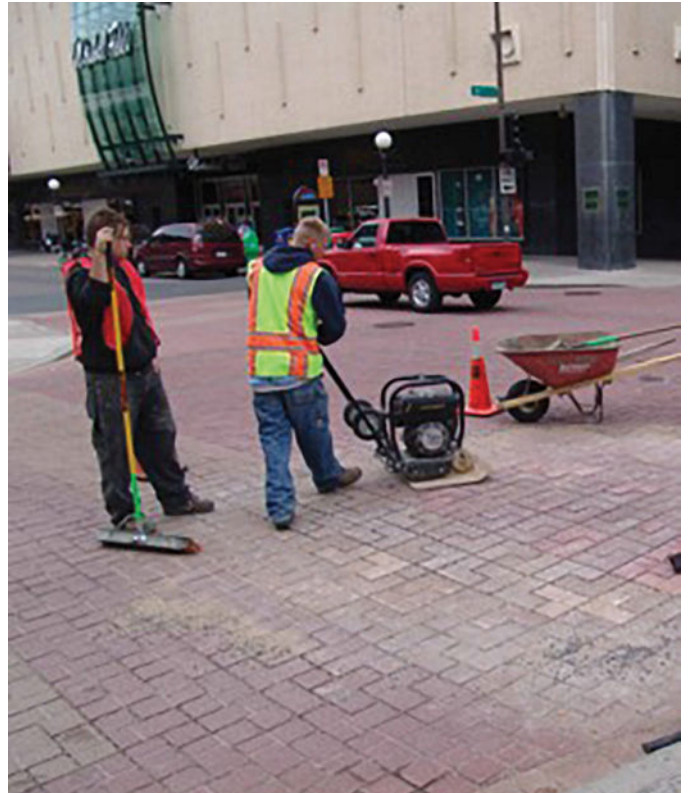
Figure 42. Pavers are compacted into the loose bedding sand. Joint sand is then swept and vibrated into the joints until they are filled to complete the repair.
