OPERATION AND MAINTENANCE GUIDE FOR INTERLOCKING CONCRETE PAVEMENT

Interlocking concrete pavement (ICP) provides an attractive, durable, low maintenance pavement system. However, like any pavement system, if one of the elements fails to perform, the entire system can be compromised. Performance issues can arise from inadequate design, inappropriate materials, ineffective construction techniques or absence of proper maintenance. This Tech Note provides best practices for maintenance and illustrates actions that should be taken when the system underperforms. The methods utilized apply to commercial and residential interlocking concrete pavement applications. Following the guidance provided in this Tech Note can help ensure the optimum performance.

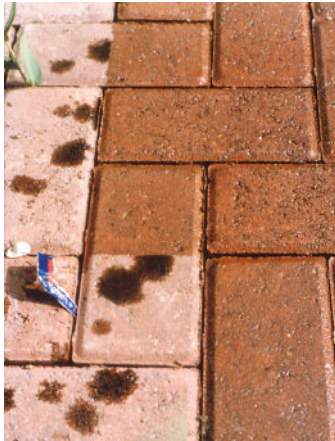
Figure 3. It is easier to remove oils stains from pavers that have been sealed.

paver surfaces as shown in Figure 3. Sealers are useful around barbecues, trash receptacles, fast food restaurants, driveways, other areas subject to stains, and where oil drippings are not wanted. Application of a sealer follows stain removal, efflorescence removal, and overall surface cleaning. Further detail is provided in CMHA Tech Note PAV-TEC-005–*Cleaning, Sealing and Joint Sand Stabilization of Interlocking Concrete Pavement*.

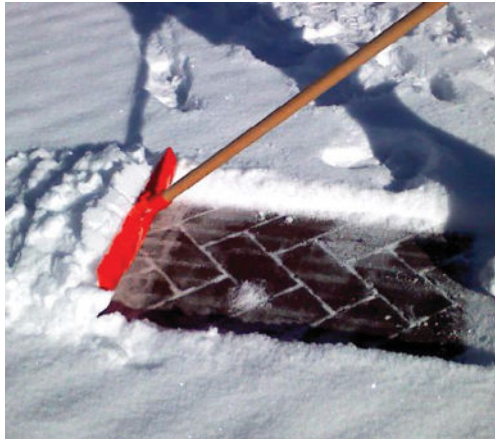
Figure 4. Shovel snow diagonal to the paver pattern to prevent catching edges.

Snow can be removed from interlocking concrete pavers using shovels, snow blowers or snowplows like any other type of pavement. Experience indicates easier snow removal by shoveling and plowing in a direction diagonal to the joints to prevent catching the edge of the pavers as shown in Figure 4. Prior to the winter season, heaved or slightly lifted units creating lippage of greater than $\frac{1}{8}$ in. (3 mm) should be repaired.

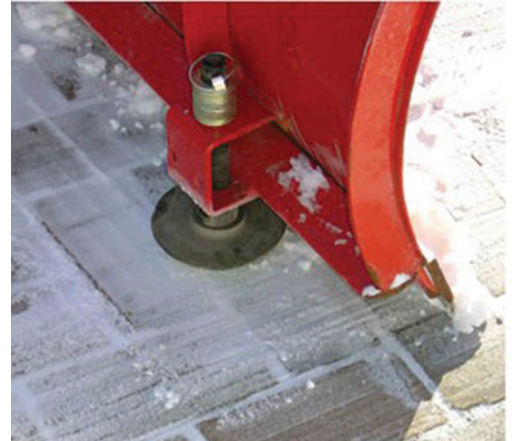
Figure 5. Shoes on plows need to be adjusted so the blade is not pushed across the surface and limits scratching the pavers.

Snow blowers and snowplows can have shoes under them that skid across the pavement surface and raise the blade just above the pavement surface. See Figure 5. Over time, these shoes wear and need to be adjusted to ensure the blade rides at a height that removes as much snow as possible without catching paver edges. Excessive snow blowing and snow plowing operations can embed metal filings from worn shoes into the paver surface that can lead to rust stains. These can be removed with rust removal cleaners. See *CMHA Tech Note PAV-TEC-005–Cleaning and Sealing interlocking Concrete Pavement–A Maintenance and Protection Guide*. Synthetic shoes are available which prevent rust staining created by shoe wear.

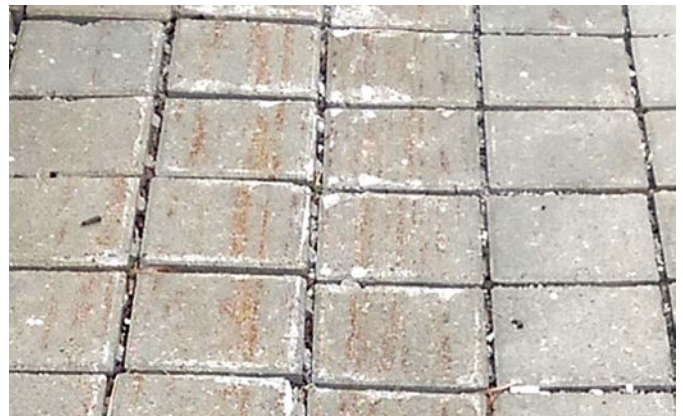
Figure 10. Excessive scratching from a snow plow can lead to rust stains.

Numerous companies sell products designed specifically to clean concrete pavers. Some are general cleaners and some are specific to the type of stain being removed. As an example, there are cleaners designed to remove only rust stains like those shown in Figure 10. Pressure washers, shown

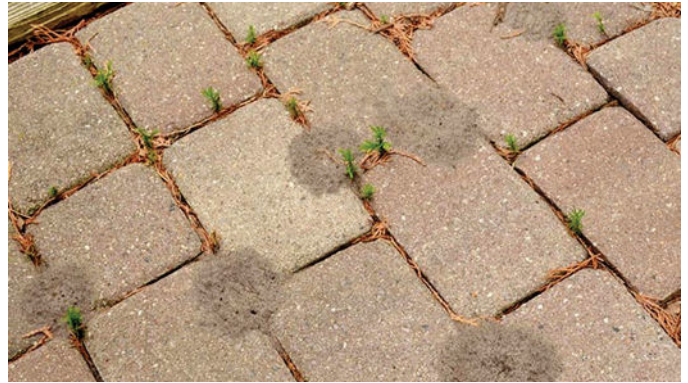
Figure 13. Joint sand stabilization could have been used to reduce the affects of weeds and ants.

Contrary to some views, weeds don’t grow from the bedding sand, base, or subgrade. Weeds can germinate between pavers from windblown seeds lodged in the joints. See Figure 13. Weeds can be removed by hand or killed using steam or a herbicide. Take care in using herbicides so that adjacent vegetated areas are not damaged. Use biodegradable products that won’t damage other vegetation or pollute water supplies when washed from the pavement surface. Besides stabilizing the joint sand, sealers can prevent seeds from germinating, and prevent ants from entering.

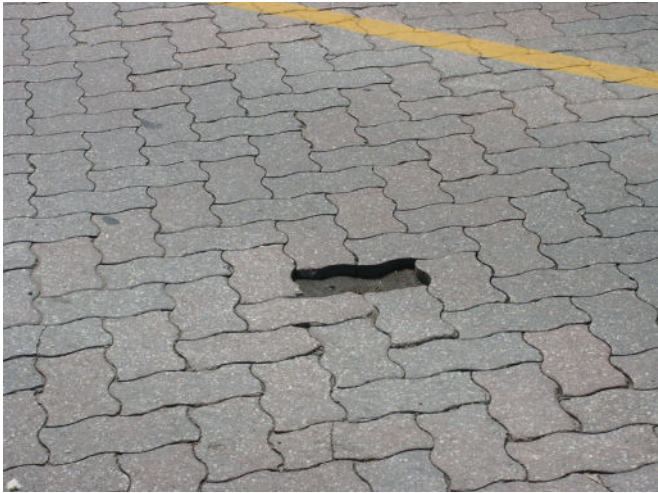
Figure 25. Missing pavers should be replaced as soon as possible to avoid damage to the surrounding units.

Description: Missing pavers, as the name implies, refers to sections of pavement without pavers resulting from removal or disintegration/damage. Missing pavers compromise the integrity of the pavement structure and promote surface roughness like potholes in flexible pavements.

Identification: One or more missing pavers as illustrated in Figure 25.

Repair: Replace with new pavers

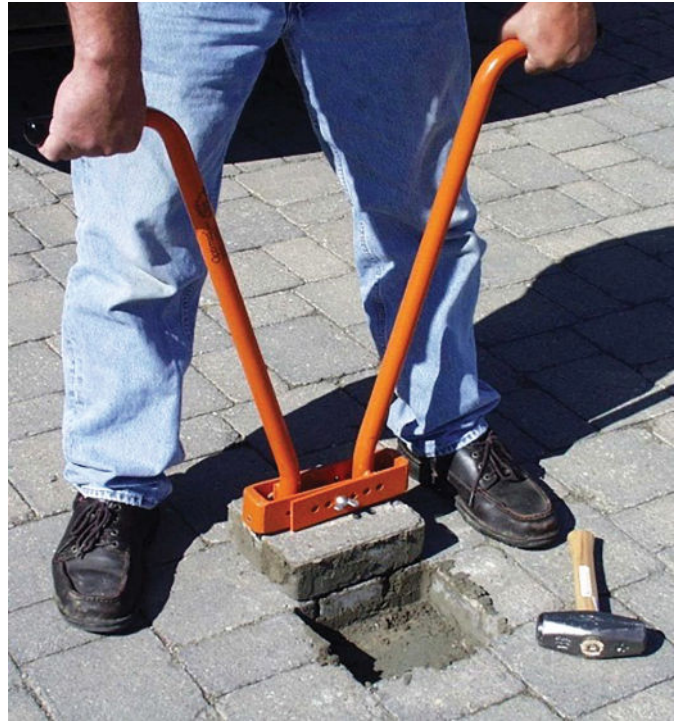
Figure 30. A paver extractor can be used to grab the first paver and wiggle it out.

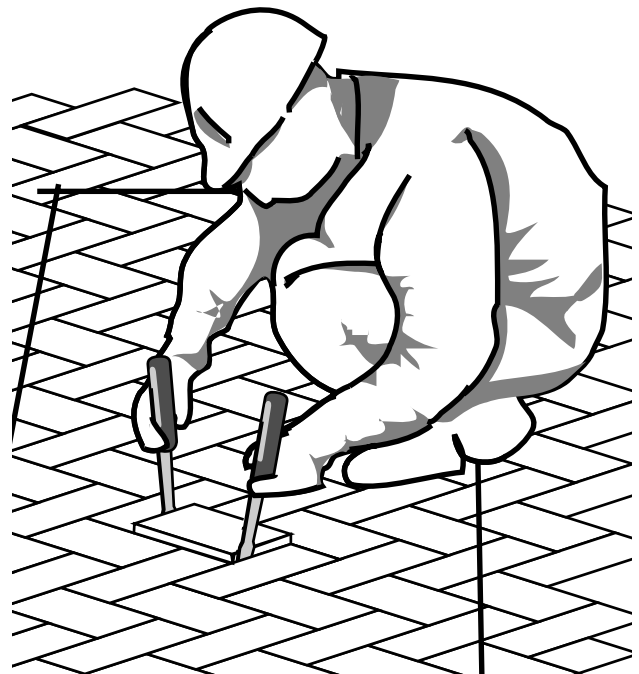
Figure 31. A pair of slot screwdrivers can also be used to wiggle out the first paver. Care must be used to slowly work the unit out and not damage the surround paver edges.

Alternately, it is possible to carefully pry each side of a paver upward with one or two large screwdrivers. Begin prying on the short ends of the paver. The paver will rise a small distance with each prying (Figure 31). When the paver is high enough to grasp, wiggle it loose, pulling upward. If necessary, pry with a screwdriver using one hand while pulling upward with the other. Sometimes, one end of the paver can be pulled above

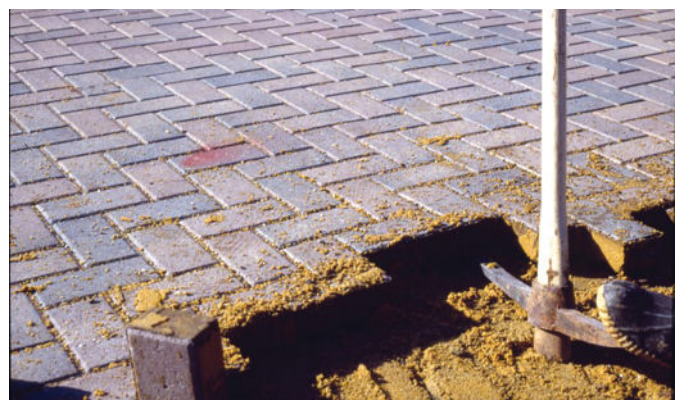
Figure 32. A pick or pry bar can be used to reach under the pavement edge and pry units out.

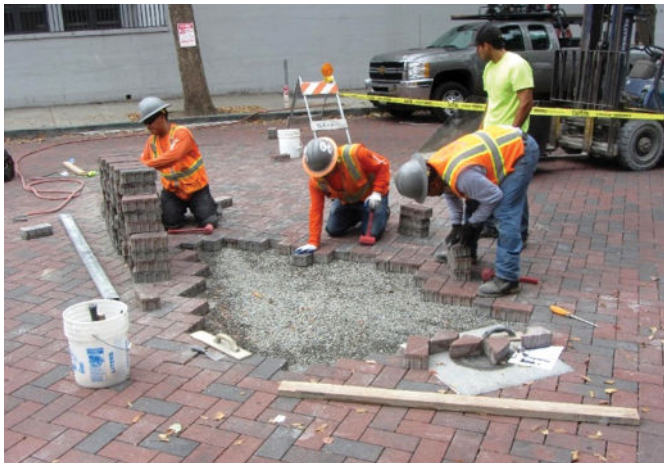
Figure 40. Pavers salvaged during the disassembly can be brought back and placed according to the original pattern. Care needs to be taken to ensure any remaining sand on the bottom or sides of the pavers is removed before placement.
