## REPAIR OF UTILITY CUTS WITHIN INTERLOCKING CONCRETE PAVEMENTS

Revised August 2023

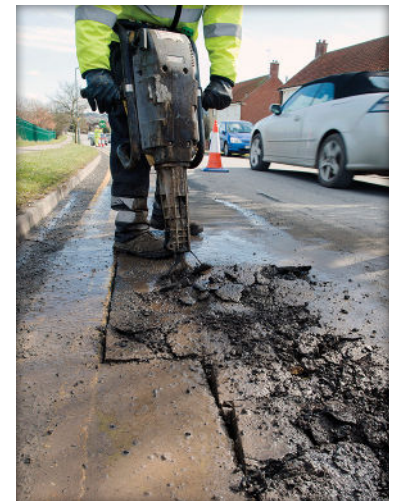
Figure 1. Repairs to utilities are a common sight in cities, incurring costs to cities and taxpayers.

North American cities have thousands of utility cuts made in their streets each year. Figure 1 shows a daily occurrence in most cities: repairs to underground utility lines for water, sewer, gas, electric, steam, phone, fiber-optic, or cable services. A sample is given below of the number of annual utility cuts in a few cities.

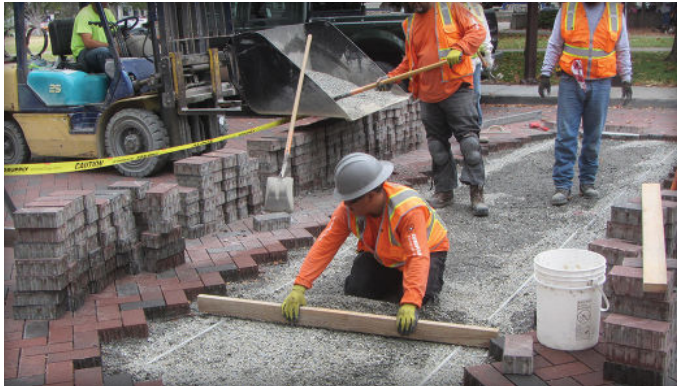
Figure 2. After compaction of the base, bedding material is screeded. Edge restraints would typically be required to prevent the pavers from moving during disassembly and reinstatement.

Figures 2, 3, 4, 5 and 6 show the process of repair and illustrate the continuity of the paver surface after it is completed. The reinstated units are knitted into existing ones through the interlocking paving pattern and sand filled joints. Besides providing a pavement surface without cuts, the joints distribute loads by shear transfer. The joints allow minor settlement in

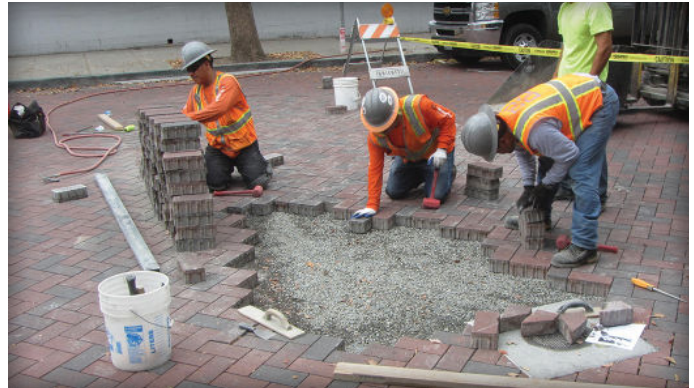
Figure 3. Once smoothed and joined with undisturbed materials at the opening perimeter, the bedding receives concrete pavers.

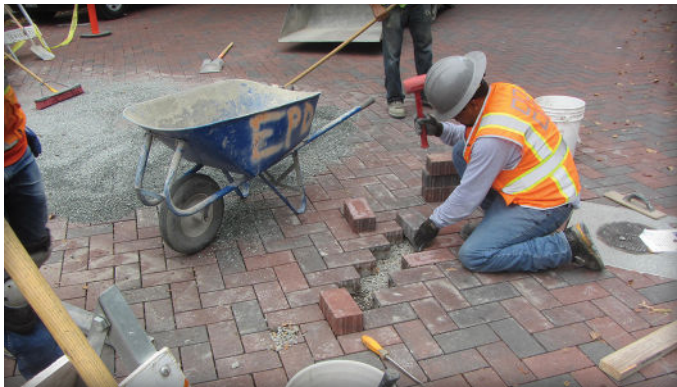
Figure 4. Reinstatement using the same pavers continues following the existing herringbone paving pattern.

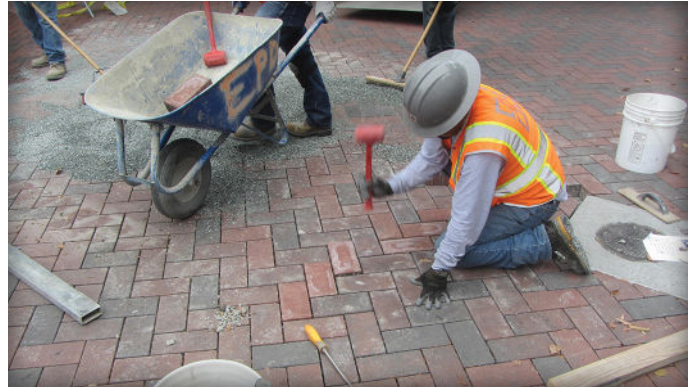
Figure 5. The final paver is inserted, the reinstated area compacted, joints filled, and compacted again. There are not cuts or damage to the pavement surface.

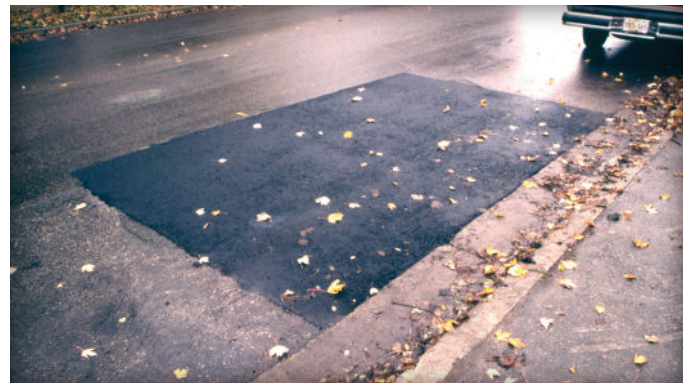
Figure 7. Pavement damage from settlement and shrinkage of cold patch asphalt.

Any break in monolithic pavement, e.g., joints, cuts or cracks, normally shortens pavement life because the continuity of the material is broken as shown in Figure 7. In contrast, the joints of the modular units in interlocking concrete pavements maintain structural continuity.

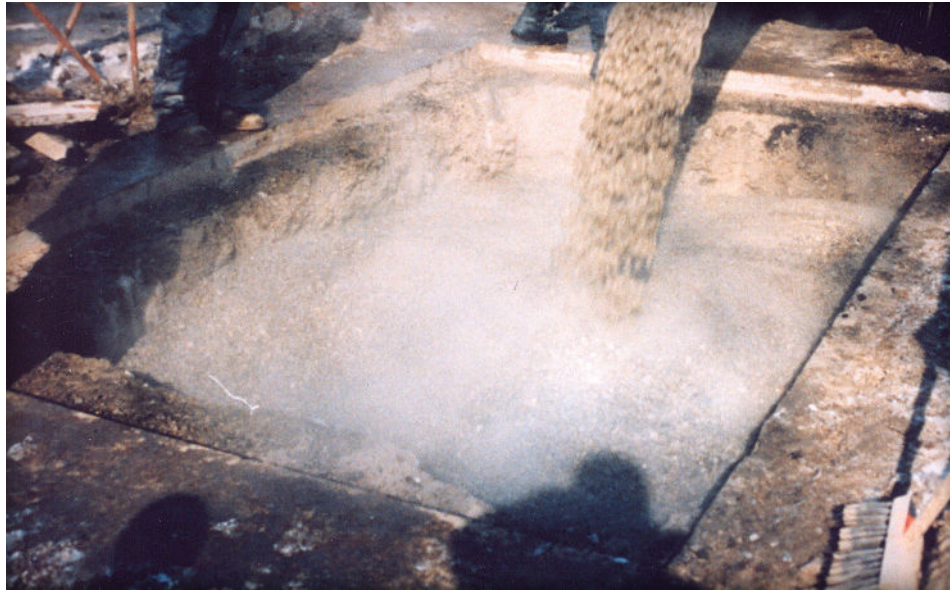
Figure 8. Low density concrete fill (unshrinkable fill) poured into a utility trench from a ready-mix concrete truck.

Unshrinkable fill being poured into a trench is shown in Figure 8. The fill flows into undercuts providing additional support, and in places where the soil or base has fallen from the sides of the trench. These places are normally impossible to completely fill and compact with aggregate base or backfill material.
