# TECH NOTE TEK 06-13B

# THERMAL BRIDGES IN WALL CONSTRUCTION

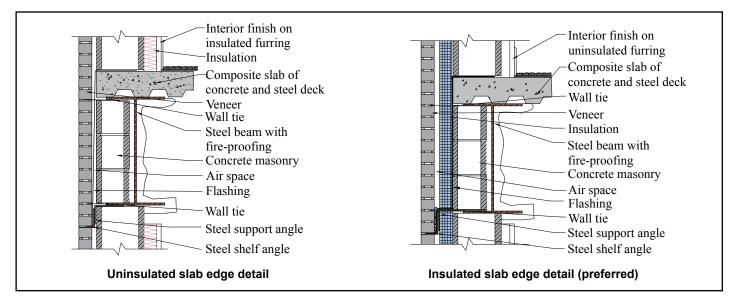
Another common thermal bridge is shown in Figure 3. When this wall system is insulated on the interior, as shown on the left, thermal bridging occurs at the steel beam and where the concrete floor slab penetrates the interior masonry wythe.

A better alternative is to place insulation in the cavity, as shown on the right in Figure 3, rather than on the interior. This strategy effectively isolates both the slab edge and the steel beam from the exterior, substantially reducing heat flow through these areas and condensation potential, and decreasing heating loads (ref. 3).

A third alternative, not illustrated, is to install insulation on the interior of the steel beam. This solution, however, does not address the thermal loss through the slab edge. In addition, the interior insulation causes the temperature of the steel beam to be lower, and can lead to condensation unless a tight and continuous vapor retarder is provided.

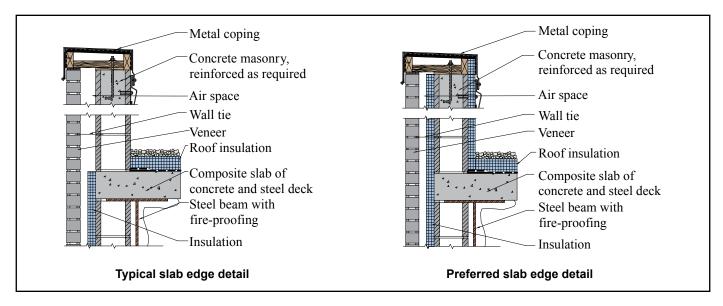
Because a parapet is exposed to the outside environment on both sides, it can act as a thermal fin, wicking heat up through the wall. Figure 4 shows two alternative insulation strategies for a masonry parapet. On the left, even though the slab edge is insulated, the parapet is not. This allows heat loss between the roof slab and the masonry backup.

A better alternative is shown on the right in Figure 4. Here, the parapet itself is insulated, maintaining a thermal boundary between the interior of the building and the outdoor environment. This significantly reduces heating and cooling loads, and virtually eliminates the potential for condensation on the underside of the roof slab.
