Repair of Utility Cuts Within Interlocking Concrete Pavements

Interlocking Concrete
Pavement Institute®

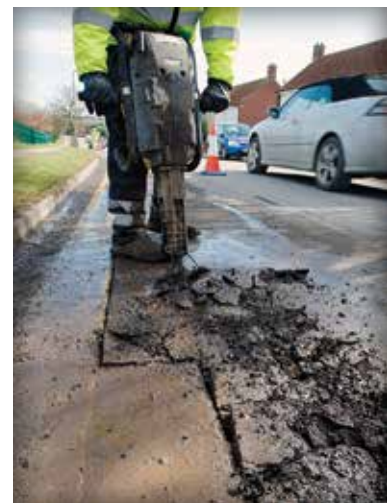
Figure 1. Repairs to utilities are a common sight in cities, incurring costs to cities and taxpayers.

North American cities have thousands of utility cuts made in their streets each year. Figure 1 shows a daily occurrence in most cities: repairs to underground utility lines for water, sewer, gas, electric, steam, phone, fiber-optic, or cable services. A sample is given below of the number of annual utility cuts in a few cities.

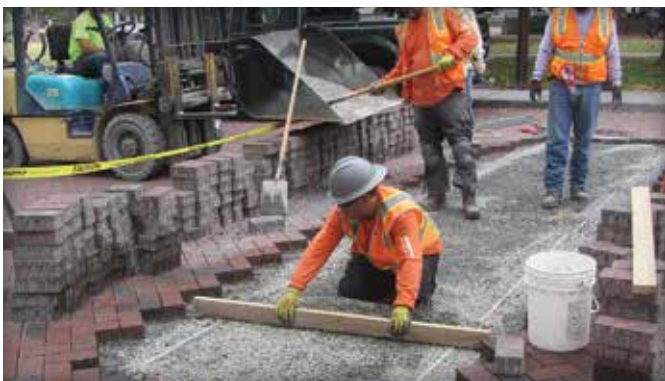
Figure 2. After compaction of the base, bedding material is screeded.

Figures 2, 3, 4, 5 and 6 show the process of repair and illustrate the continuity of the paver surface after it is completed. The

Bedding sand can be installed when the concrete is firm enough to walk on, generally within a few hours after placement. The bedding sand should be as hard as available and should conform to the grading requirements of ASTM C33 (11) or CSA A23.1 (10). *Mason sand, limestone screenings or stone dust should not be used.* The sand should be moist, but not saturated or frozen. Screed the bedding with 1 in. (25 mm) diameter screed pipe. Remove excess sand from the opening.

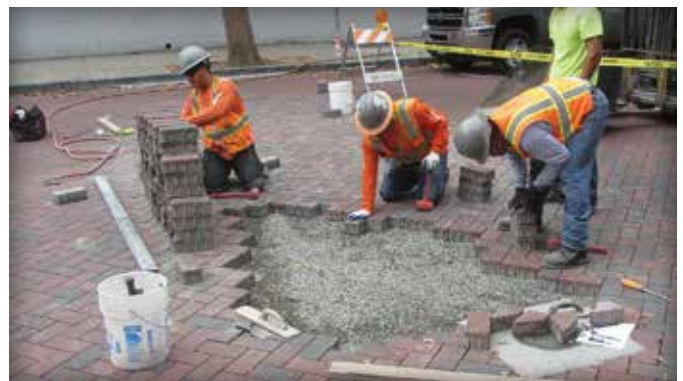
Figure 3. Once smoothed and joined with undisturbed materials at the opening perimeter, the bedding receives concrete pavers.

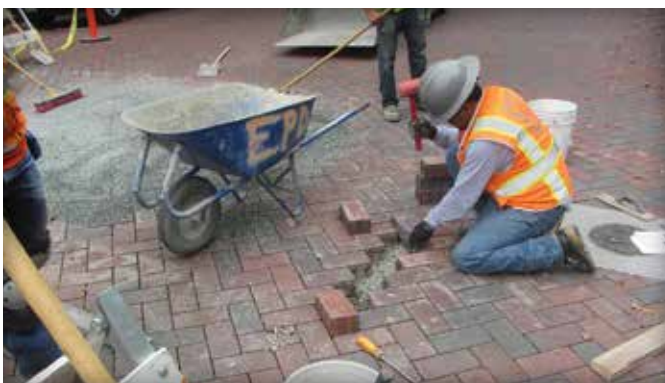
Figure 4. Reinstatement using the same pavers continues following the existing herringbone paving pattern.

Place pavers between the border course in a 90 degree herringbone pattern (Figure 12). Joints between pavers should be between $\frac{1}{16}$ and $\frac{3}{16}$ in. (2 to 5 mm). Compact the pavers with a minimum 5,000 lbf (22 kN) plate compactor. Make at least four passes with the plate compactor. A small test area of pavers may need to be compacted to check the amount of settlement. The bedding sand thickness should be adjusted in thickness to yield pavers no higher than $\frac{1}{8}$ in. (3 mm) above the edge of the undisturbed pavers.

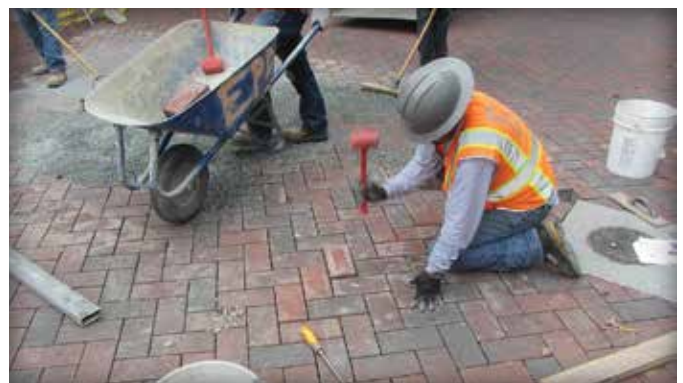
Figure 5. The final paver is inserted, the reinstated area compacted, joints filled, and compacted again. There are not cuts or damage to the pavement surface.

Spread and compact sand into the joints. The joint sand is typically finer than the bedding sand, and should conform to the grading requirements of ASTM C144 (11) or CSA A179 (10). The joints must be completely full of sand after compaction. Remove excess sand and other debris. The pavers may be painted with the same lane, traffic, or crosswalk markings as any other concrete pavements. Plastic markings are not recommended. Light colored pavers can be used for pavement markings. This can save re-painting costs.

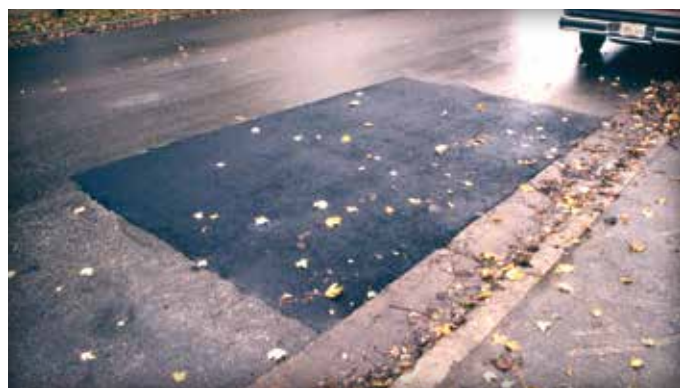
Figure 7. Pavement damage from settlement and shrinkage of cold patch asphalt.

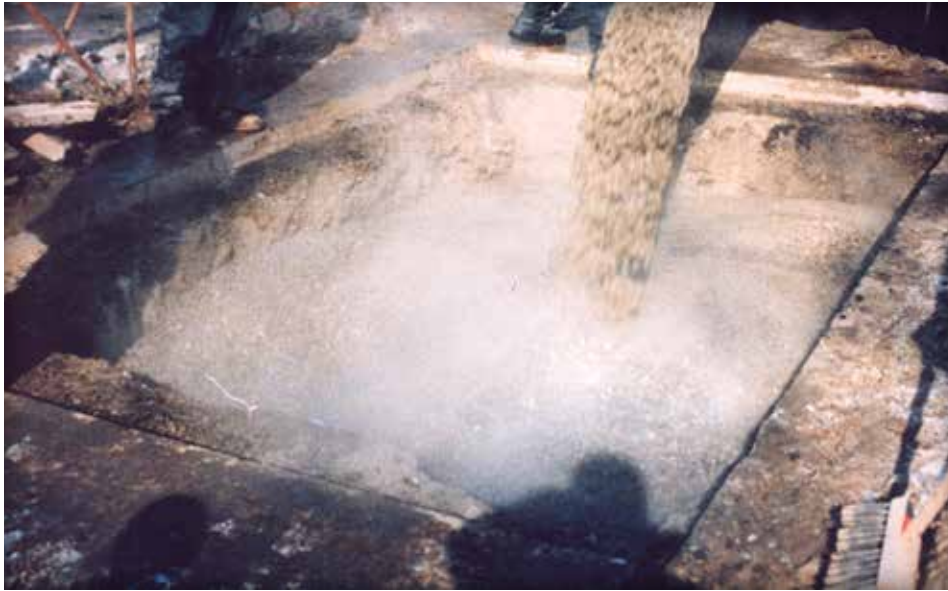
Figure 8. Low density concrete fill (unshrinkable fill) poured into a utility trench from a ready-mix concrete truck.

Unshrinkable fill poured into a trench is shown in Figure 8. The fill flows into undercuts providing additional support, and in places where the soil or base has fallen from the sides of the trench. These places are normally impossible to completely fill and compact with aggregate base or backfill material.

There are many mixes used for low-density concrete fill (7)(8). Proprietary mixtures include those made with fly-ash that harden rapidly. Others are made with cement. A recommended mix can be made with ASTM C150 (9) Type I Portland cement (or Type 3 for winter repairs), or CAN3-A23.5-M type 10 (or type 30 Portland cement) (10). The slump of the concrete should be between
