# Hydraulic Design of Permeable Interlocking Concrete Pavement (PICP)

Recipient: University of Missouri-Kansas City, Kansas City, MO  
Grant: \$112,519 Pls: John Kevern, PhD and Jerry Richardson, PhD  
Completion: 2016  
Project Summary: 9

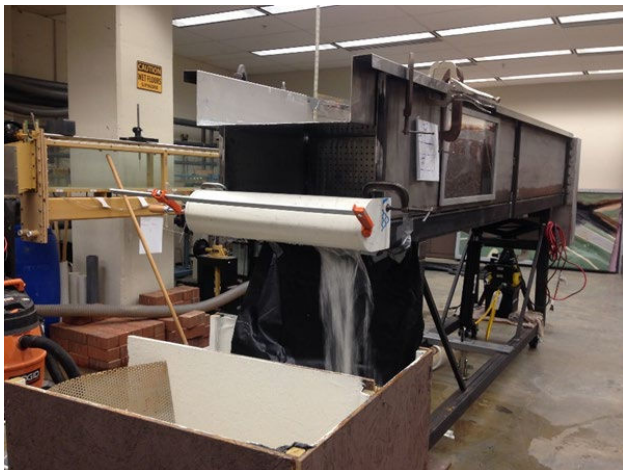
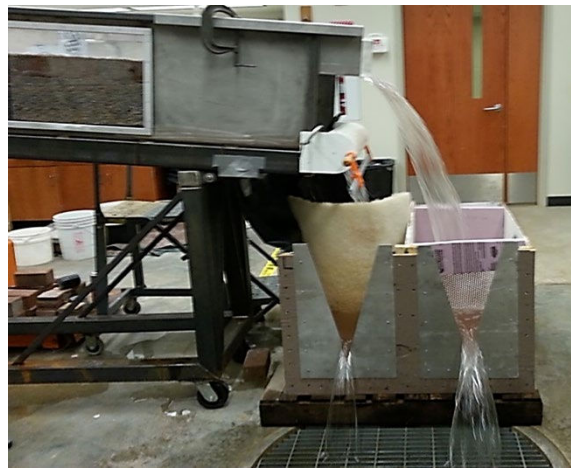
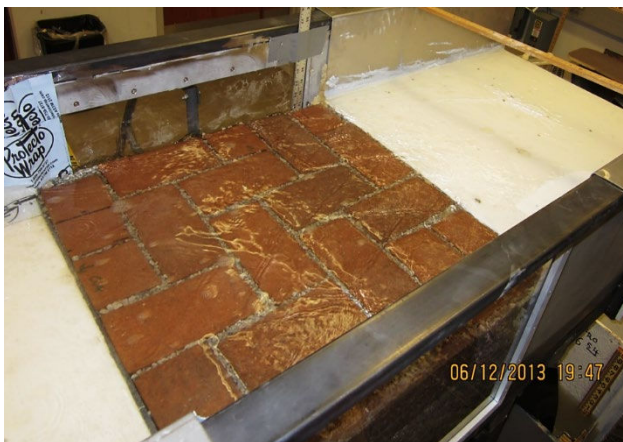
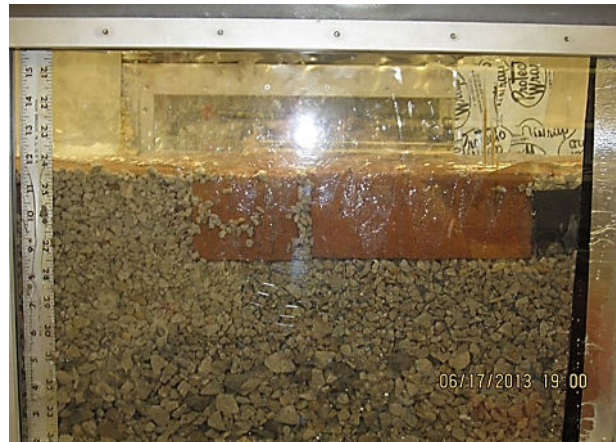
Top left and right: Flume containing PICP measures surface and subsurface flows and volumes. Bottom left and right: PICP surface at the flume end and cross section with jointing, bedding and No. 57 stone base.

This research developed a hydraulic design methodology and laboratory verification to allow proper selection impervious contributing drainage area (CDA) into PICP as well as prediction of surface cleaning. This was accomplished by building a full-scale, two-layer hydraulic PICP model to measure surface and subsurface flows. PICP sections were constructed with 6, 10, and 12.5 mm joint widths using ASTM No. 8 and 9 jointing aggregate and flow tested at slopes up to 10%. 60 mm thick pavers
